**Section 19 Flood and Water Management Act 2010**

**Debenham Flood Investigation - Storm Babet October  
2023**

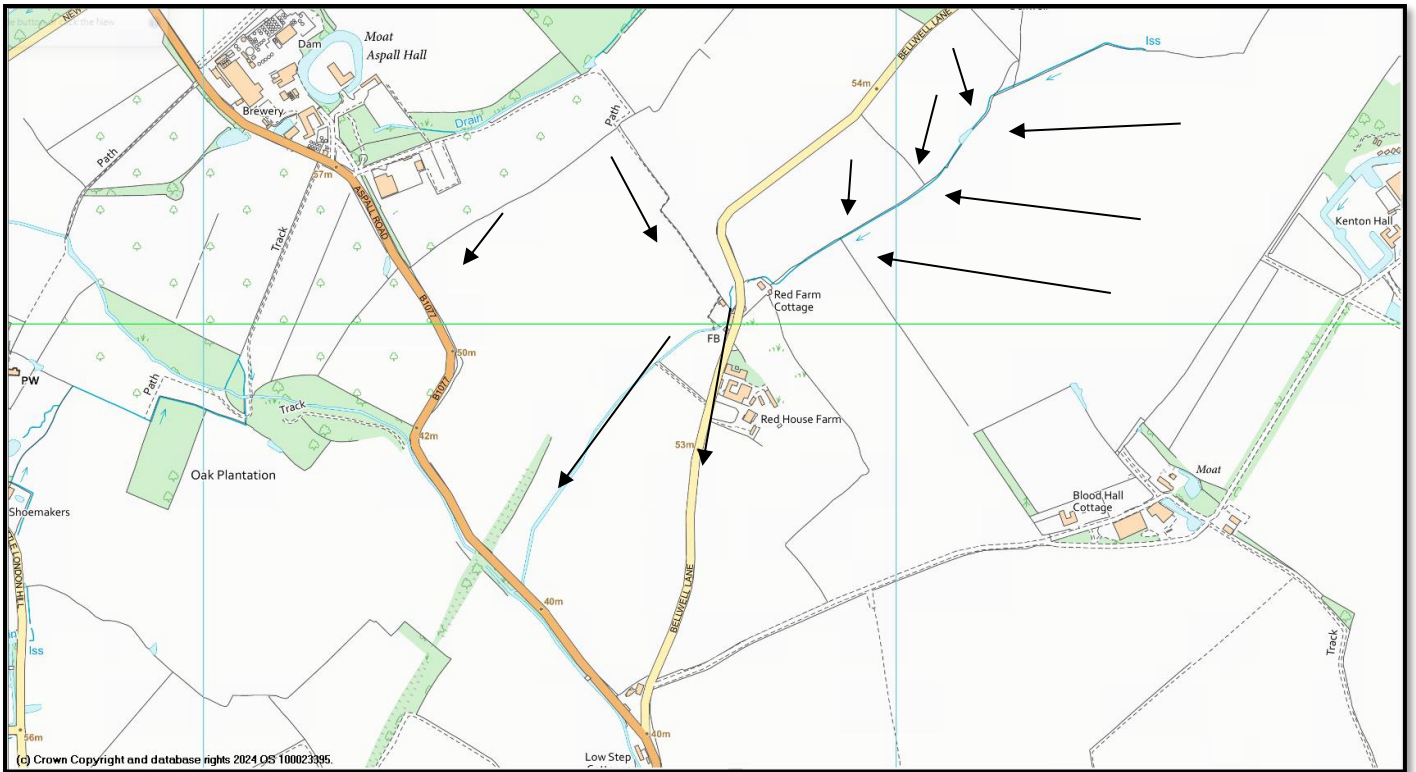
Figure 10 – Flow paths in northern Debenham

Located north of the village, Bellwell Lane runs adjacent to an ordinary watercourse which travels under the road, through a culvert located approximately 2 kms north of the village centre. According to reports, the culvert in this area was overwhelmed early in the day due to the volume of water coming off the surrounding field network.

A small ordinary water course inflows from the east taking water from a large surrounding area. A site visit confirmed there to be three interconnecting watercourses in this area which appear to flow through a large box culvert under the highway. There appeared to be a significant level of silt in the culvert which may have influenced its functioning capacity during the event. Additionally, there is a headwall in the northern watercourse which does not appear to contain a pipe to continue the flow, either the pipe is buried under significant debris or there is not a pipe to convey the water. This headwall then effectively forces the water onto the highway at this point preventing its movement downstream in the watercourse.

The flows in this area continued down the path of the watercourse and on the road towards Aspoll Road, eventually converging with the flood water in Debenham village. Reports suggest that a small number of properties on Bellwell Lane were flooded, which flooded previously in May 2023 potentially due to a blockage of the culvert under the highway.

- Drainage assets were overwhelmed beyond their capacity.
- Culvert under the road may have been blocked or not working correctly, resulting in impedance of flood water.
- Watercourse in area may have been blocked or not flowing at full capacity, resulting in impedance of flood water.

- Suffolk County Council Highways Authority to investigate possible blockage and silt build up in culvert located on Bellwell Lane.
- Riparian owner to carry out regular maintenance on watercourse to ensure a good flow of water.
- Investigate possibility of Natural Flood Management features on the west side of Bellwell Lane just to the south of where the culvert outfalls.

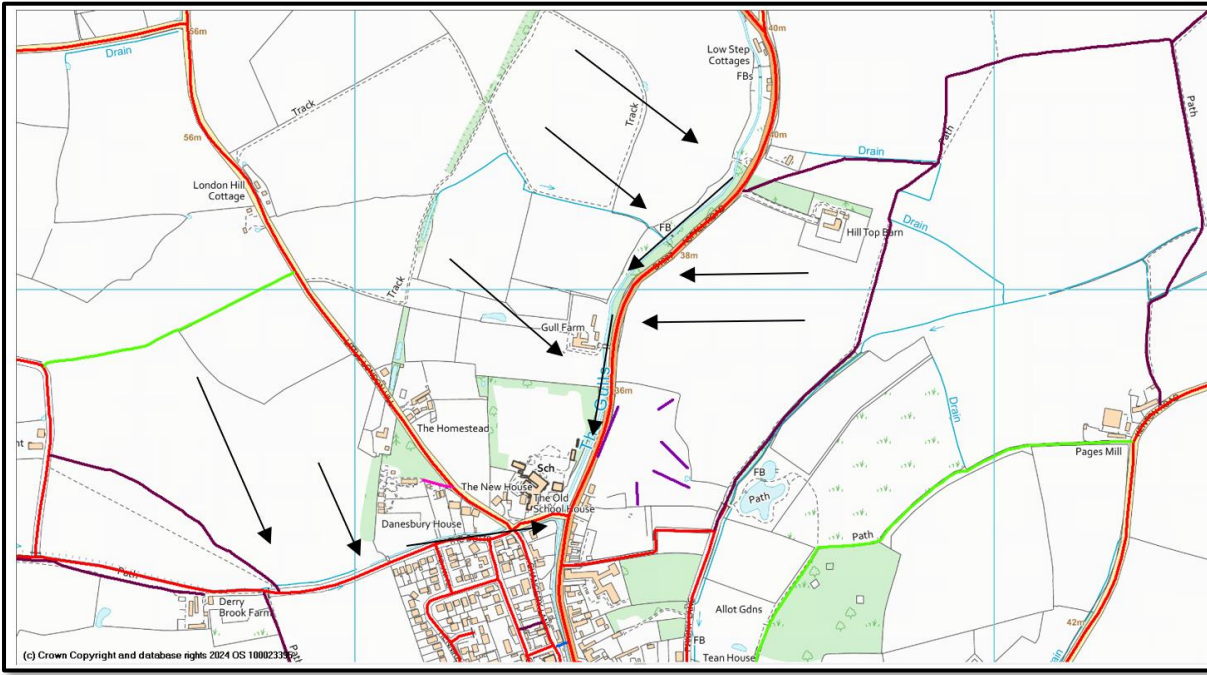
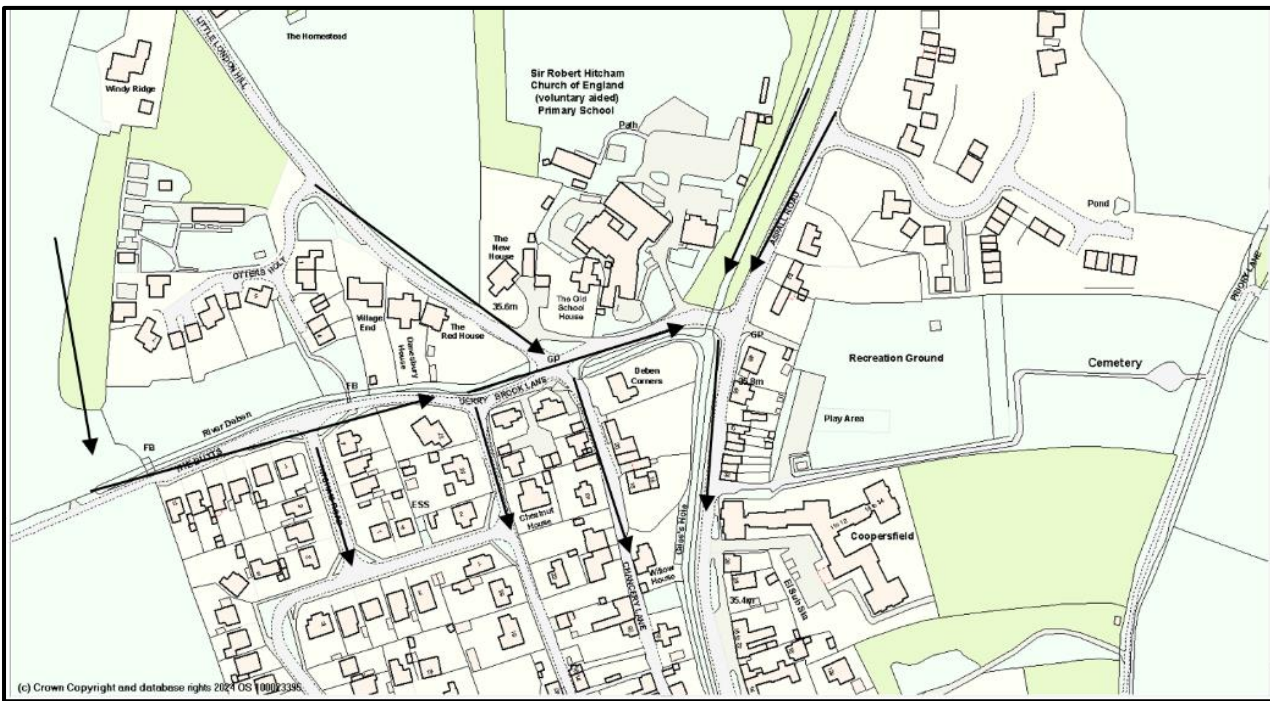
Reports from the southern end of Chancery Lane and Aspall road suggest sewage and oil were present in the flood water suggesting the sewerage system had become overwhelmed, and reports from the community suggest a home oil storage tank had slipped into the watercourse, possibly causing an additional blockage and leaking oil into the river.

The flow from the north, down Aspall Road and the adjacent watercourse, meets the main river Deben beside the road junction with the Butts, just south of the primary school. There is additional flow from Little London Hill and The Butts which travels in from the west. As a result of the overtopped river Deben, water flowed south down Chancery Lane and Aspall Road where it affected 25 properties across the two roads. Reports suggest internal water depths ranging from 5cm to 45cm, resulting in damaged properties, cars and the need to evacuate homes.

- Large volume of water runoff from surrounding fields possibly caused damage to watercourses and allowed water to flow down the road.
- Concerns that the attenuation features on the new housing developments were not working correctly.

- Watercourses overtopping into the highway possibly exacerbated by high levels of vegetation in the area.
- Possible changes in cultivation direction could have funnelled water towards the highway and watercourses faster.

- Local Planning Authority to finalise the investigation into the local housing development to ensure the attenuation features are built to agreed plans and work effectively.
- Landowner to investigate possibility of cultivating fields across the hill rather than up and down which may help to slow up the surface water run-off.

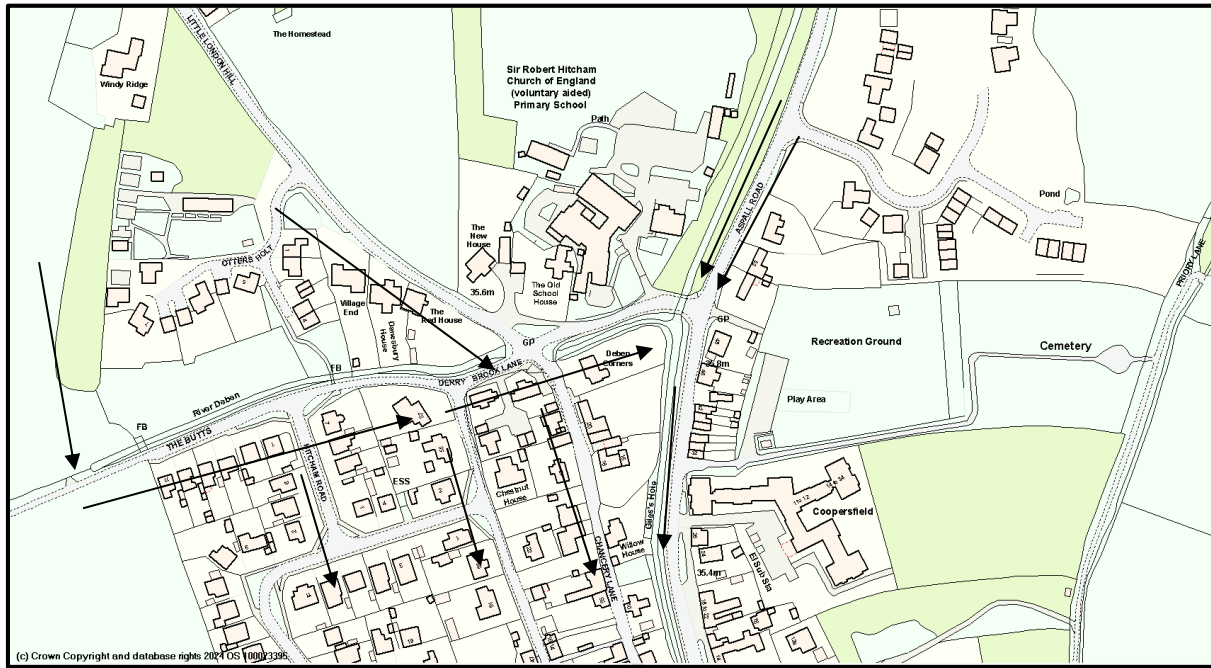
Figure 13 – Flow paths in northern Debenham

The flow path for the water in this area is from the west and north, heading east and south into the central village catchment. The overtopping of the Derry Brook in this area causing the road to act as a secondary flow path, contributing to the flooding experienced here and on the surrounding and adjoining streets such as Aspall Road and Chancery Lane.

Reports have said that internal flooding was experienced by at least 5 properties across the four roads with internal depths of water reaching 35cm and external depths deep enough to fully submerge cars.

- Overwhelmed watercourses caused spill of flood water onto the highway which then entered properties from the highway.
- Concerns about recent housing developments and the management of surface water from the site.
- Saturated and low permeable ground could have exacerbated the flooding on this occasion.

- LPA to complete investigations into housing developments water management

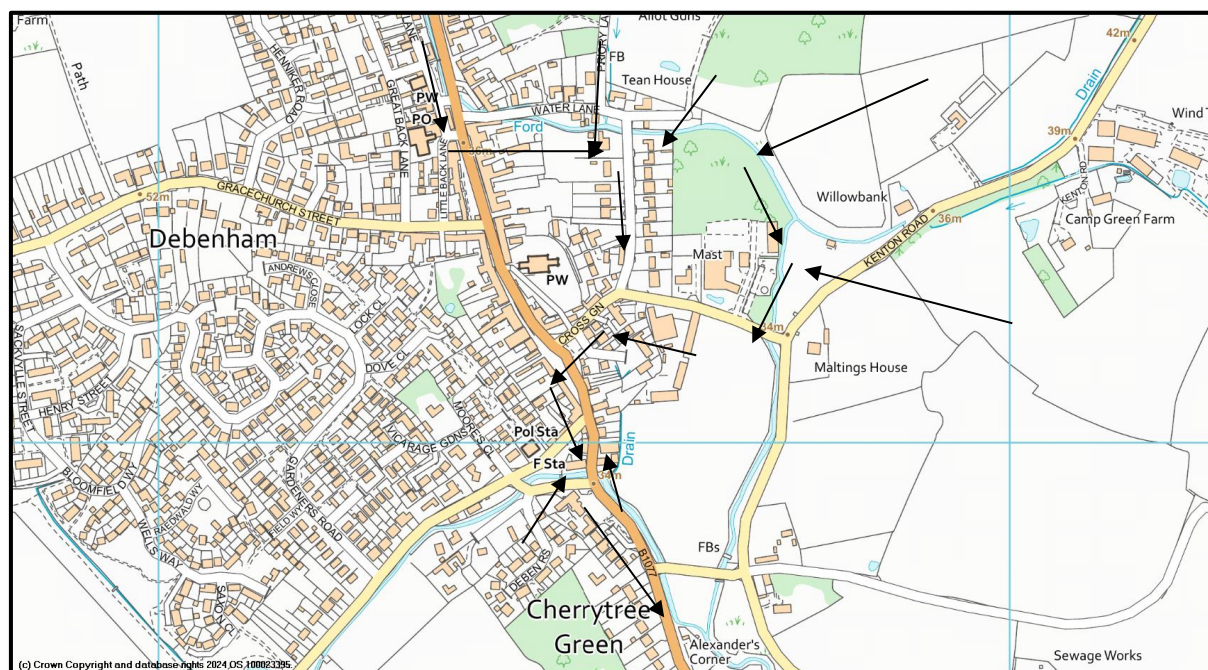
Figure 14 – Flow paths in central Debenham

The flow in this area comes primarily from the over topped River Deben, with water traveling south along Aspell Road and Chancery Lane, before flowing along Water Lane and down Priory Lane. Flow paths from northern Priory Lane and Kenton Road to the east, added to the flows, and resulted in the flooding of Cross Green and the Meadow Works business park.

There is some concern that the watercourse on the northern arm of Priory Lane and the culvert under the road on water lane were not operating to full capacity due to overgrowth and silting up of the features. This may have contributed to the severity of the flooding within this location. Currently the riparian ownership responsibilities of the section of watercourse in northern Priory Lane is under discussion. It should however be acknowledged that the volume of rainfall experienced, is likely to have exceeded the design capacity of drainage assets and led to the overwhelming of infrastructure in spite of vegetation levels.

There were 24 reports of affected properties in this area with internal flooding depths ranging from 20cm to over 90cm and external flood water being over 150cm deep.

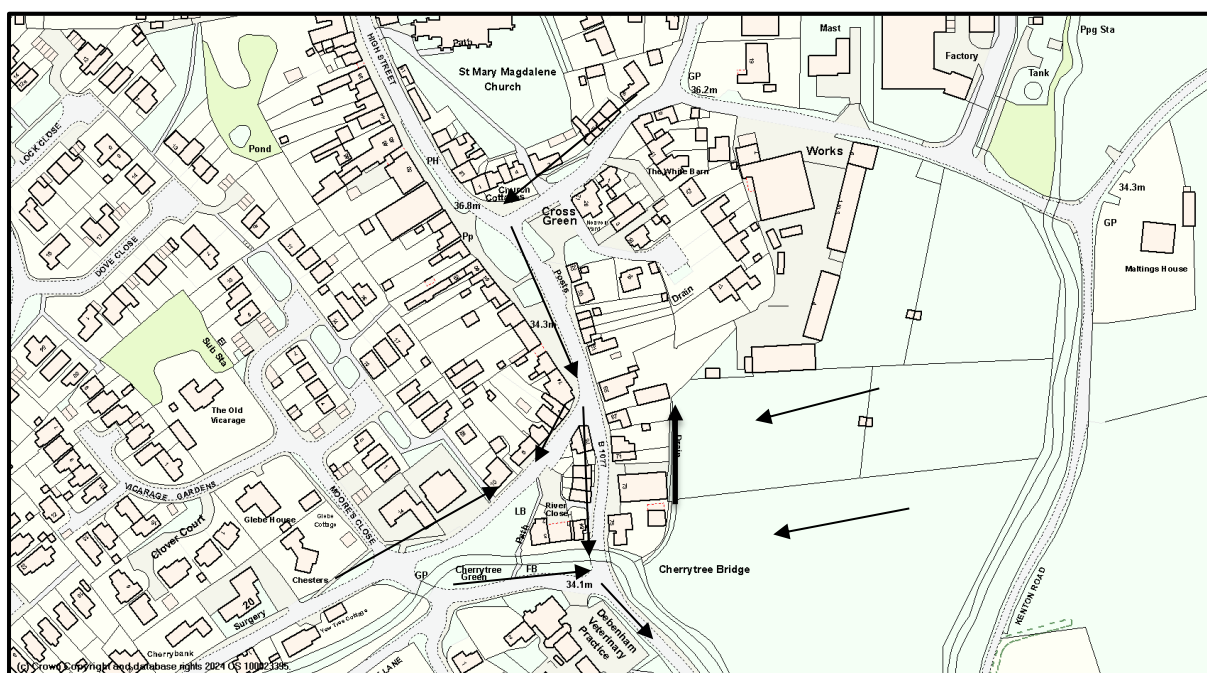
Figure 15 – Flow paths in central Debenham

Due to the significant amount of rainfall, once the Cherry Tree Brook and River Deben had been overwhelmed reports suggest that water was being forced north (against the natural flow) along an ordinary water course which borders the easterly edge of the back gardens of properties on the High Street, as a result of this the watercourse was very quickly overwhelmed and spilled out affecting properties from the back in addition to the water already coming from the highway to their front.

The land to the east of the High Street behind the properties is known to be one of the worst affected spots and is at very high risk of flooding from both fluvial and pluvial sources.

24 Properties are known to have been affected in this area with reports ranging from 15cm to over 60cm of internal flooding.

- Flood water from Cherry Tree Brook, Cross Green, and green space to the east of high street congregated in this area.
- Overland flows resulted in the cherry tree brook and River Deben to reach capacity.
- Continued vehicle movement through flood water caused worsening of flood water ingress to properties.
- Drainage assets on the highway were overwhelmed.

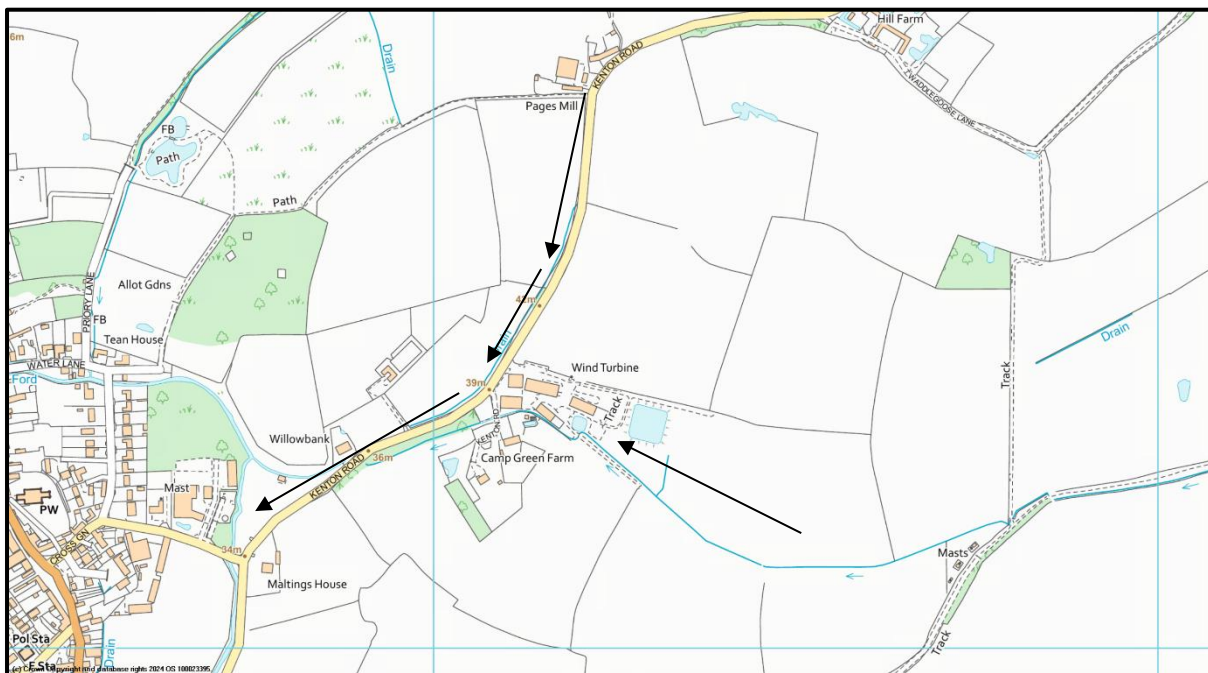
Figure 16 – Flow paths in eastern Debenham

Located to the east of the village centre, Kenton Road was an isolated case from the rest of the village. Reports suggest a combination of fast flowing surface water and overwhelmed watercourses in the area, contributed to the flooding, the water simply flowed to the lowest point once watercourses were overwhelmed.

Kenton Road is a main flow path on the predicted risk of surface water flooding maps. There are several ordinary watercourses in the area which flow adjacent to the road on both sides. Additionally, there are a number of watercourses that are piped, which may have caused a constriction if blocked or have insufficient capacity during Storm Babet. This may have resulted in the overwhelming of watercourses and contributed to flooding experienced in this location.

Flooding was recorded as being approximately 45cm deep affecting offices, farm buildings and workshops.

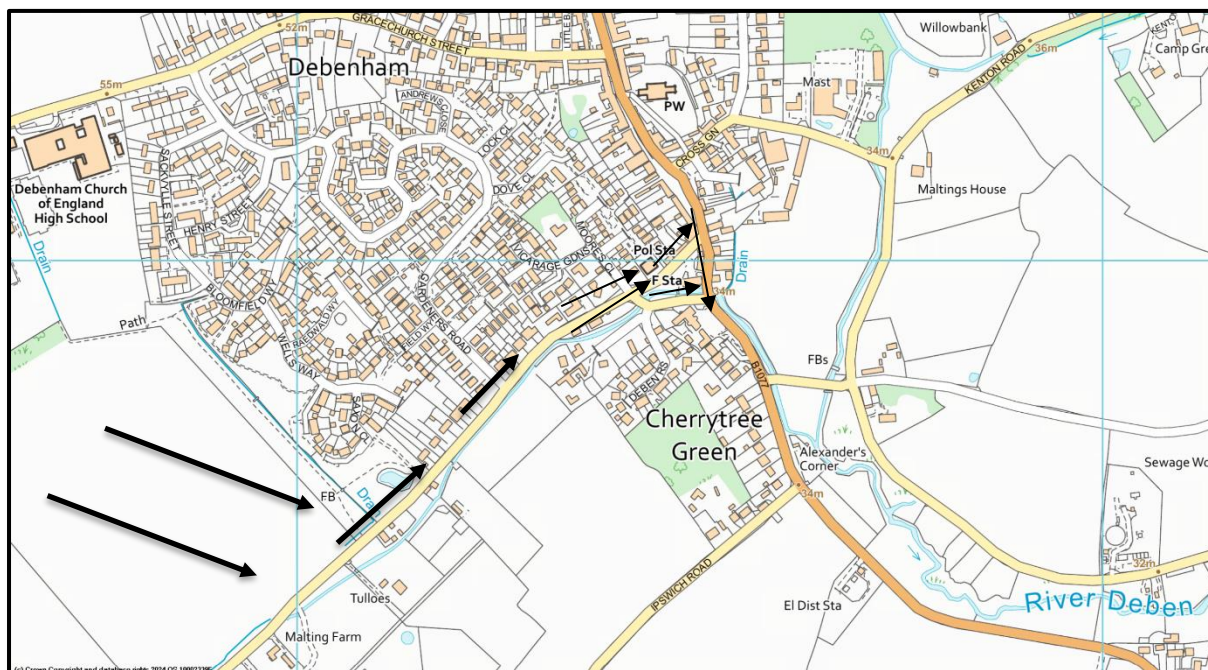
Figure 17 – Flow paths in southern Debenham

Many properties in the area reported being affected from both the road at the front of the property and the Brook at the back of the property. Properties were surrounded by flood water and in some cases flood water was coming up through the floor due to rising groundwater levels.

The flow path experienced is in line with the predicted flood risk map, coming along the line of the Cherry Tree Brook and spilling on Low Road and Cherry Tree Lane. As the water passes along Low Road, it meets the High Street, accumulating here before flowing south out of the catchment.

Commercial and residential properties in this area were affected, with significant damage being done to resources in local emergency services stations and charitable centres. 23 properties are known to have been affected with reports suggesting internal flooding levels of between 15cm and 90cm being recorded and external depths of over 90cm being observed.

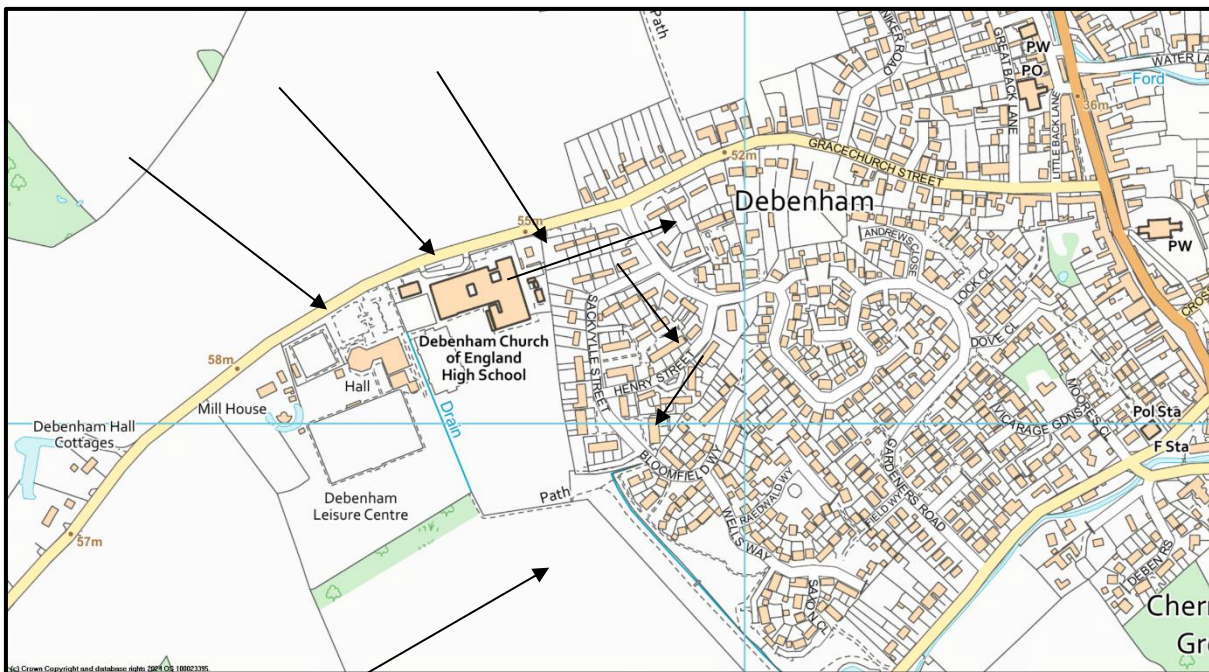
Figure 18 – Flow paths in western Debenham

It is therefore likely that volume of water and potential blockages within highways networks were contributing factors.

Gracechurch Street shows as an area of very low risk to surface water flooding on the predicted flood maps. However, reports in the area suggest that a blocked sewer or highways drainage gully could have been a contributing factor. Given only a small number of properties were affected, a localised blockage could have contributed to the flooding.

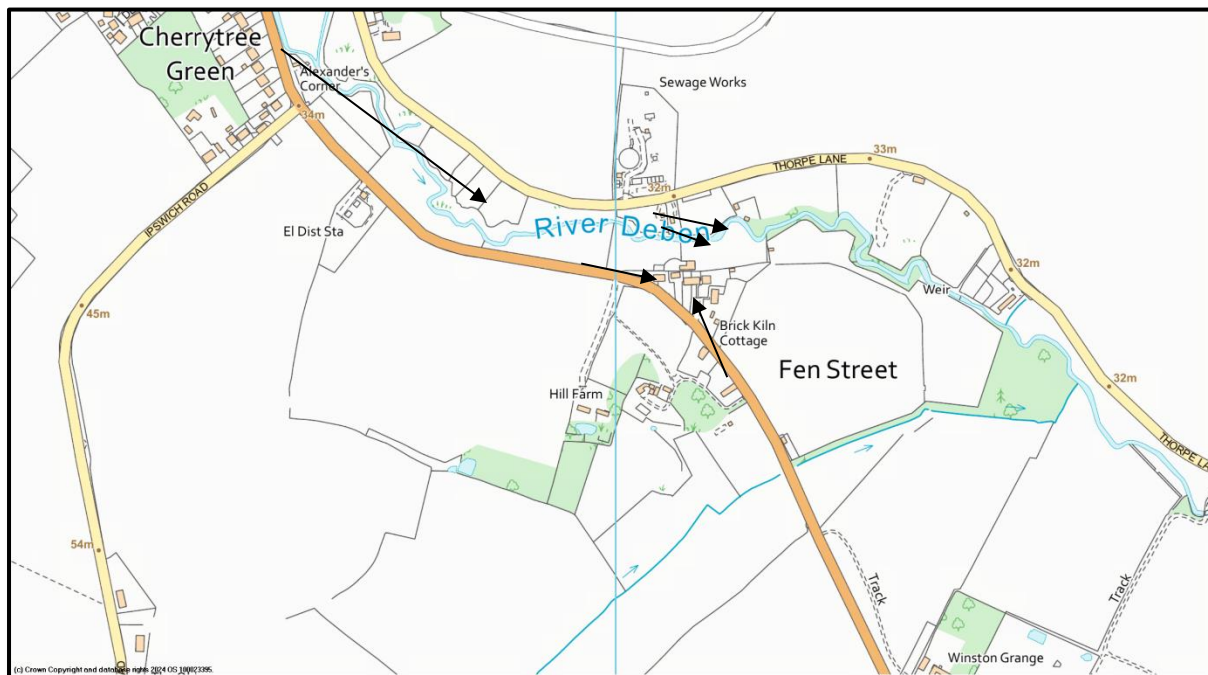
Figure 19 – Flow paths in southern Debenham

Fen Street is a Hamlet along Winston Road (B1077), half a kilometre southeast of Debenham village. A small number of properties were reported to have flooded during Storm Babet and are situated parallel to the River Deben. There is limited information for this area but of what has been received, it was reported that the River Deben overtopped its banks onto the flood plain before flooding properties from the rear. Flood water also travelled from the road descending north towards the properties resulting in properties being surrounded by flood water. Impacted properties are situated lower than the road.

- No action suggested beyond those made to all affected residents in the recommendations section of this report.

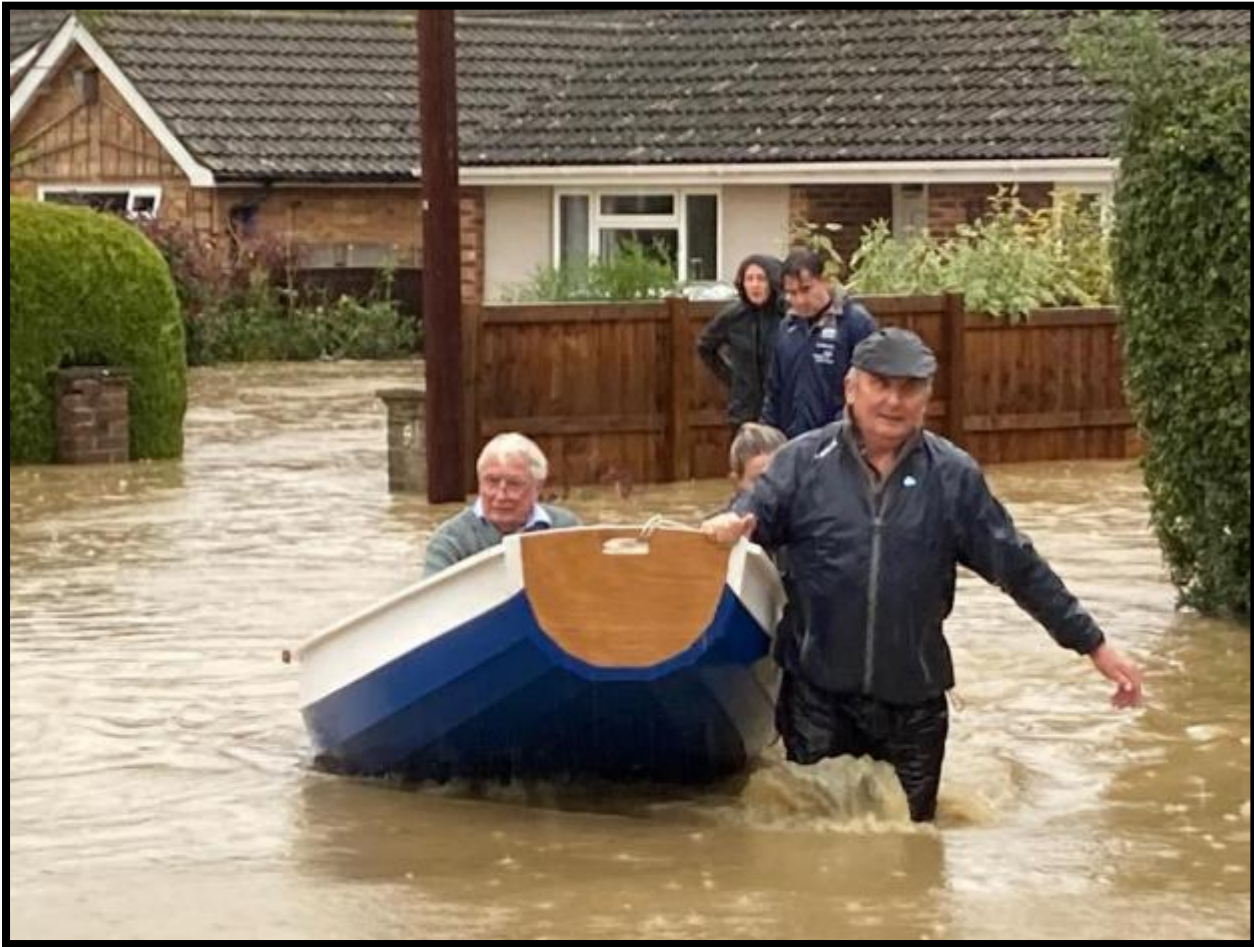
Central Debenham, residents having to be rescued by boat

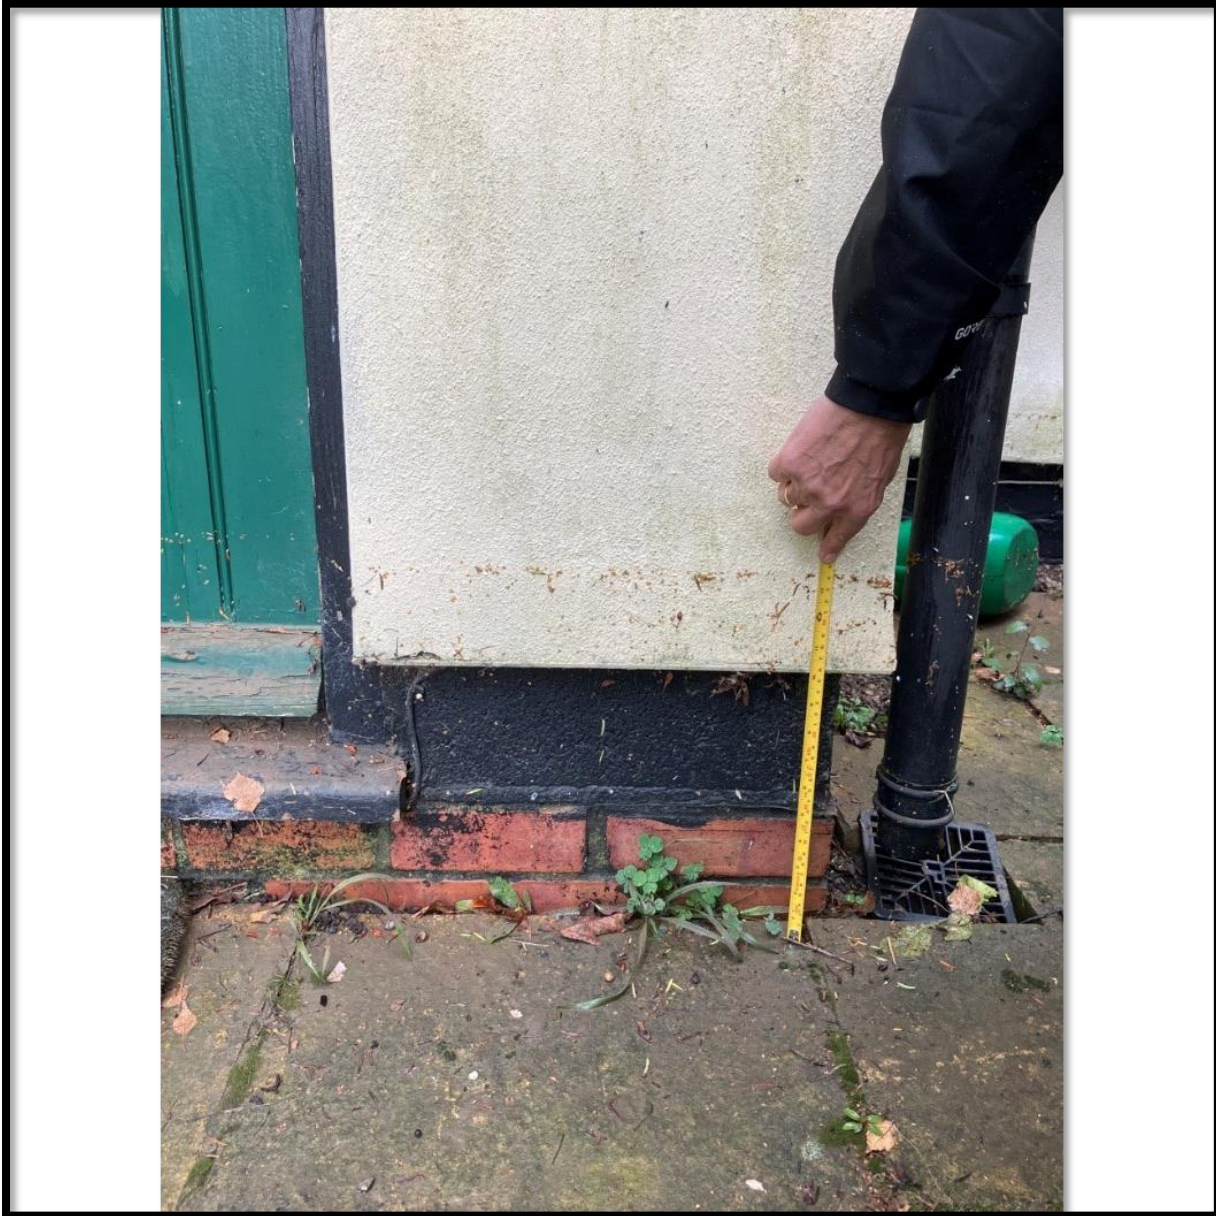
Post event wrack marks measured by EA CIOs

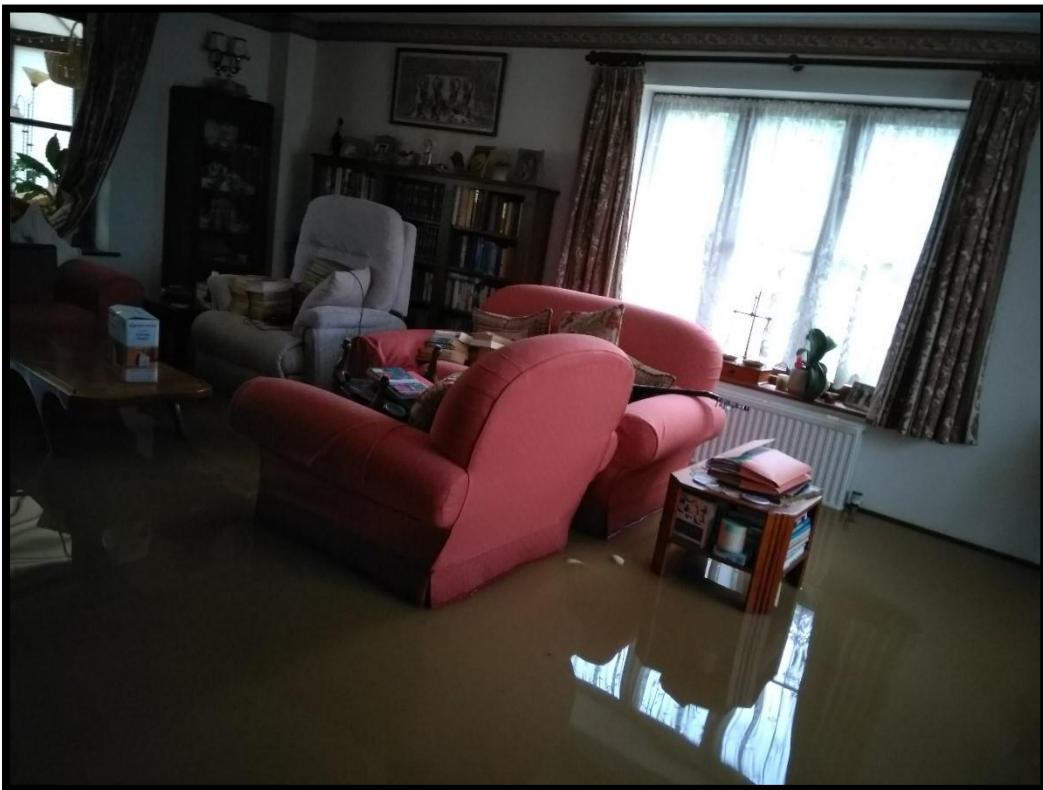
Internal Flooding extents

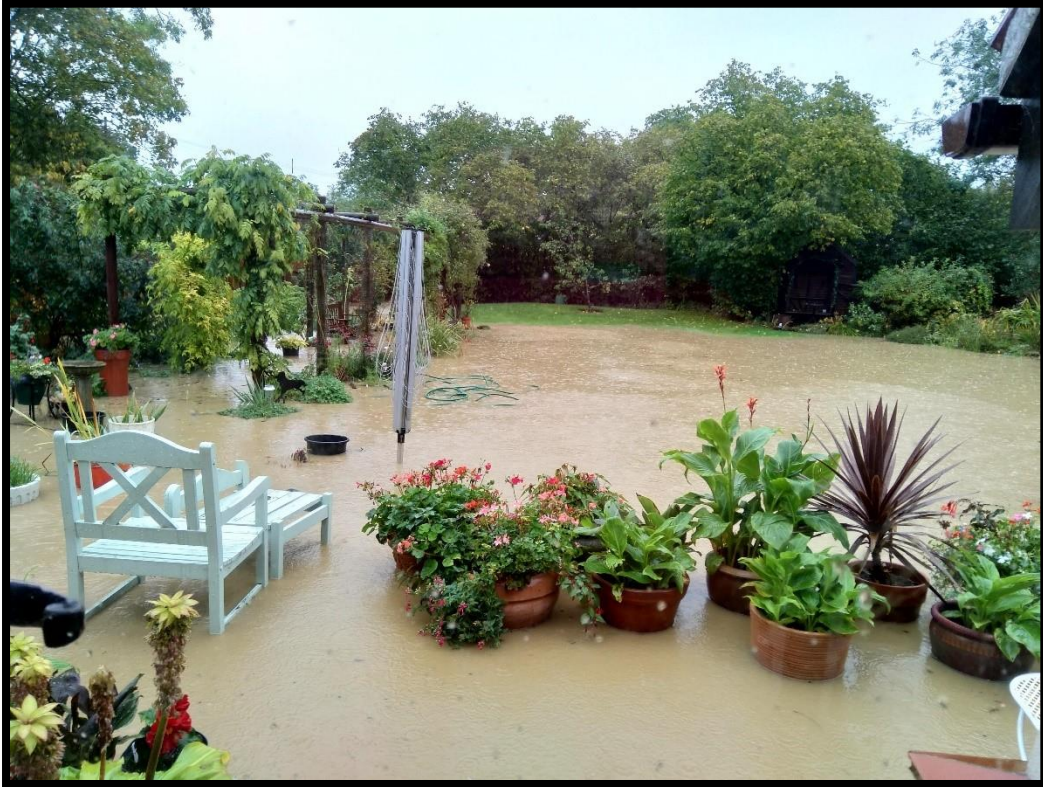
External flooding extents
