## Section 19 Flood and Water Management Act 2010

### Debenham Flood Investigation - Storm Babet October 2023

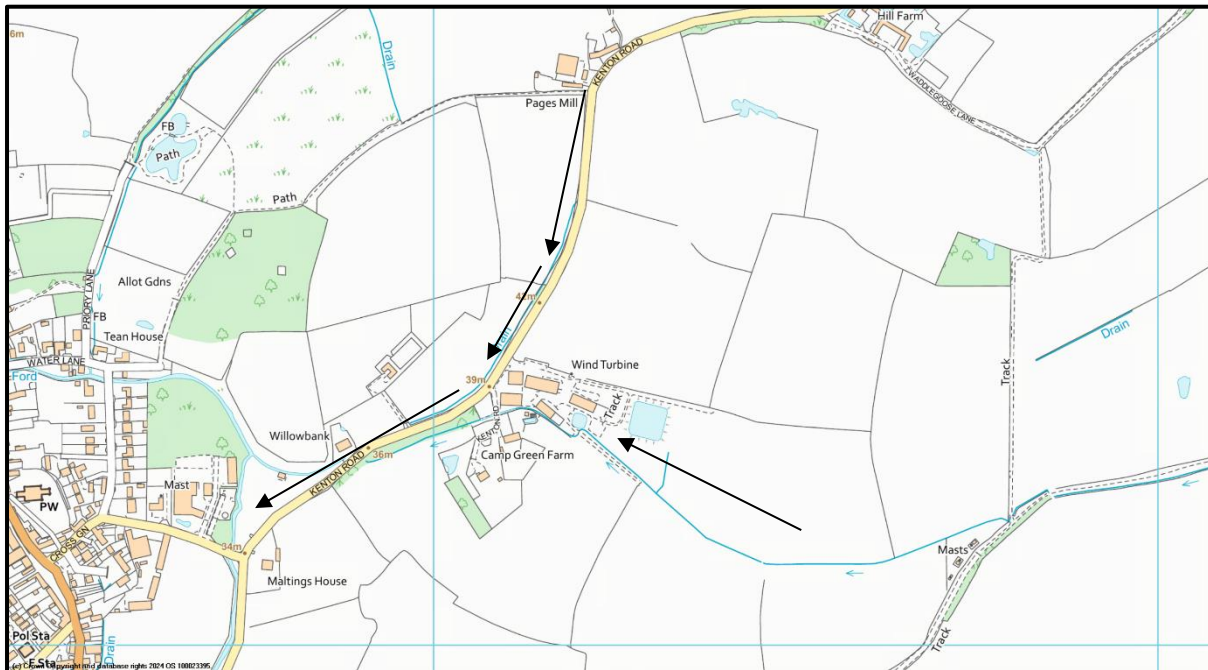
Figure 16 – Flow paths in eastern Debenham

Located to the east of the village centre, Kenton Road was an isolated case from the rest of the village. Reports suggest a combination of fast flowing surface water and overwhelmed watercourses in the area, contributed to the flooding, the water simply flowed to the lowest point once watercourses were overwhelmed.

Kenton Road is a main flow path on the predicted risk of surface water flooding maps. There are several ordinary watercourses in the area which flow adjacent to the road on both sides. Additionally, there are a number of watercourses that are piped, which may have caused a constriction if blocked or have insufficient capacity during Storm Babet. This may have resulted in the overwhelming of watercourses and contributed to flooding experienced in this location.

Flooding was recorded as being approximately 45cm deep affecting offices, farm buildings and workshops.

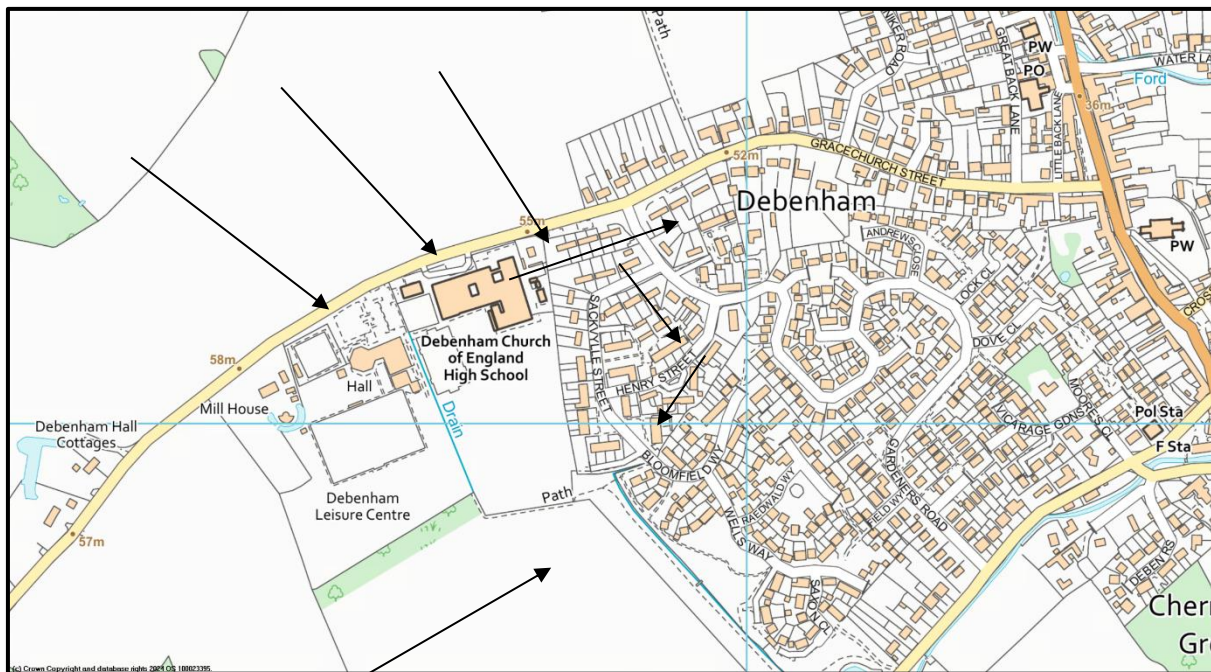
Figure 18 – Flow paths in western Debenham

It is therefore likely that volume of water and potential blockages within highways networks were contributing factors.

Gracechurch Street shows as an area of very low risk to surface water flooding on the predicted flood maps. However, reports in the area suggest that a blocked sewer or highways drainage gully could have been a contributing factor. Given only a small number of properties were affected, a localised blockage could have contributed to the flooding.
