## Section 19 Flood and Water Management Act 2010

### Charsfield Flood Investigation – Storm Babet 2023

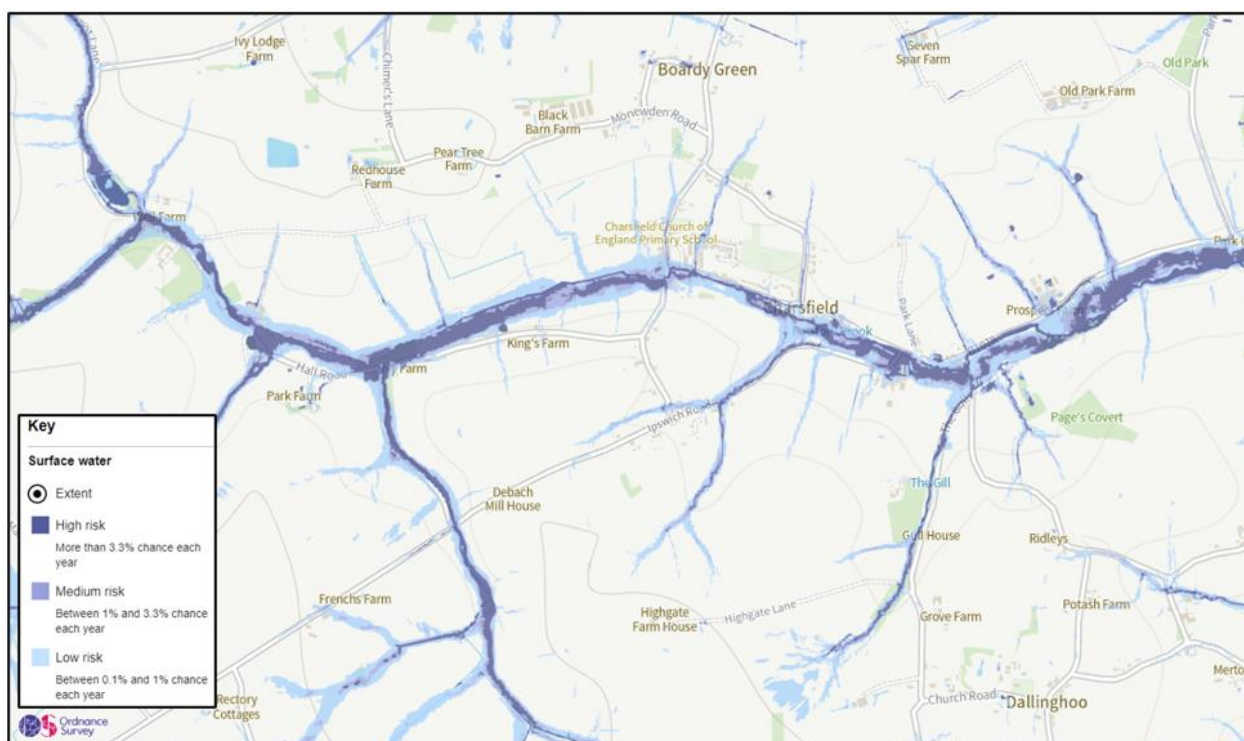
Figure 5 - Predicted surface water flood risk

Figure 5 highlights the predicted pluvial (surface water run-off from surrounding land) flood risk within Charsfield, with multiple floodwater flow paths flowing into the village. There is significant risk of surface water flooding in Charsfield, with Chapel Lane, St. Peter's Close, Church Road, Hall Road and The Street all identified to be at risk. These areas were affected by flooding during Storm Babet.

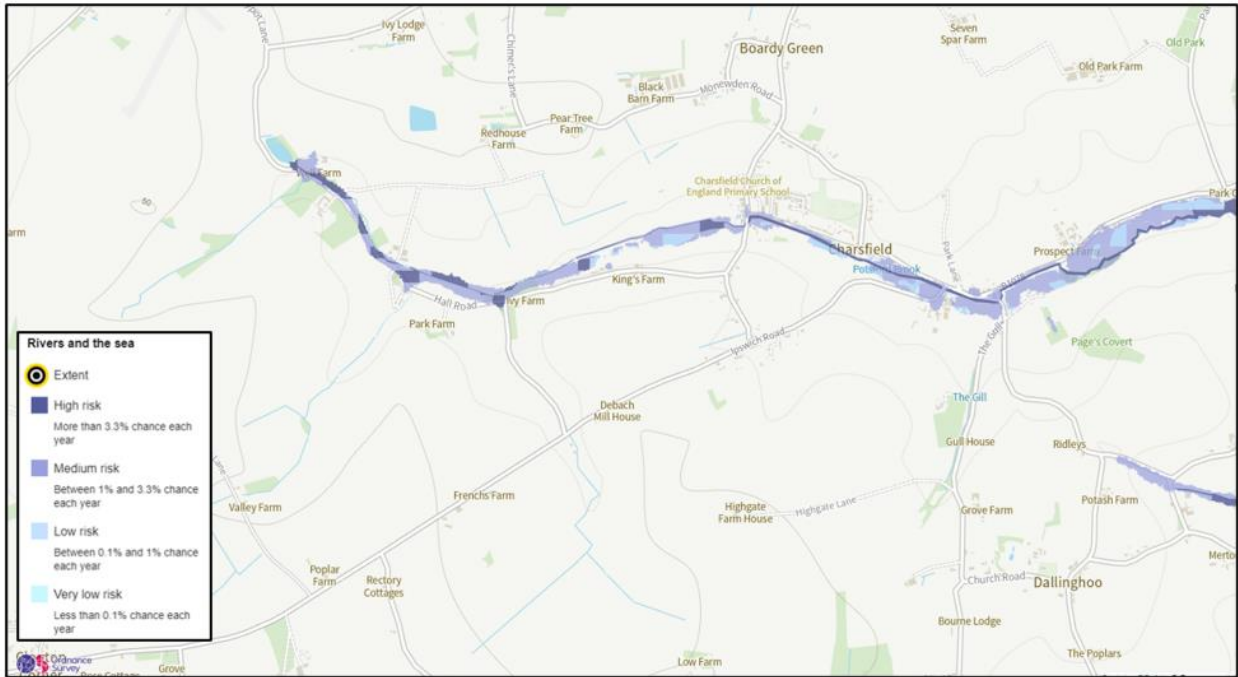
Figure 6 - Predicted flood risk from rivers and sea

Figure 6 highlights the predicted fluvial (from ordinary watercourse and main river) flood risk within Charsfield. The main fluvial influence is the Potsford Brook, a tributary of the River Deben. Church Road, The Street and Wickham Market Road are shown as being at risk from fluvial flooding. These areas were affected by flooding during Storm Babet.

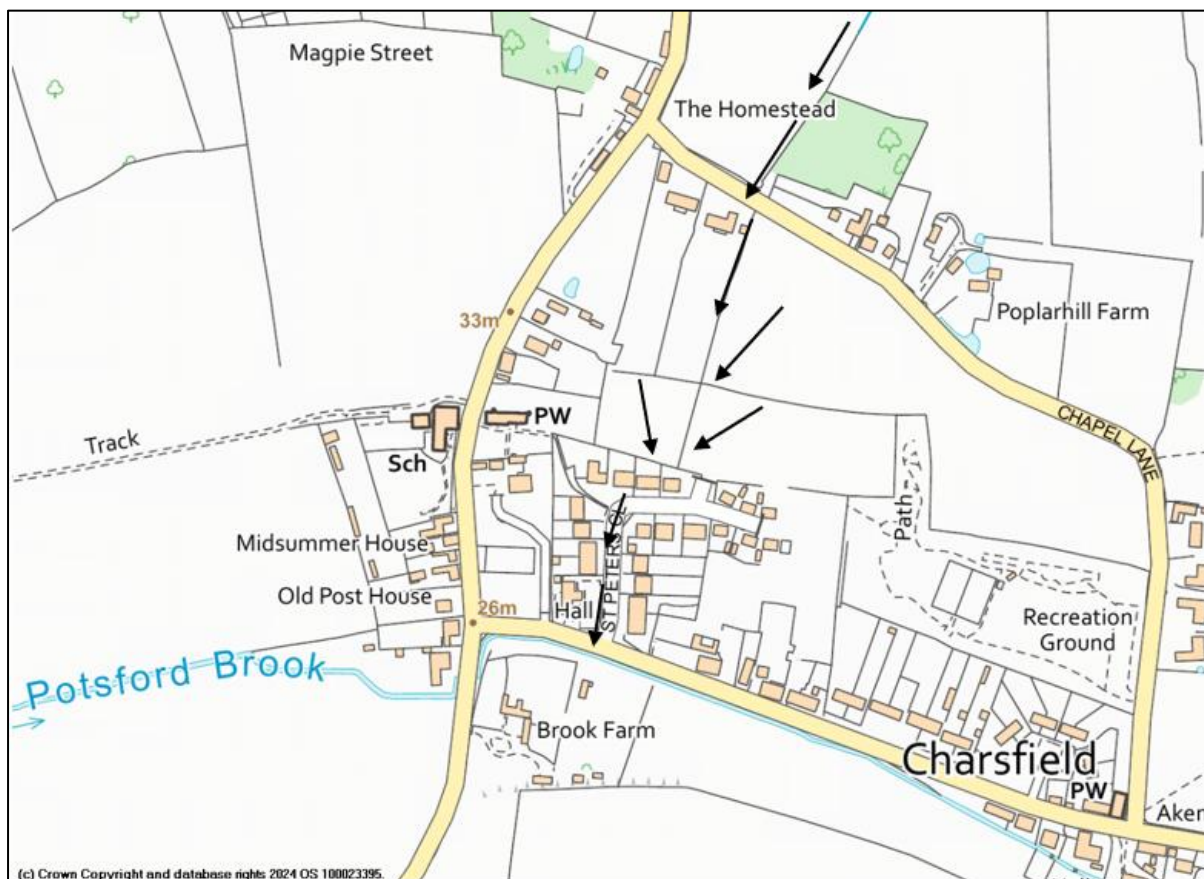
Figure 12 - Approximate flood water flow routes towards and through St. Peters Close

Residents reported that the floodwater flow path continued south of the western section of Chapel Lane across the fields towards St Peters Close (see Figure 12). Properties at the top of St Peters Close were impacted directly to the rear by the surface water coming down the ditch. The ditch feeds into a pipe which was unable to cope with the volume of water. The capacity of the ditch and pipe behind the houses were very quickly overwhelmed and overtopped, coming through and around the gardens and then flowing down the length of St Peters Close like a torrent. The flooding seen on St Peters Close during Storm Babet mirrored the previous flood event experienced earlier in the year on 9 May 2023. On that occasion an intense rainfall event produced localised flooding and was concluded to be from surface water run-off from the fields to the north.

- Investigate potential Natural Flood Management (NFM) projects and funding opportunities which aim to attenuate water and 'slow the flow' in the upper catchment north of Charsfield, including the ditch north of St Peters Close.
- Investigate the options to extend the ditch or introduce tree planting or a hedgerow buffer zone along the north side of Chapel Lane.
- Ensure the completion of the existing highway drainage asset cyclic maintenance on St Peters Close and the western end of Chapel Lane.
- Investigate if the capacity and condition of the drainage assets at the western end of Chapel Lane and on St Peters Close are sufficient.
- Landowner to investigate if the capacity of the piped watercourse above St Peters Close can be increased.
- Maximise the take up of the £5k PFR Grant currently available to residents.

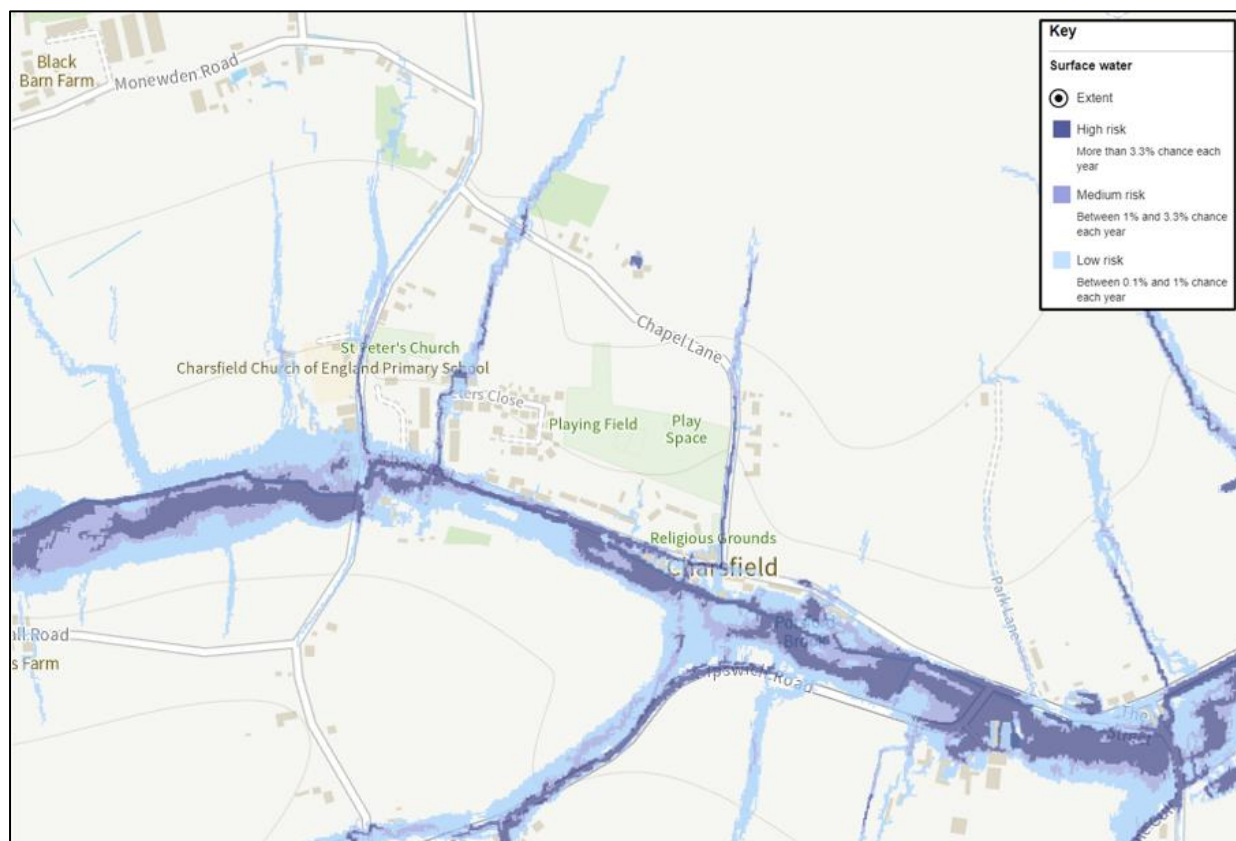
Figure 13 - Predicted surface water flood risk for Charsfield

Floodwater was accumulating at the bottom of St Peters Close from 7:00am onwards, making it one of the earliest sites of flooding in the village (Image 5). Internal flooding on St Peters Close was reported from 8:00am onwards with no sign of lessening until late afternoon. The observed floodwater flow path seen on Chapel Lane and St Peters Close is consistent with the predicted surface water flood risk which is defined as Medium to High in this location (see Figure 13).

There is a significant flow path identified along Chapel Lane, as outlined in Figure 13, with flood flows merging at the junction with The Street. There are a series of 'grips' to allow water to flow off the road and into the adjacent watercourse. These have become silted up and are last recorded to have been formally inspected in 2019. Whilst there is a minor watercourse running parallel to Chapel Lane, floodwater mainly flowed down the highway, which is relatively steep, collecting in large volumes at the southern end of Chapel Lane where it meets The Street (Image 3). At this point the watercourse is piped for a short section before out falling into Potsford Brook. However, as the pipe is relatively small (approx. 300mm in diameter) and most of the floodwater was within the highway rather than the upstream watercourse, this indicates the pipe could not accommodate the flow. The piped section has less capacity than the original open channel and has likely reduced the volume of water that could be safely conveyed from the bottom of Chapel Lane into Potsford Brook during a storm event.

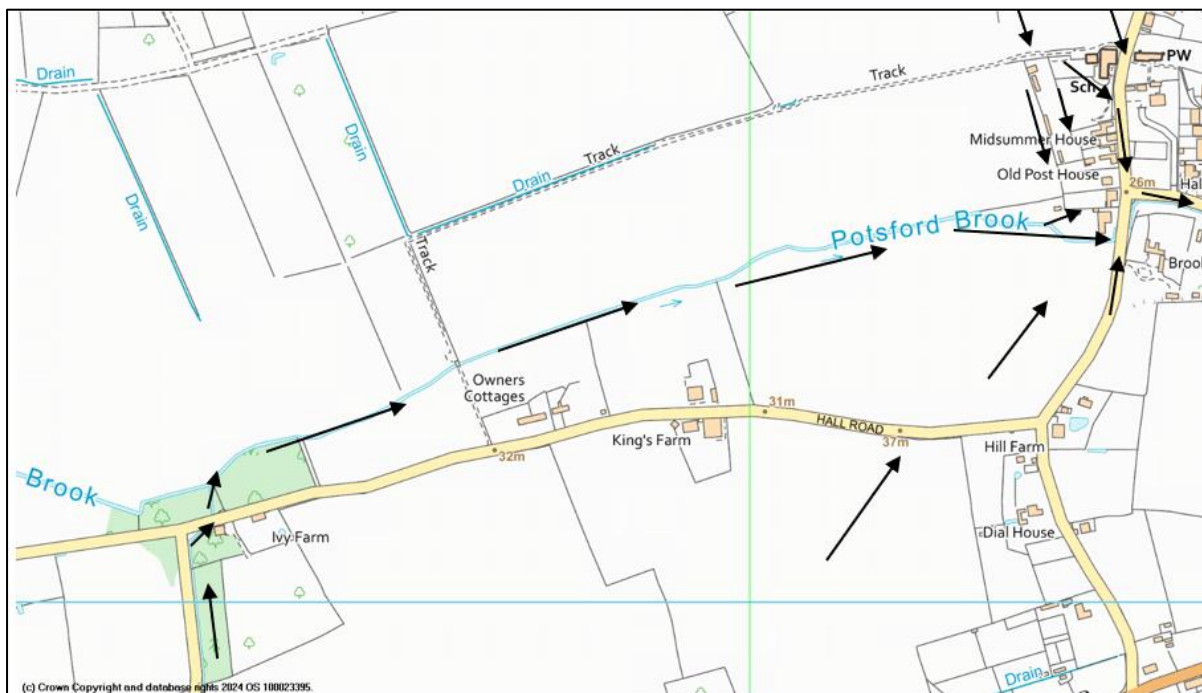
Figure 14 - Approximate flood water flow routes on Church Road and Hall Road

With the amount of water flowing into the Brook from fields north, south and the catchment further west, its capacity was completely overwhelmed and floodwater spilled onto Church Road. Properties were internally flooded from 10am onwards. Residents reported flood debris, including straw from the fields, building up and snagging at the road bridge under Church Road. The capacity under the bridge simply could not cope with the volume of water, which backed up, flooding the highway and nearby gardens (Image 4). Suffolk Highways are aware of a number of pre-existing issues at this location which may have reduced capacity at the road bridge.

At this point Church Road was acting as a secondary river channel, carrying floodwater downstream, which overflowed into The Street. The Street is amongst the lowest points in Charsfield and acted as the central basin into which the floodwater was accumulating. The roadside drainage assets were completely overwhelmed. Outfalls for highway drainage were quickly submerged as they fell below the peak water level in the Brook and were unable to discharge fully into the Brook causing the water to back up further.

- High rainfall resulted in large amounts of surface water run-off coming from fields to the west of Church Road and along the highway from north and south.
- Pottsford Brook was completely overwhelmed, the fields upstream of the road bridge were inundated with floodwater.
- Floodwater overtopped from the Brook at the road bridge as the capacity underneath was exceeded. Accumulated debris and pre-existing damaged Highways drainage infrastructure may have contributed to the problem.
- Drainage assets on the highways were overwhelmed.

- Any observed blockages at the road bridge on Church Road to be reported to Suffolk Highways.
- Ensure the completion of existing highway drainage asset maintenance on Church Road and Hall Road.
- Investigate the known Highways drainage issues at the road bridge on Church Road.
- Maximise the take up of the £5k PFR Grant currently available to residents.

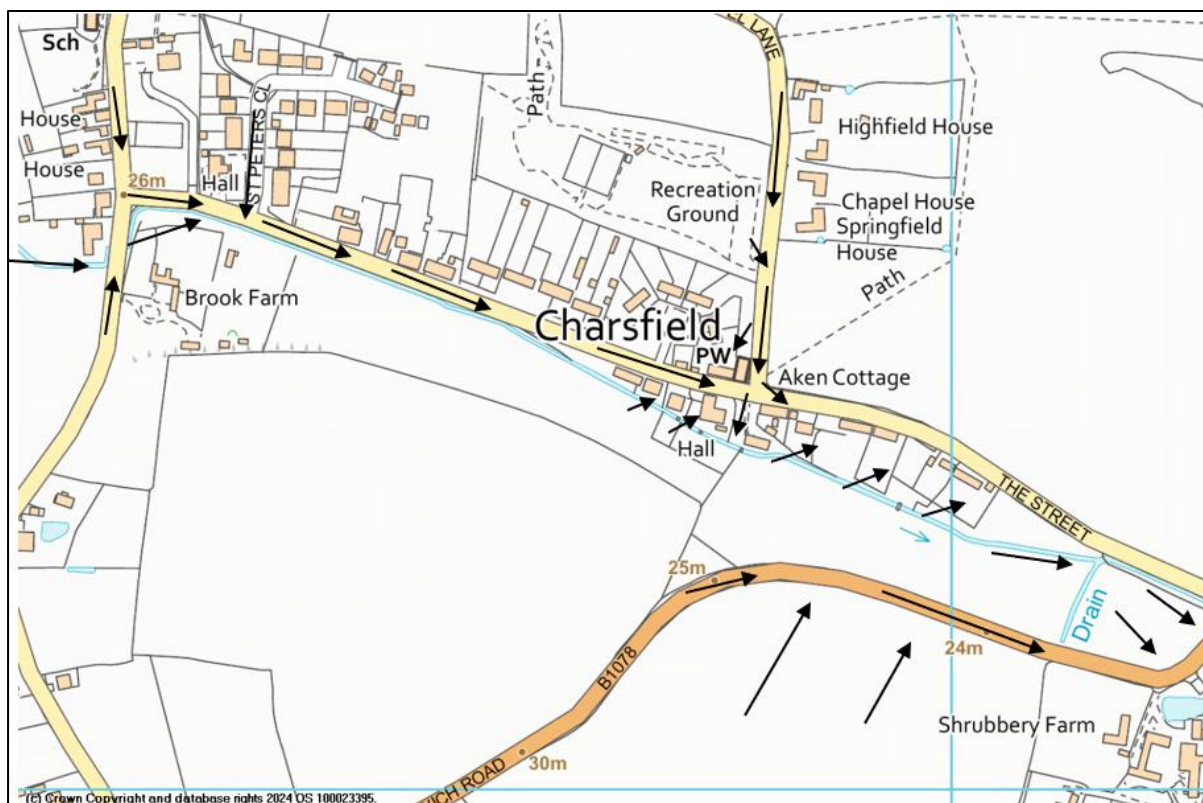
Figure 15 - Approximate flood water flow routes on The Street

Further along The Street, some residents suffered additional flooding to the rear of their properties as the water level in the Brook continued to rise and eventually overtop into gardens and houses from behind. There was a time lag between the initial onset of surface water to the front and water levels in Brook exceeding capacity. Fluvial floodwater rapidly filled the rear gardens. The properties were caught in the middle, surrounded by flood water from both sides. Consequently, as the drainage assets on the highway were overwhelmed, the flood water on the road could not discharge into the river, creating a large expanse of water around the properties.

Suffolk Highways are aware of pre-existing drainage issues at the junction of Chapel Lane and The Street. Highways records show instances of water surcharging from inspection chambers and water frequently pooling on the road surface. Further investigation is needed to fully understand the causes and likely solution to the problems.

- Investigate potential NFM projects and funding opportunities which aim to attenuate water and 'slow the flow' in the catchments to the west and north of Charsfield, targeting the flowpaths that feed into Potsford Brook.
- Any observed blockages within the main river section of Potsford Brook to be reported to the EA.
- Ensure the completion of existing highway drainage asset maintenance on Chapel Lane and The Street.
- Re-cut the grips on Chapel Lane
- Investigate the known Highways drainage issues at the junction of Chapel Lane and The Street.
- Maximise the take up of the £5k PFR Grant currently available to residents.

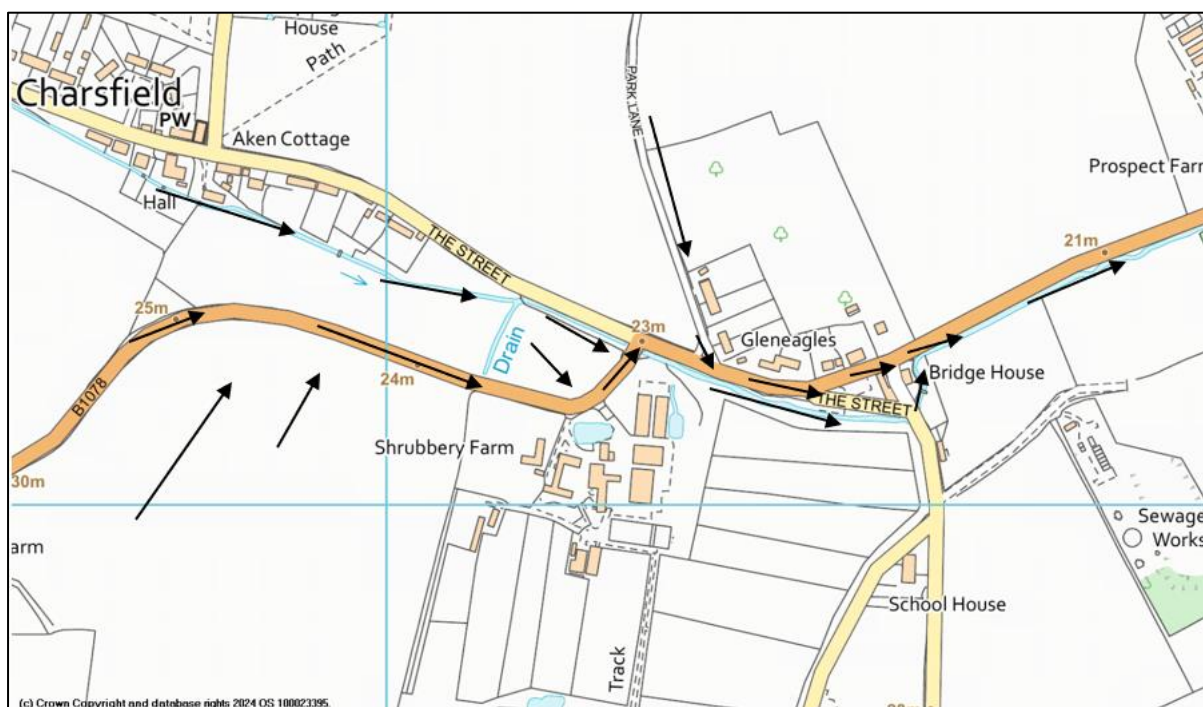
Figure 16 - Approximate flood water flow routes on Wickham Market Road

On the east side of Charsfield, a number of properties on the Wickham Market road were impacted by internal flooding. Large amounts of floodwater were reported to be flowing along the road surface from the junction of the B1078 and The Street (Image 8). The floodwater on the B1078 originated as run-off from the fields to the south. There was also fluvial flooding from the Potsford Brook as the water levels rose out of bank, water in the channel backed up at the road bridge as it was partially blocked and silted up on the upstream side. It then merged with the expanse of floodwater on the road with additional flows coming from the fields to the north down Park Lane.

The properties were flooded to the front from the road. The flooding in this area is reported to have occurred between 11am and 1pm, slightly later than other parts of the village presumably indicating the time taken for the peak flow to travel through the village from the west.

- Investigate potential NFM projects and funding opportunities which aim to attenuate water and 'slow the flow' in the fields south of the B1078, and north of Park Lane.
- Any observed blockages within the main river section of Pottsford Brook to be reported to the EA.
- Any observed blockages at the B1078 road bridge to be reported to Suffolk Highways.
- Ensure the completion of highway drainage asset maintenance on along the B1078 and The Street.
- Maximise the take up of the £5k PFR Grant currently available to residents.

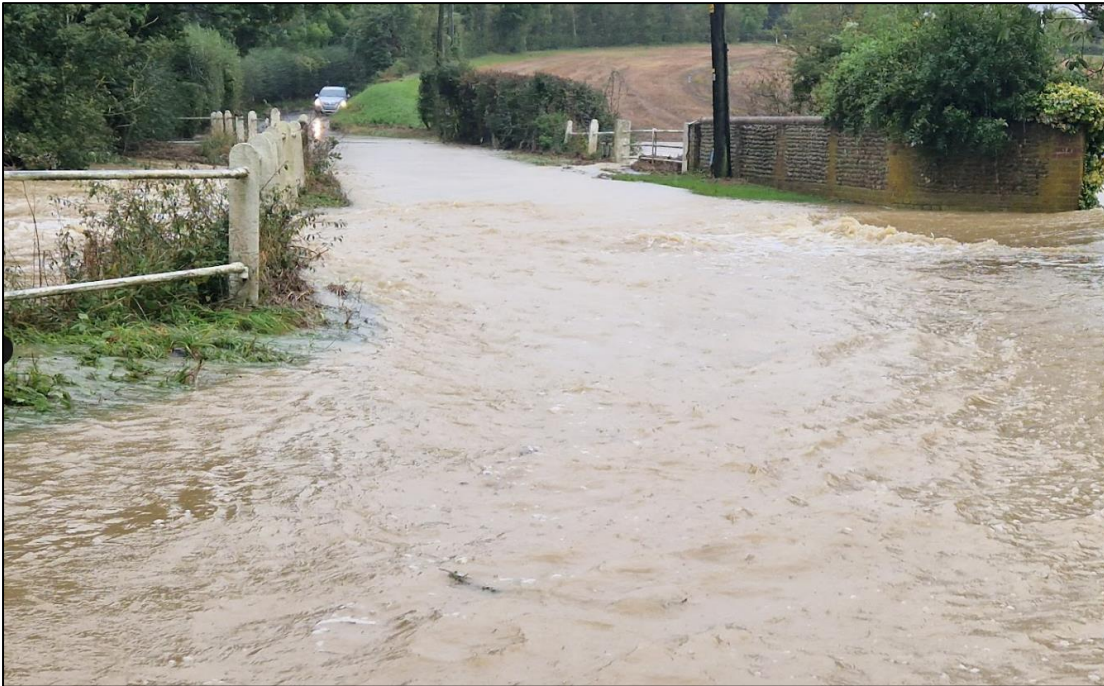
*Image 4 - Flooding on Church Road bridge*

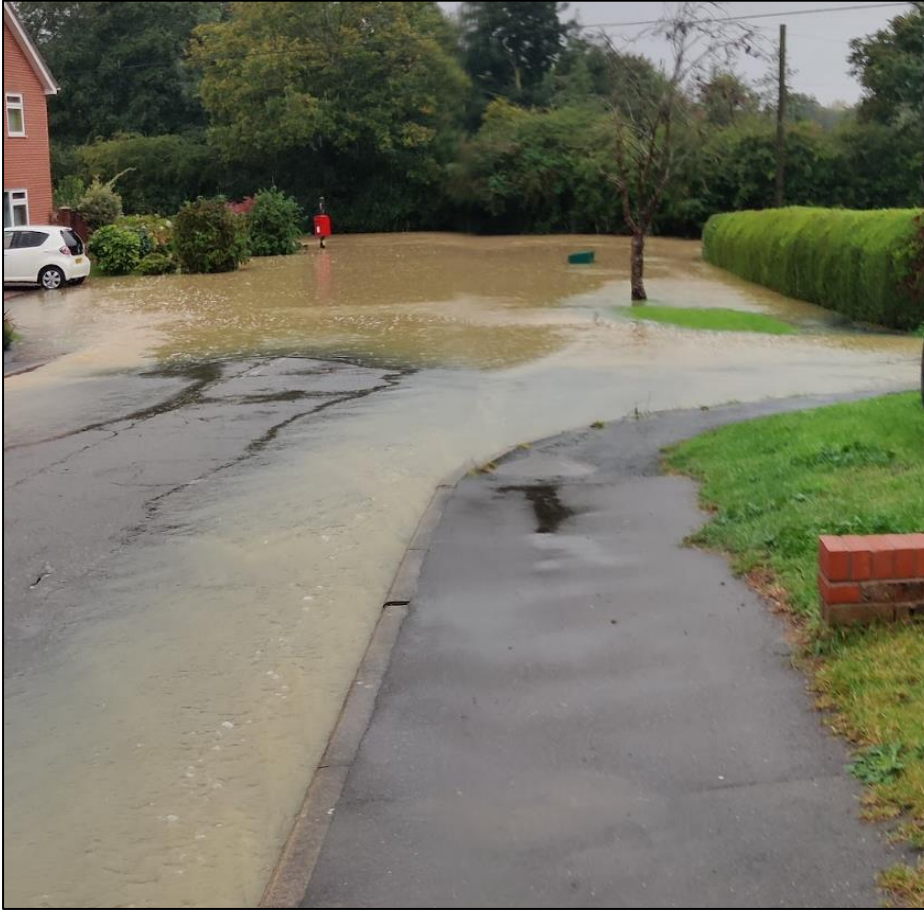
*Image 5 - Looking south on St Peters Close toward The Street*

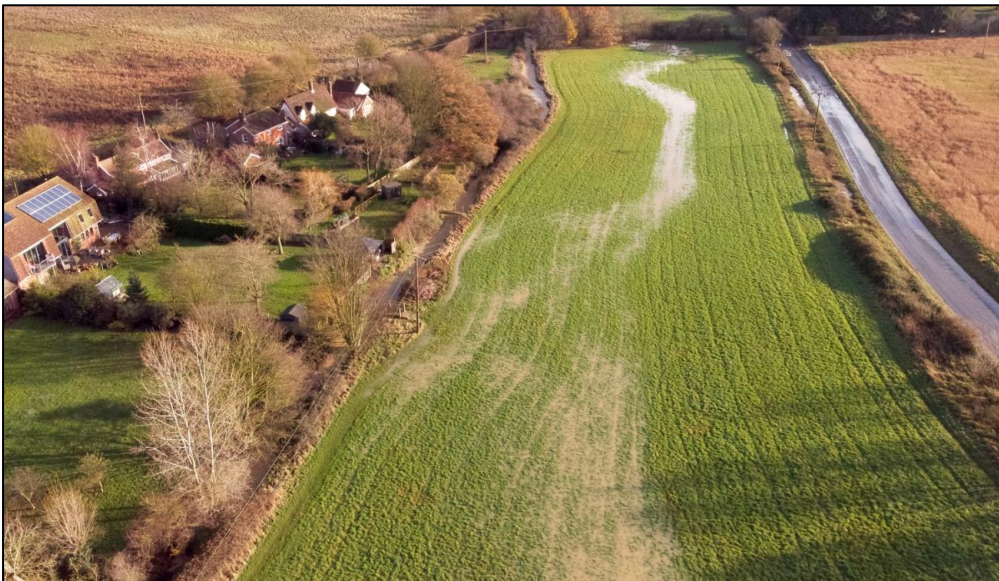
*Image 6 - View over Longmeadow showing Potsford Brook and possible former river channel*

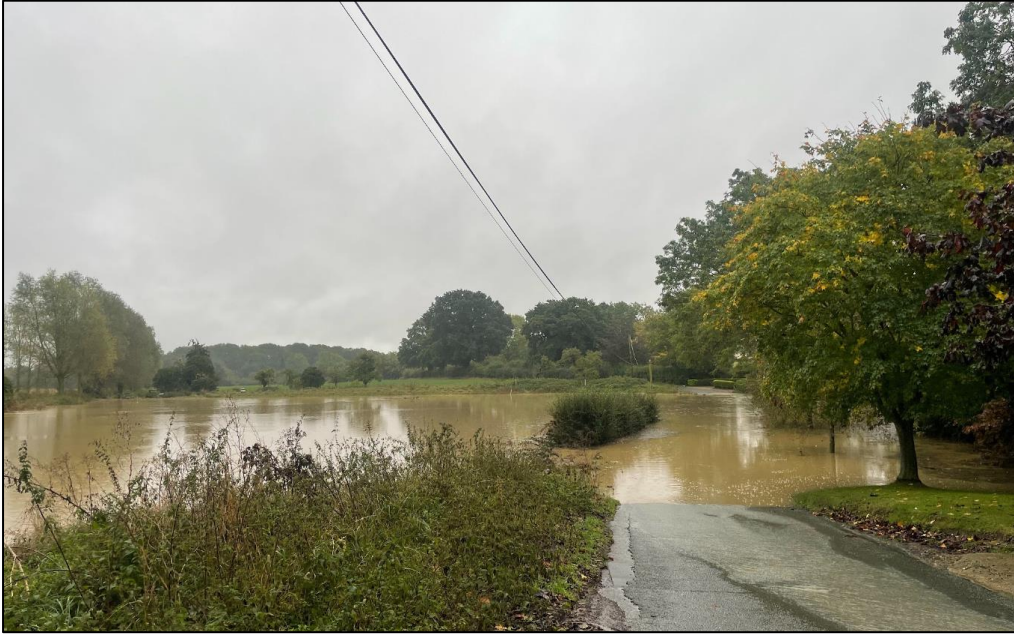
*Image 7 - Flooding on Hall Road*

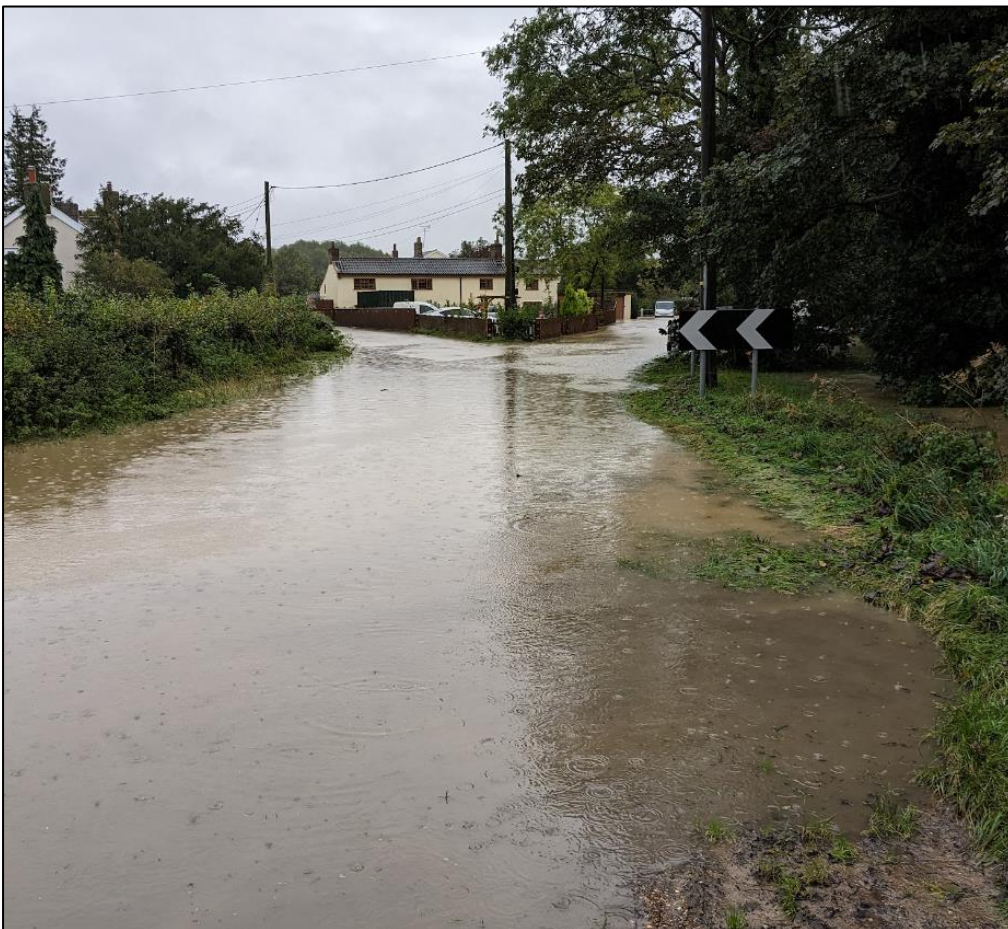
*Image 8 - View from The Street looking towards Wickham Market Road*
