## Section 19 Flood and Water Management Act 2010

### Hoxne Flood Investigation – Storm Babet 2023

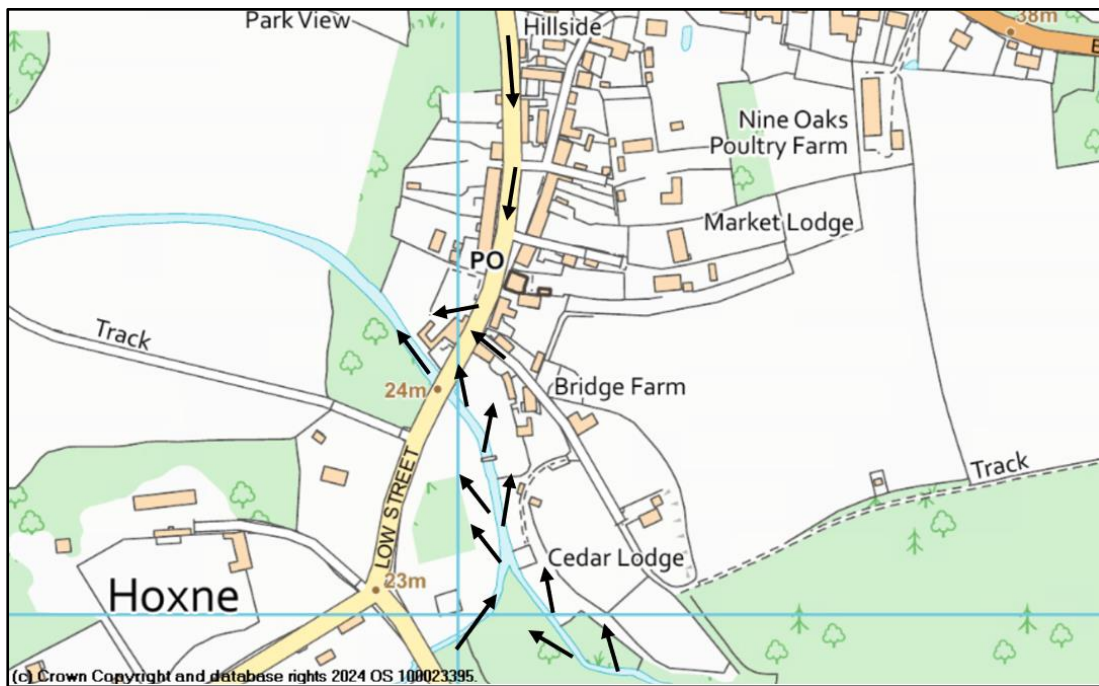
Figure 11. Approximate floodwater flow routes on Low Street

Excess surface water from the rainfall flowed down the gradient from the north end of Low Street towards the Swan bridge area. The highway gullies on the west side of Low Street were seen to be clogged with fallen leaves inhibiting drainage. On 20 October from 9:30am water was surcharging from the manhole in front of the Swan pub indicating the surface water drainage system was already reaching capacity and/or may have become blocked with the floodwater debris. This surcharging water was merging with the surface water flowing down Low Street, pooling across the highway to the pub, swan bridge and along Sandpit Lane (see Image 3).

The Gold Brook watercourse overtopped its banks with the fields and areas either side of the watercourse upstream of the bridge extensively flooded (see Figure 11). Swan bridge acted as a constriction to the large volume of water flowing down the catchment from the Gold Brook and Chickering Beck watercourses. The floodwater flowed across gardens with multiple properties suffering internal flooding ranging from 10 to 45cm deep. As the floodwater continued to back up at Swan bridge, a torrent of water flowed from Sandpit Lane across Low Street and into the Swan pub carpark (see Image 4). By 4:00pm the entire area was submerged as the floodwater extended and merged with the surface water from the highway. The highway drainage assets and infrastructure in this location were overwhelmed and could not discharge into the already overfull watercourse. Residents have reported that the flood water level on Low Street peaked around 8:30pm and at 9:15pm the electricity on Low Street went off.

- Intense and prolonged rainfall resulted in excess surface water flowing down the highway on Low Street, merging with surcharging water from a manhole and pooling around the Swan pub and bridge area.
- The Gold Brook watercourse overtopped its banks whilst the high flows in the channel backed up at Swan bridge.
- By late afternoon, a wide area was entirely submerged as the floodwater flowed in a torrent across Sandpit Lane and into the Swan pub carpark.
- Existing drainage assets on the highway were overwhelmed.

- Residents to install Property Flood Resilience (PFR) via grant funded scheme.
- Investigate the capacity and condition of highway drainage infrastructure and Anglian Water assets on Low Street, particularly the area in the vicinity of the Swan pub.
- Report any observed blockages below Swan bridge on the Suffolk Highways Online Reporting Tool.
- Landowners to carry out watercourse maintenance to reduce flood risk as necessary as per their riparian responsibilities.

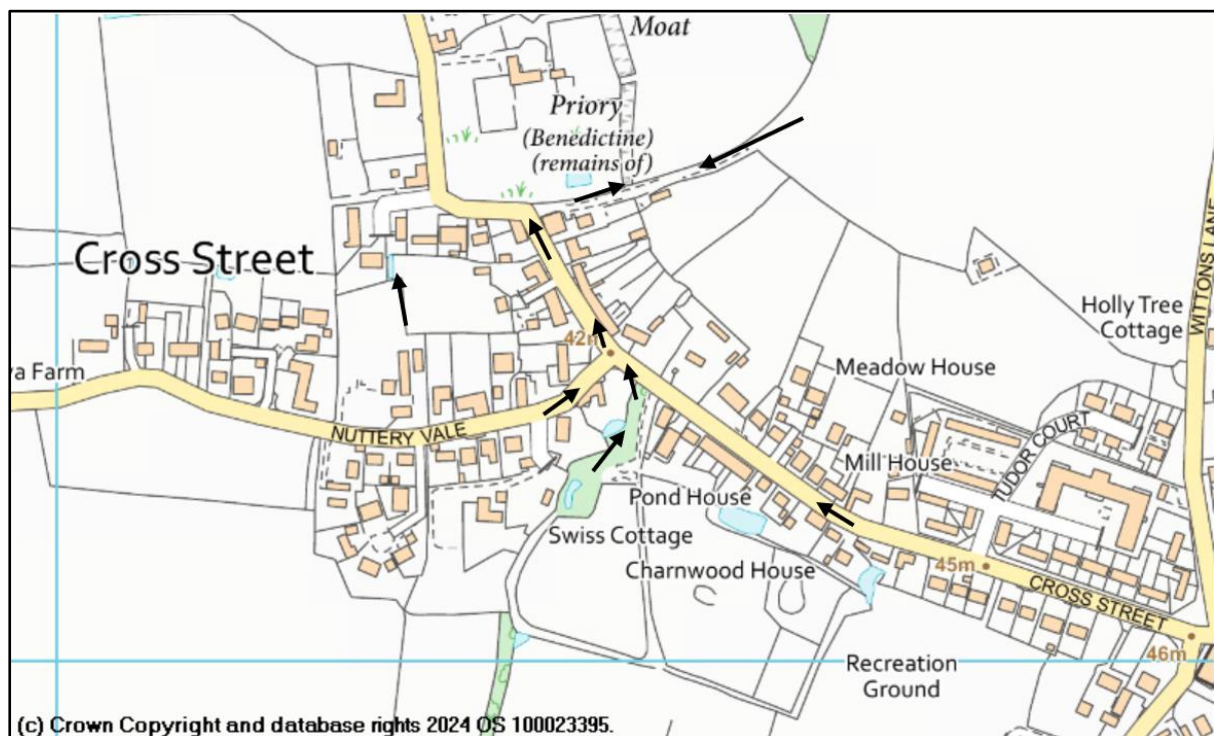
Figure 13. Approximate floodwater flow routes on Cross Street

On Cross Street multiple properties were impacted by surface water flooding. During the morning of 20 October heavy rainfall resulted in large volumes of floodwater pooling on the road in different locations as the highway drainage gullies and sewer infrastructure reached capacity.

Residents reported a number of manholes on Cross Street were surcharging and bubbling up with a mixture of foul water and rainwater in the middle of the street. Several reports indicated that almost all the roadside gullies were blocked and/or overwhelmed and failed to drain the increasing amounts of surface water from the highway.

- Residents to install Property Flood Resilience (PFR) via grant funded scheme.
- Investigate potential NFM projects to 'slow the flow' and attenuate water on overland flow paths (leaky dams, restoration of watercourses, etc.) north of Cross Street.
- Ensure the completion of highway drainage asset cyclic maintenance on Cross Street.
- Landowners to carry out watercourse/ditch maintenance to reduce flood risk as necessary as per their riparian responsibilities.
- Investigate highway drainage and sewer infrastructure on Cross Street generally to ensure capacity and condition are sufficient.

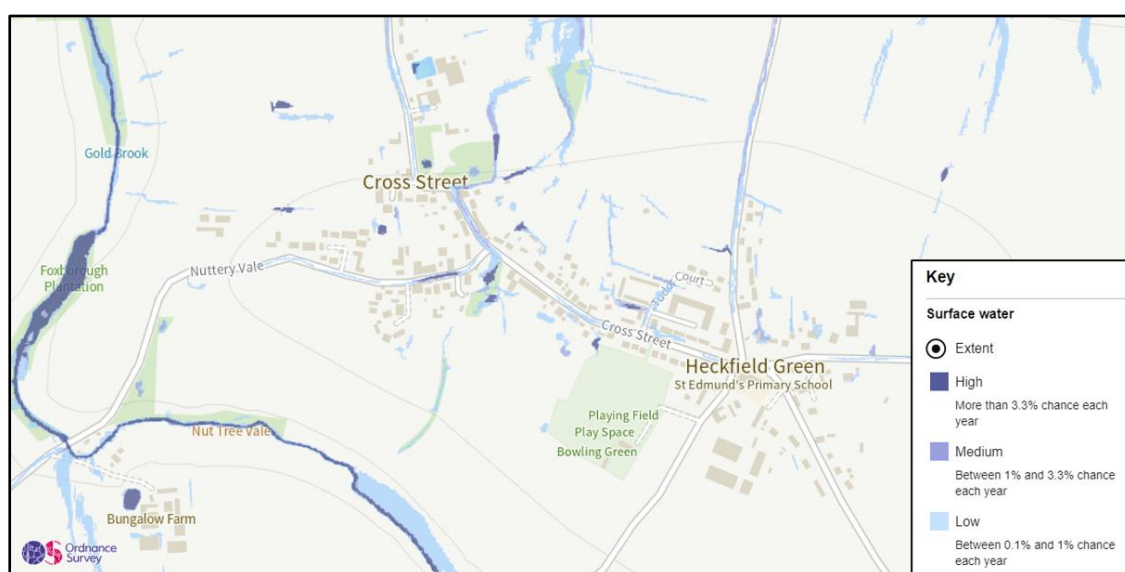
Figure 14. Surface Water flood risk on Cross Street and Nuttery Vale

Additional surface water flows originating from the fields to the northeast flowed into the ditch behind the properties to the north of Cross Street. This surface water run off filling the ditch reduced the effectiveness of the highway drainage assets and added to the flooding. The national flood risk mapping shows large sections of Cross Street and the adjoining Nuttery Vale to be at medium to high risk of surface water flooding (see figure 14).

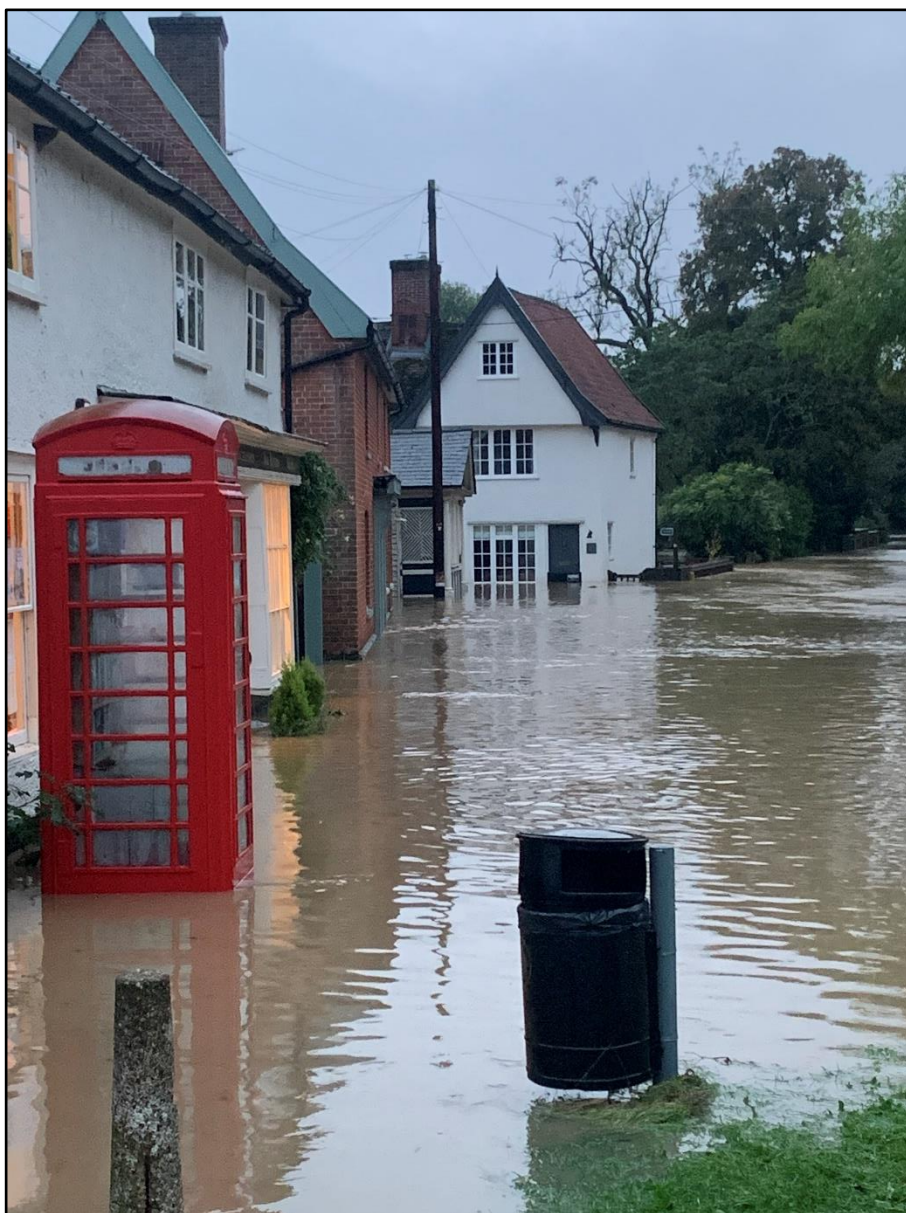
*Image 1. Flooding outside the Post Office on Low Street*

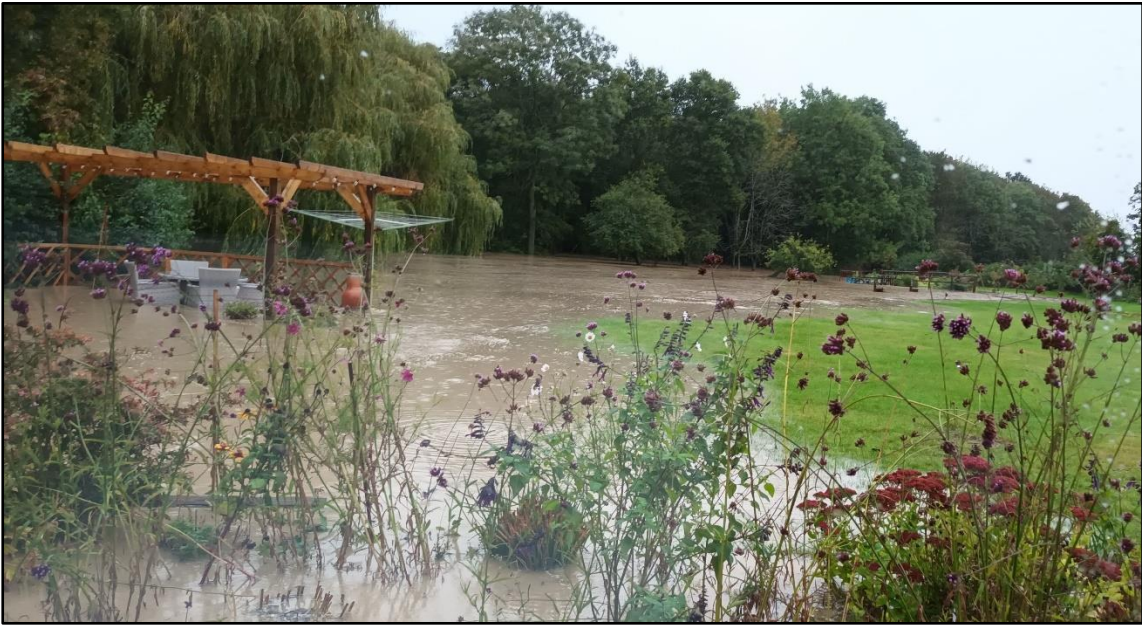
*Image 2. Flooding from Chickering Beck watercourse*
