## Section 19 Flood and Water Management Act 2010

### Debenham Flood Investigation - Storm Babet October 2023

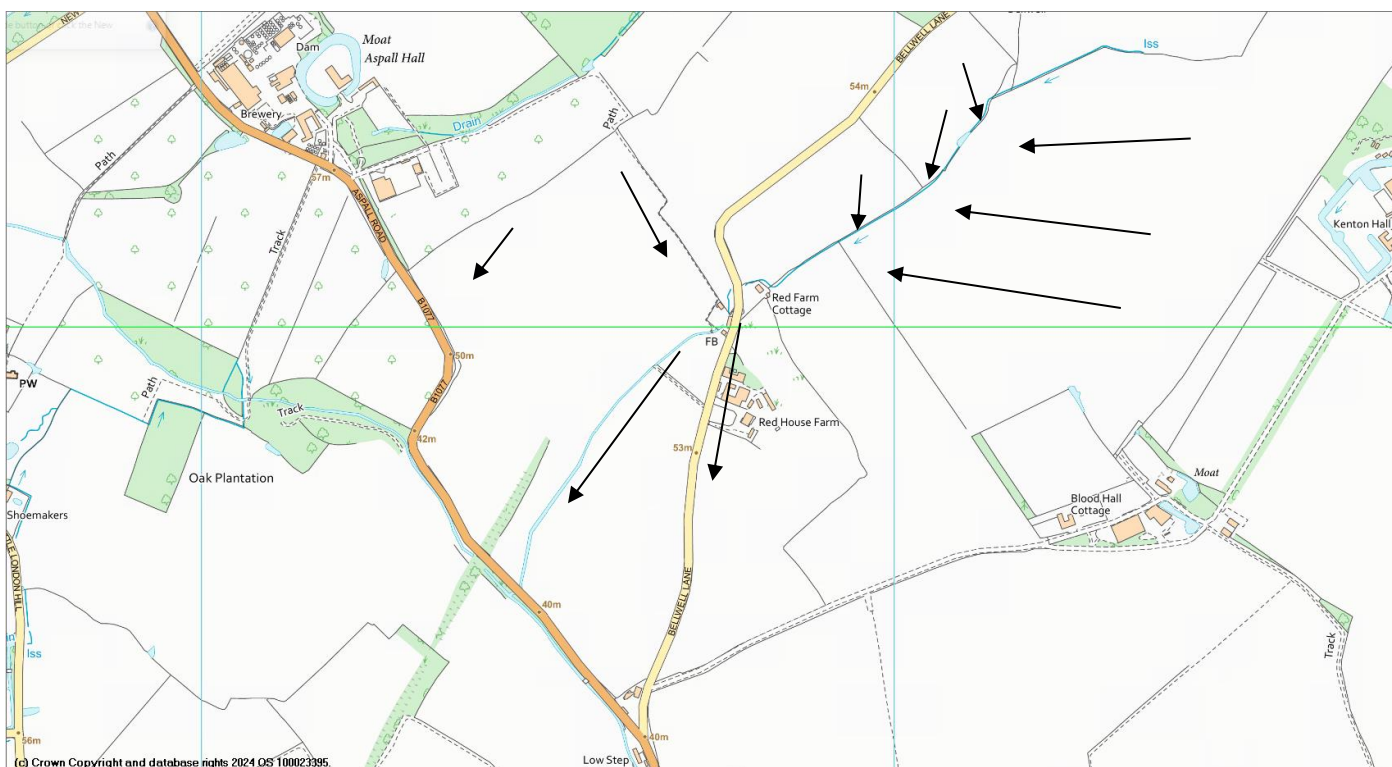
Figure 10 – Flow paths in northern Debenham

Located north of the village, Bellwell Lane runs adjacent to an ordinary watercourse which travels under the road, through a culvert located approximately 2 kms north of the village centre. According to reports, the culvert in this area was overwhelmed early in the day due to the volume of water coming off the surrounding field network.

A small ordinary water course inflows from the east taking water from a large surrounding area. A site visit confirmed there to be three interconnecting watercourses in this area which appear to flow through a large box culvert under the highway. There appeared to be a significant level of silt in the culvert which may have influenced its functioning capacity during the event. Additionally, there is a headwall in the northern watercourse which does not appear to contain a pipe to continue the flow, either the pipe is buried under significant debris or there is not a pipe to convey the water. This headwall then effectively forces the water onto the highway at this point preventing its movement downstream in the watercourse.

The flows in this area continued down the path of the watercourse and on the road towards Aspoll Road, eventually converging with the flood water in Debenham village. Reports suggest that a small number of properties on Bellwell Lane were flooded, which flooded previously in May 2023 potentially due to a blockage of the culvert under the highway.

- Drainage assets were overwhelmed beyond their capacity.
- Culvert under the road may have been blocked or not working correctly, resulting in impedance of flood water.
- Watercourse in area may have been blocked or not flowing at full capacity, resulting in impedance of flood water.

- Suffolk County Council Highways Authority to investigate possible blockage and silt build up in culvert located on Bellwell Lane.
- Riparian owner to carry out regular maintenance on watercourse to ensure a good flow of water.
- Investigate possibility of Natural Flood Management features on the west side of Bellwell Lane just to the south of where the culvert outfalls.

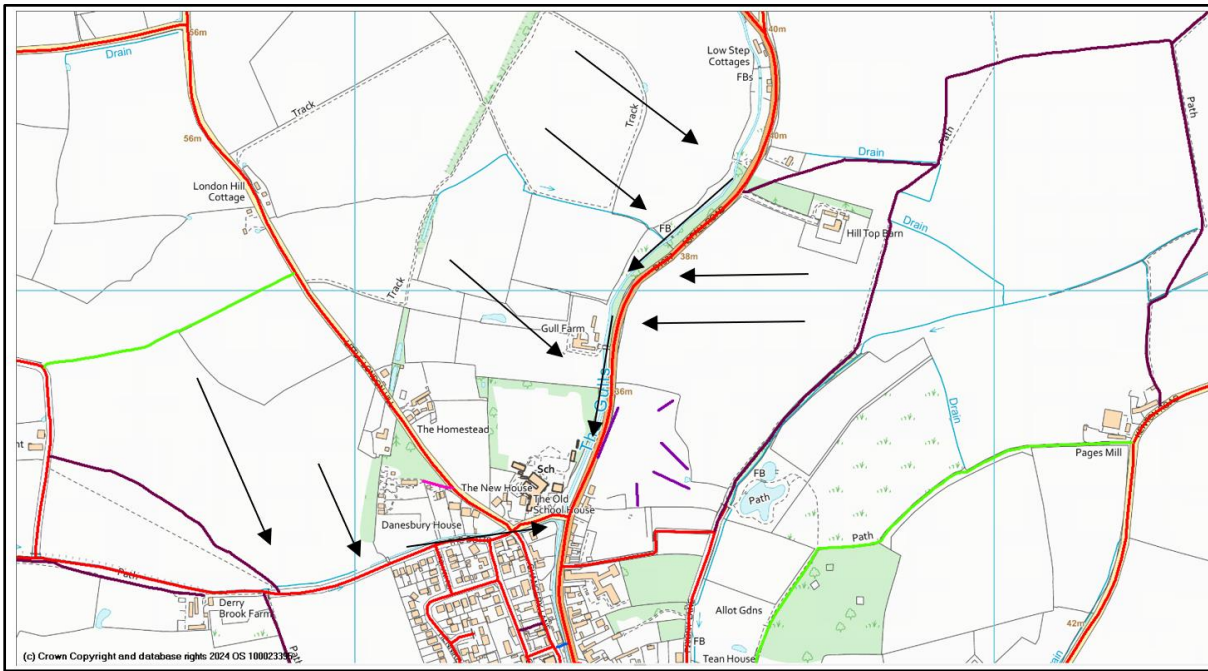
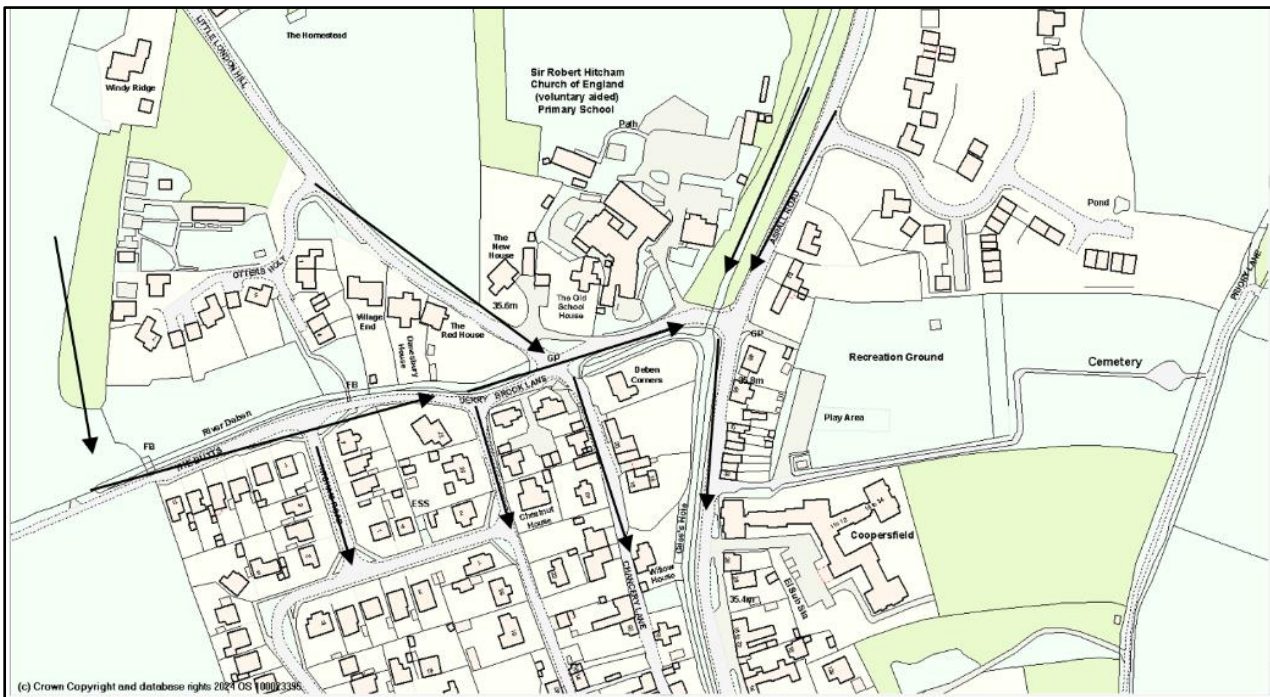
Figure 11 – Flow paths in northern Debenham

Reports from the southern end of Chancery Lane and Aspall road suggest sewage and oil were present in the flood water suggesting the sewerage system had become overwhelmed, and reports from the community suggest a home oil storage tank had slipped into the watercourse, possibly causing an additional blockage and leaking oil into the river.

The flow from the north, down Aspall Road and the adjacent watercourse, meets the main river Deben beside the road junction with the Butts, just south of the primary school. There is additional flow from Little London Hill and The Butts which travels in from the west. As a result of the overtopped river Deben, water flowed south down Chancery Lane and Aspall Road where it affected 25 properties across the two roads. Reports suggest internal water depths ranging from 5cm to 45cm, resulting in damaged properties, cars and the need to evacuate homes.

- Large volume of water runoff from surrounding fields possibly caused damage to watercourses and allowed water to flow down the road.
- Concerns that the attenuation features on the new housing developments were not working correctly.

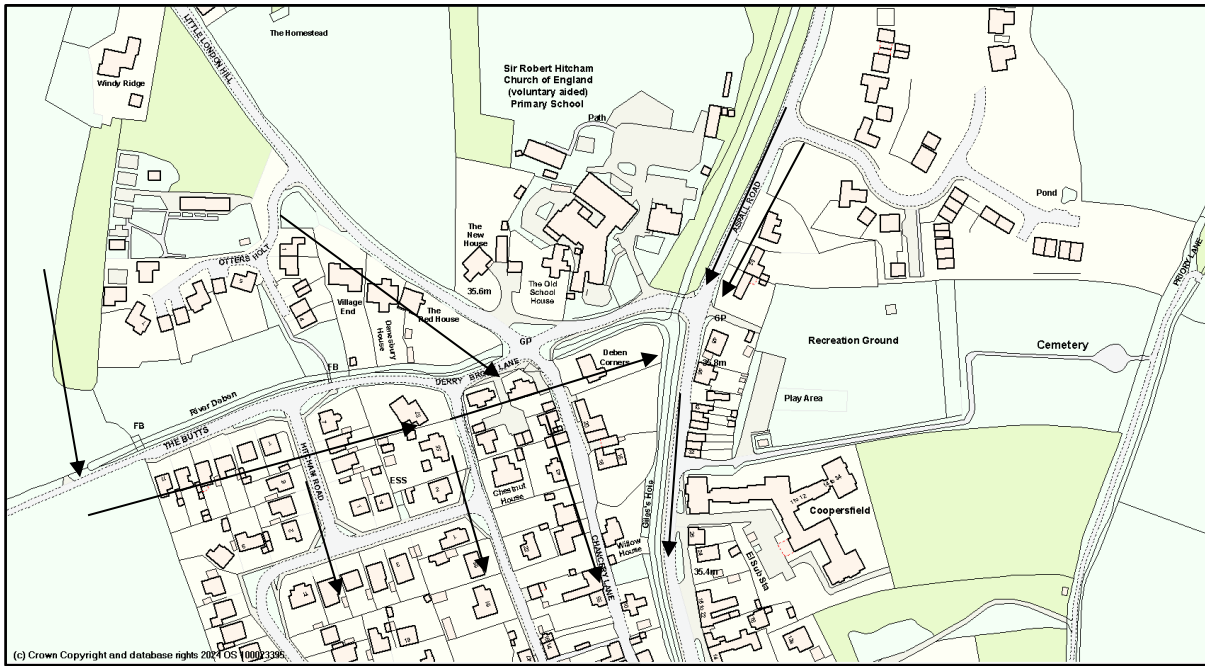
Figure 13 – Flow paths in northern Debenham

The flow path for the water in this area is from the west and north, heading east and south into the central village catchment. The overtopping of the Derry Brook in this area causing the road to act as a secondary flow path, contributing to the flooding experienced here and on the surrounding and adjoining streets such as Aspall Road and Chancery Lane.

Reports have said that internal flooding was experienced by at least 5 properties across the four roads with internal depths of water reaching 35cm and external depths deep enough to fully submerge cars.

- Overwhelmed watercourses caused spill of flood water onto the highway which then entered properties from the highway.
- Concerns about recent housing developments and the management of surface water from the site.
- Saturated and low permeable ground could have exacerbated the flooding on this occasion.

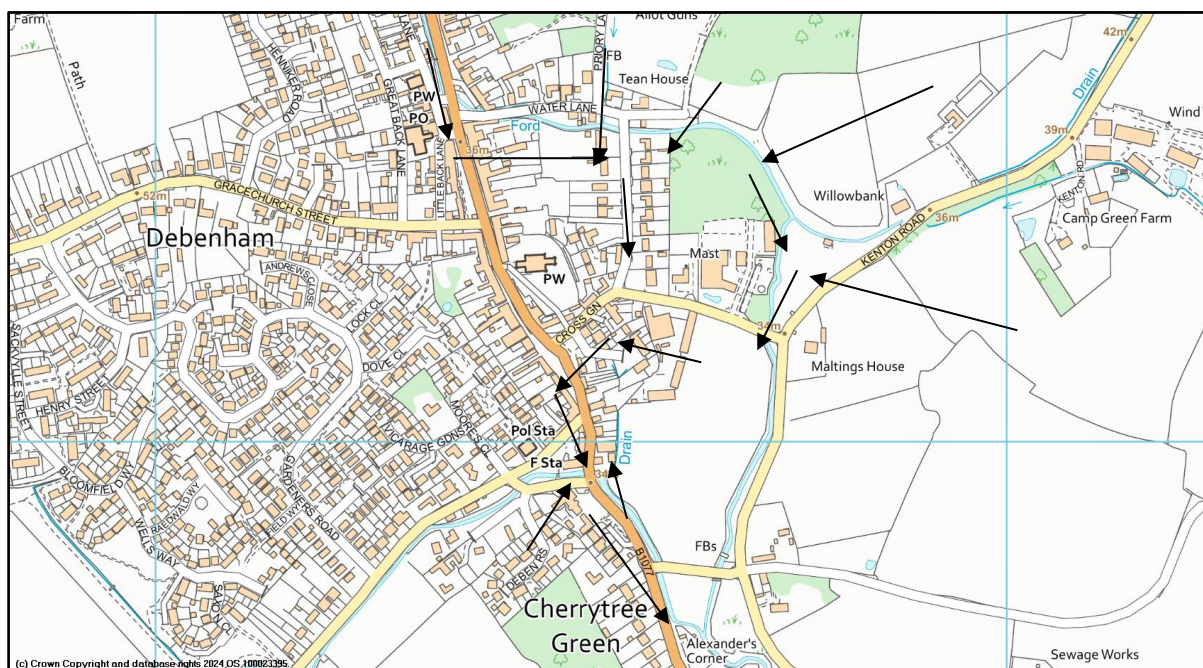
Figure 14 – Flow paths in central Debenham

The flow in this area comes primarily from the over topped River Deben, with water traveling south along Aspell Road and Chancery Lane, before flowing along Water Lane and down Priory Lane. Flow paths from northern Priory Lane and Kenton Road to the east, added to the flows, and resulted in the flooding of Cross Green and the Meadow Works business park.

There is some concern that the watercourse on the northern arm of Priory Lane and the culvert under the road on water lane were not operating to full capacity due to overgrowth and silting up of the features. This may have contributed to the severity of the flooding within this location. Currently the riparian ownership responsibilities of the section of watercourse in northern Priory Lane is under discussion. It should however be acknowledged that the volume of rainfall experienced, is likely to have exceeded the design capacity of drainage assets and led to the overwhelming of infrastructure in spite of vegetation levels.

There were 24 reports of affected properties in this area with internal flooding depths ranging from 20cm to over 90cm and external flood water being over 150cm deep.

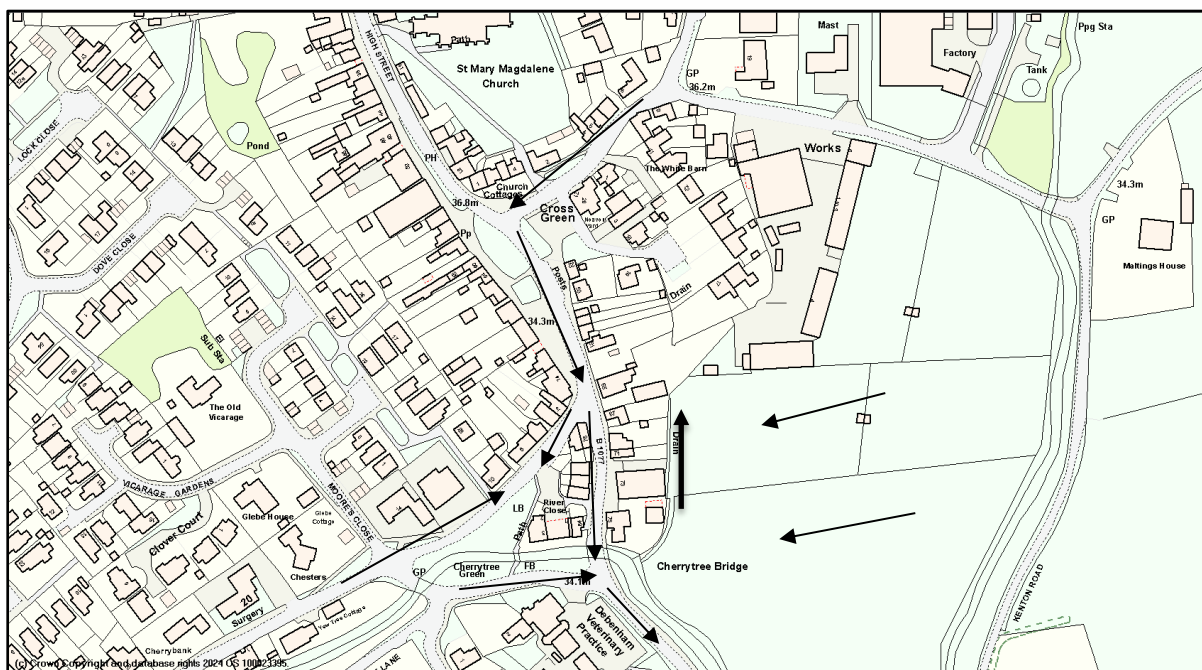
Figure 15 – Flow paths in central Debenham

Due to the significant amount of rainfall, once the Cherry Tree Brook and River Deben had been overwhelmed reports suggest that water was being forced north (against the natural flow) along an ordinary water course which borders the easterly edge of the back gardens of properties on the High Street, as a result of this the watercourse was very quickly overwhelmed and spilled out affecting properties from the back in addition to the water already coming from the highway to their front.

The land to the east of the High Street behind the properties is known to be one of the worst affected spots and is at very high risk of flooding from both fluvial and pluvial sources.

24 Properties are known to have been affected in this area with reports ranging from 15cm to over 60cm of internal flooding.

- Flood water from Cherry Tree Brook, Cross Green, and green space to the east of high street congregated in this area.
- Overland flows resulted in the cherry tree brook and River Deben to reach capacity.
- Continued vehicle movement through flood water caused worsening of flood water ingress to properties.
- Drainage assets on the highway were overwhelmed.

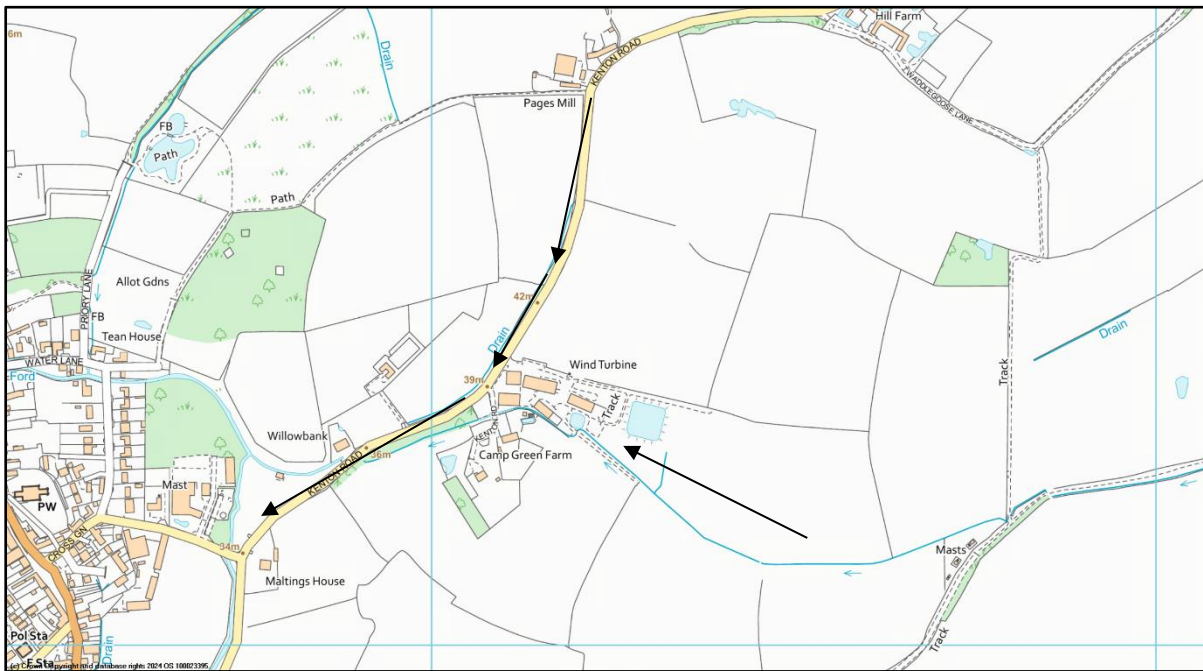
Figure 16 – Flow paths in eastern Debenham

Located to the east of the village centre, Kenton Road was an isolated case from the rest of the village. Reports suggest a combination of fast flowing surface water and overwhelmed watercourses in the area, contributed to the flooding, the water simply flowed to the lowest point once watercourses were overwhelmed.

Kenton Road is a main flow path on the predicted risk of surface water flooding maps. There are several ordinary watercourses in the area which flow adjacent to the road on both sides. Additionally, there are a number of watercourses that are piped, which may have caused a constriction if blocked or have insufficient capacity during Storm Babet. This may have resulted in the overwhelming of watercourses and contributed to flooding experienced in this location.

Flooding was recorded as being approximately 45cm deep affecting offices, farm buildings and workshops.

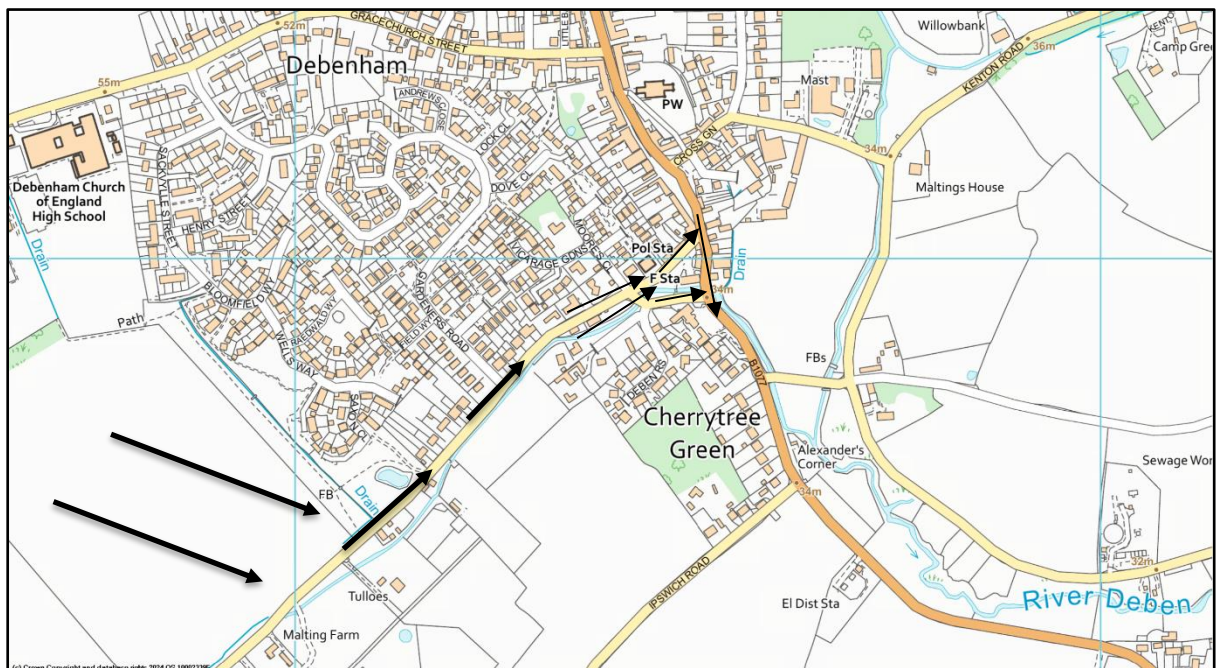
Figure 17 – Flow paths in southern Debenham

Many properties in the area reported being affected from both the road at the front of the property and the Brook at the back of the property. Properties were surrounded by flood water and in some cases flood water was coming up through the floor due to rising groundwater levels.

The flow path experienced is in line with the predicted flood risk map, coming along the line of the Cherry Tree Brook and spilling on Low Road and Cherry Tree Lane. As the water passes along Low Road, it meets the High Street, accumulating here before flowing south out of the catchment.

Commercial and residential properties in this area were affected, with significant damage being done to resources in local emergency services stations and charitable centres. 23 properties are known to have been affected with reports suggesting internal flooding levels of between 15cm and 90cm being recorded and external depths of over 90cm being observed.

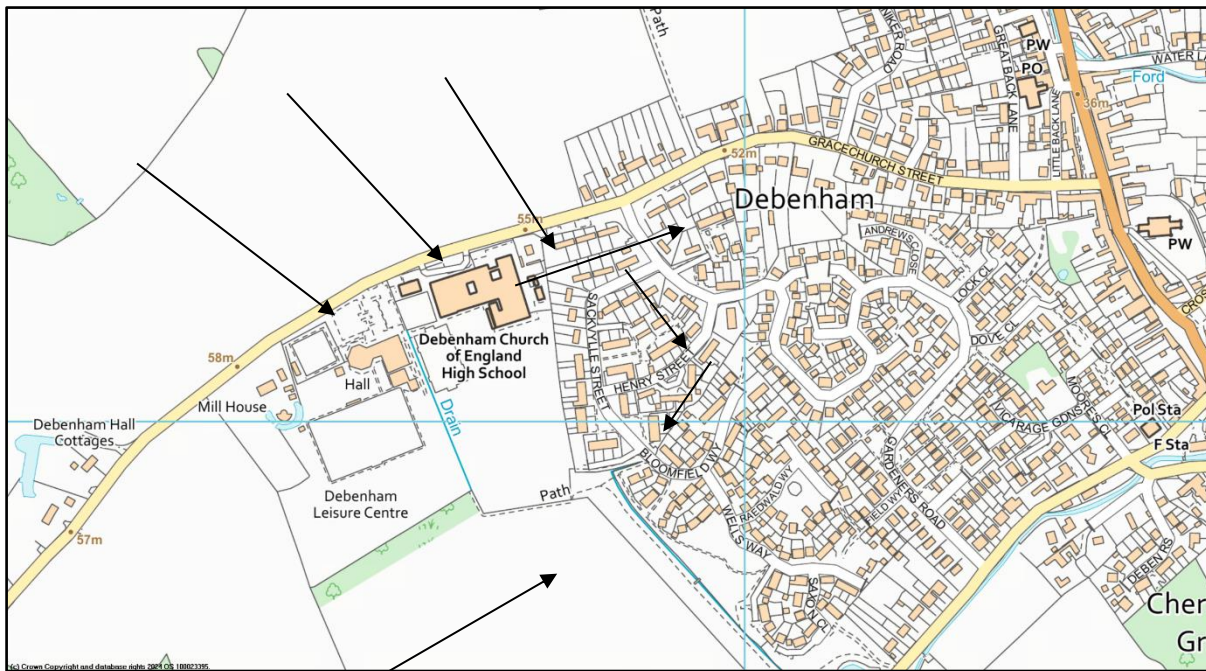
Figure 18 – Flow paths in western Debenham

It is therefore likely that volume of water and potential blockages within highways networks were contributing factors.

Gracechurch Street shows as an area of very low risk to surface water flooding on the predicted flood maps. However, reports in the area suggest that a blocked sewer or highways drainage gully could have been a contributing factor. Given only a small number of properties were affected, a localised blockage could have contributed to the flooding.

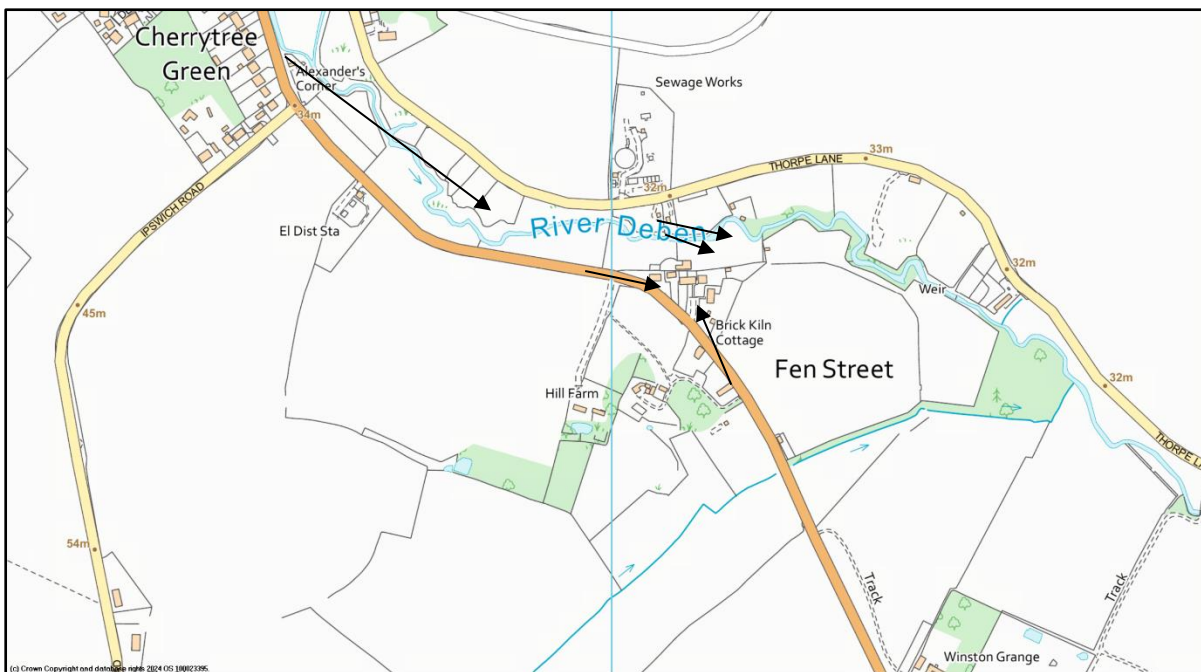
Figure 19 – Flow paths in southern Debenham

Fen Street is a Hamlet along Winston Road (B1077), half a kilometre southeast of Debenham village. A small number of properties were reported to have flooded during Storm Babet and are situated parallel to the River Deben. There is limited information for this area but of what has been received, it was reported that the River Deben overtopped its banks onto the flood plain before flooding properties from the rear. Flood water also travelled from the road descending north towards the properties resulting in properties being surrounded by flood water. Impacted properties are situated lower than the road.

- No action suggested beyond those made to all affected residents in the recommendations section of this report.

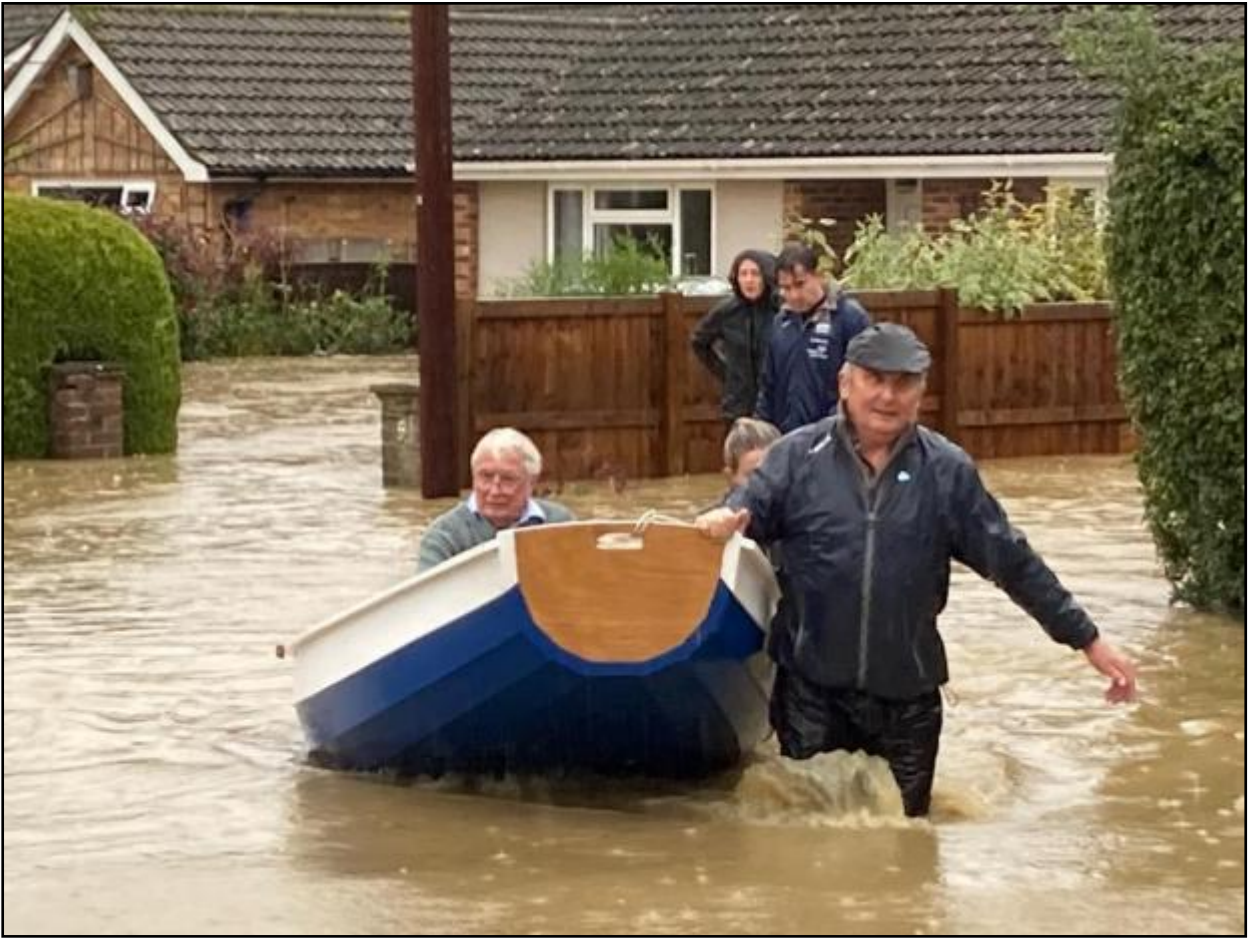
Central Debenham, residents having to be rescued by boat

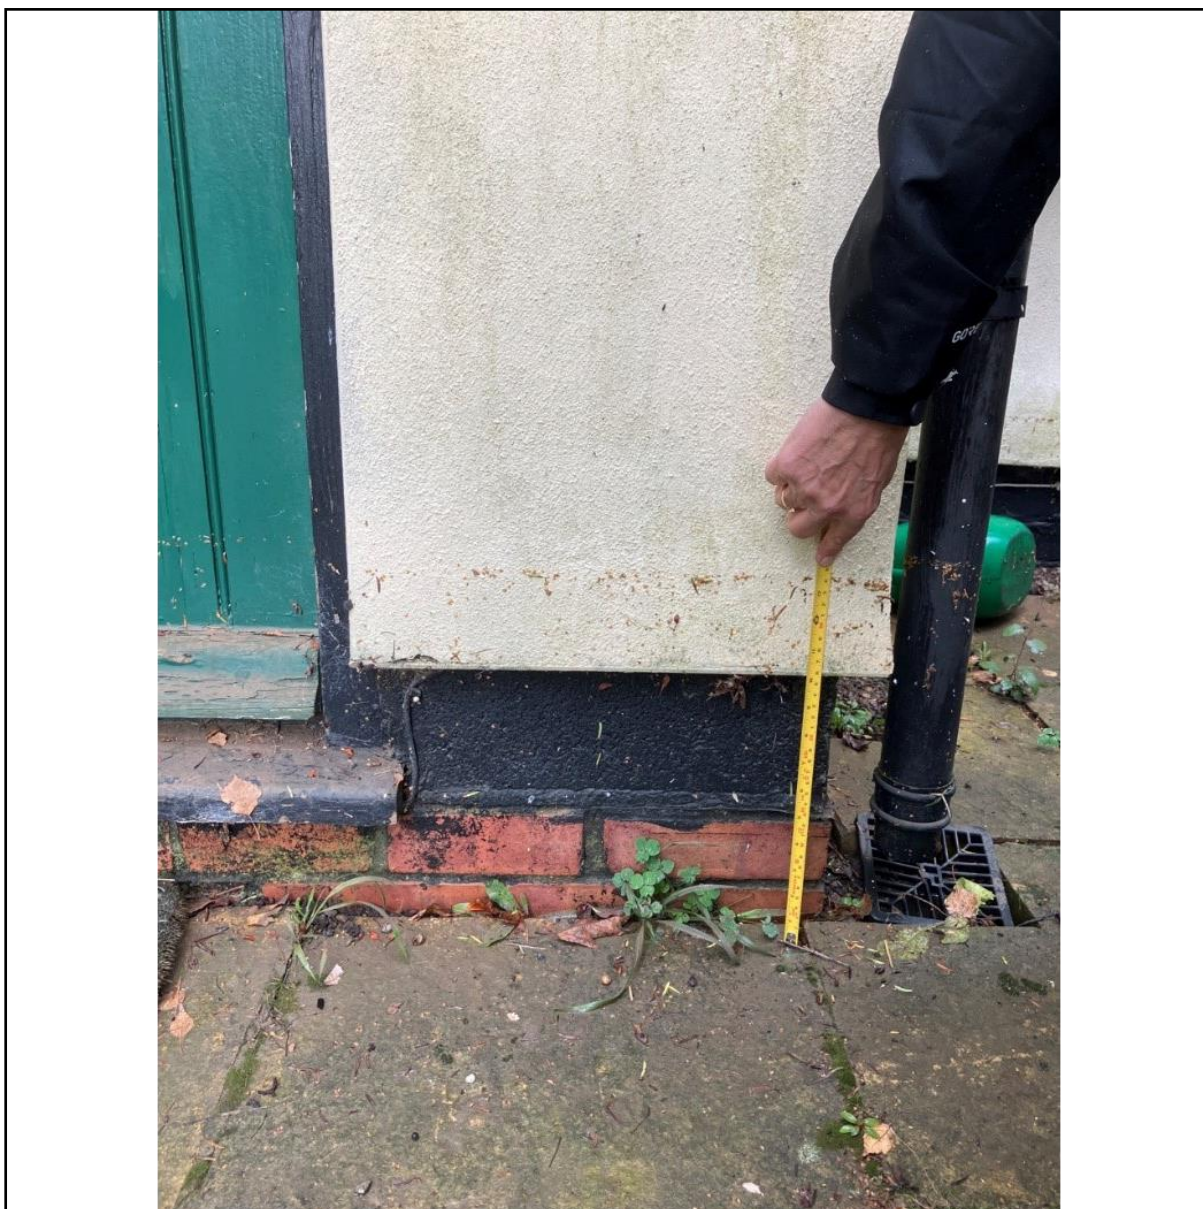
Post event wrack marks measured by EA CIOs

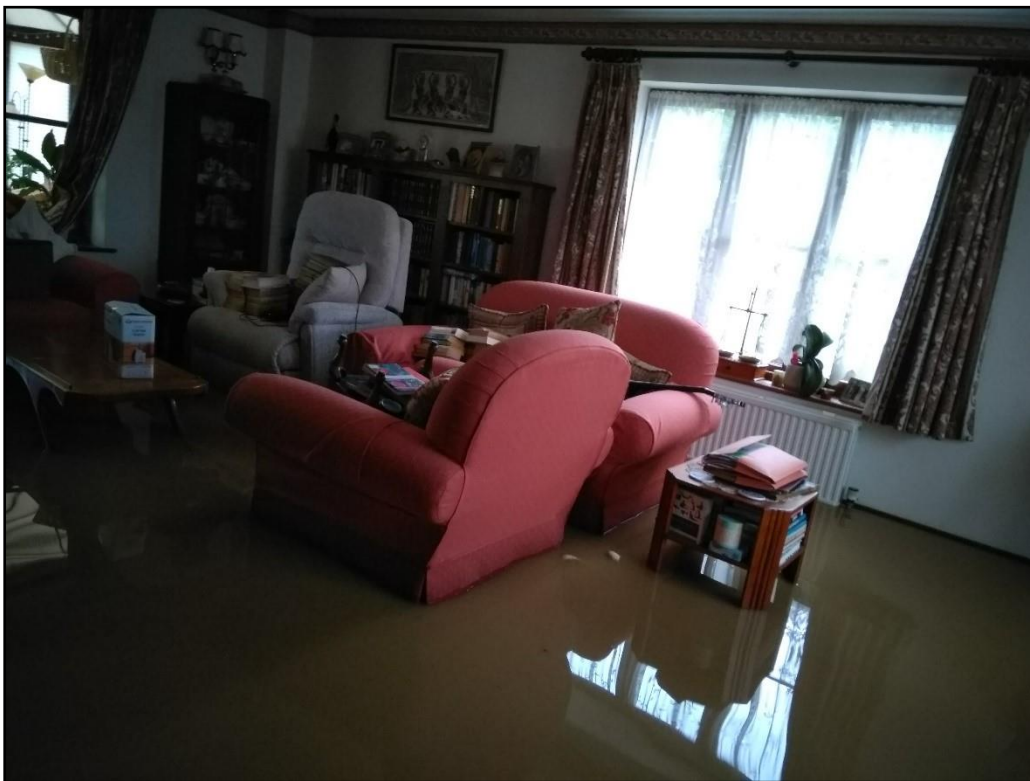
Internal Flooding extents

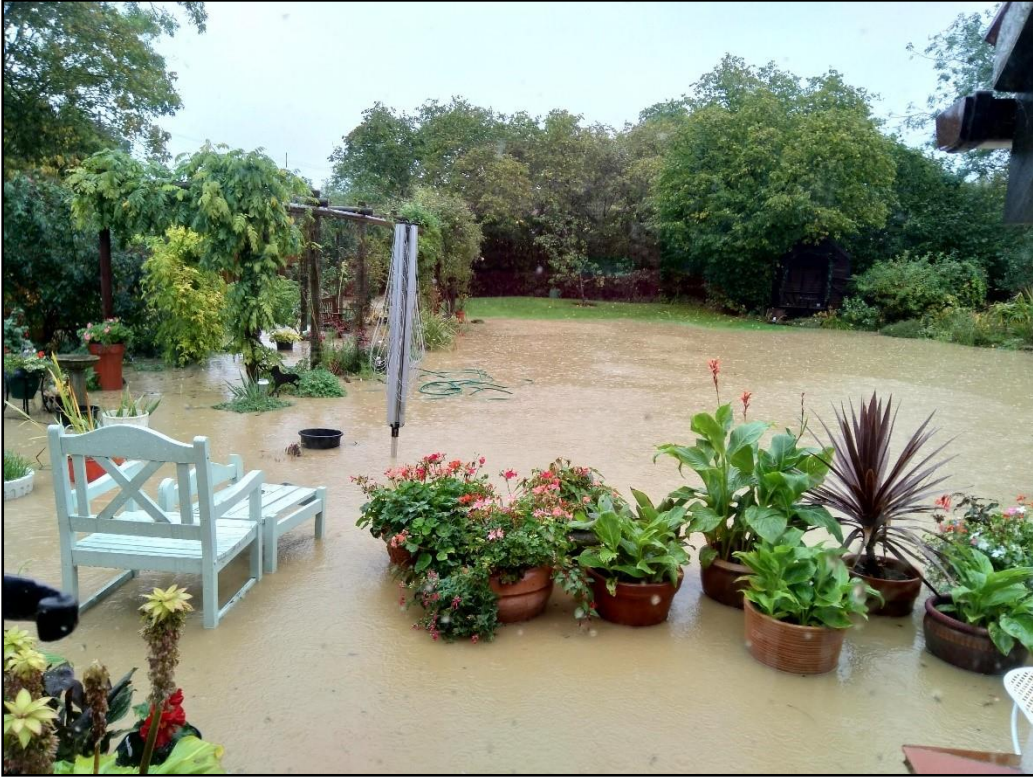
External flooding extents
