## Section 19 Flood and Water Management Act 2010

### Framsden Flood Investigation – Storm Babet 2023

<b>Name</b>	<b>Date</b>
<b>Report Author</b>	Susie Clark	
<b>Responsible Officer:</b>	Susie Clark	
<b>Checked by:</b>	Ellie Beecroft	17/10/2024
<b>RMA Review:</b>		08/11/2024
<b>Approved by:</b>	Matt Hullis	27/11/2024
<b>Date Published</b>		29/11/2024
<b>Date Report Closed</b>

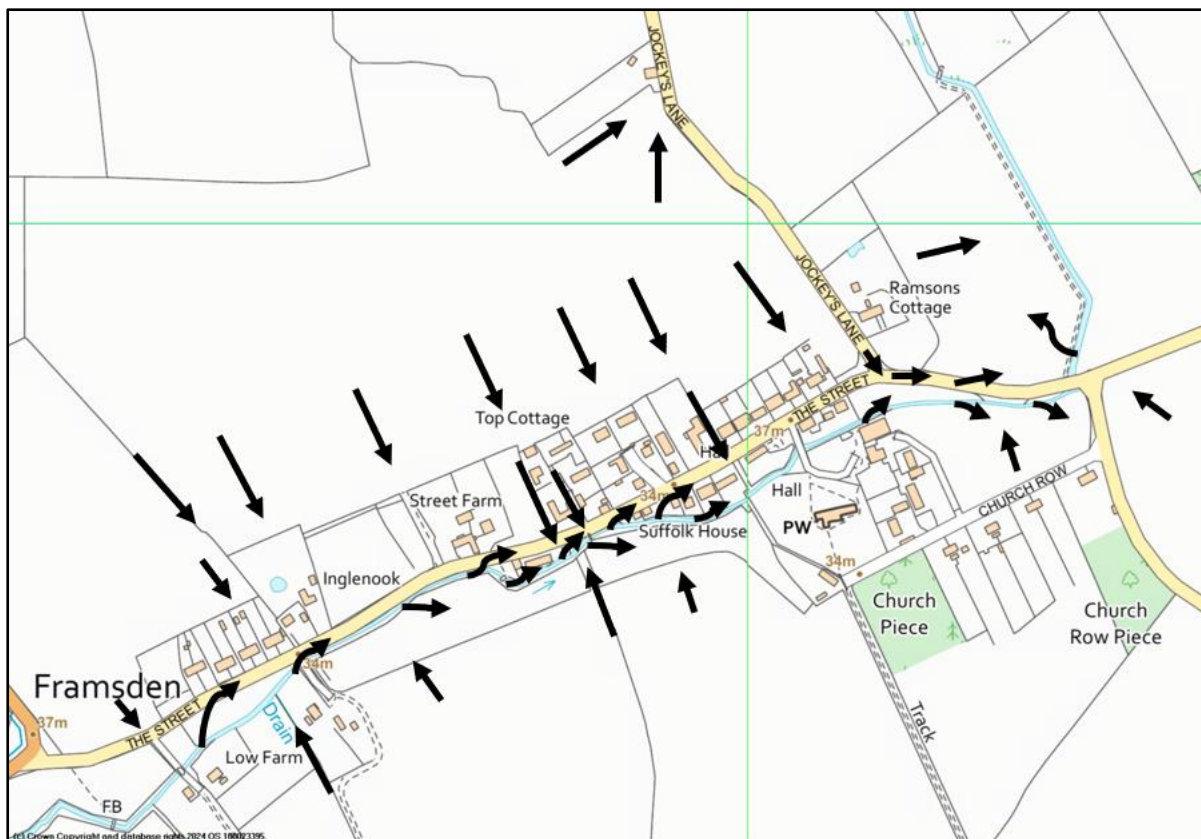
**Figure 10. Approximate floodwater flow paths, The Street and Jockey's Lane**

been observed for 34 years. Floodwater also flowed between some of the properties and began to collect on The Street, subsequently entering properties on the north and south side from the front, particularly those with driveways and properties at lower levels than the highway (Image 1). The road was reported as flooding by 10.15am on the 20<sup>th</sup> October.

There are no ditches currently within the fields to the rear of the properties on the north side of The Street, having been reported to have been removed when field drainage was installed 70 years ago. Mole drains had been redone 2 years prior to Storm Babet but the drains were described as having been overwhelmed by the volume of water. Fields were ploughed across slopes (horizontally), rather than down slopes (vertically) which is beneficial in slowing surface water flow but would have had a relatively small effect in the intense rainfall of Storm Babet. There is currently no means of attenuating the flow of surface water from these fields if the drainage network exceeds capacity.

Witnesses describe that after properties on the north side of The Street were flooded by surface water from fields, reported to have happened by 10.15am on the 20<sup>th</sup> October, Framsden watercourse overtopped its banks and began to impact the rear of properties on the south side of The Street (Image 2). The fluvial flood water merged with surface water, already present on the highway and further exacerbated the flooding of properties on the north side of The Street. Internal flooding of property on the north side of The Street was reported to have reached approximately 23cm.

- Report observed blockages, such as fallen trees, in Framsdén watercourse to the Environment Agency
- Report observed blockages of debris under highways bridges to Suffolk Highways authority.
- Residents to install Property Flood Resilience (PFR) via grant funded scheme.
- Explore potential natural flood management measures (eg. leaky dams and attenuation ponds) to “slow the flow” and attenuate water on surface water flow paths and ditches on fields south of Framsdén watercourse.
- Explore potential natural flood management (NFM) measures (eg. rough buffer strips, bunds, and/or ponds) for attenuating excess surface water flows from the fields on the north side of the eastern section of The Street.
- Explore potential NFM measures which aim to attenuate surface water in the upper catchment of Framsdén watercourse (eg. storage ponds and wetland areas).

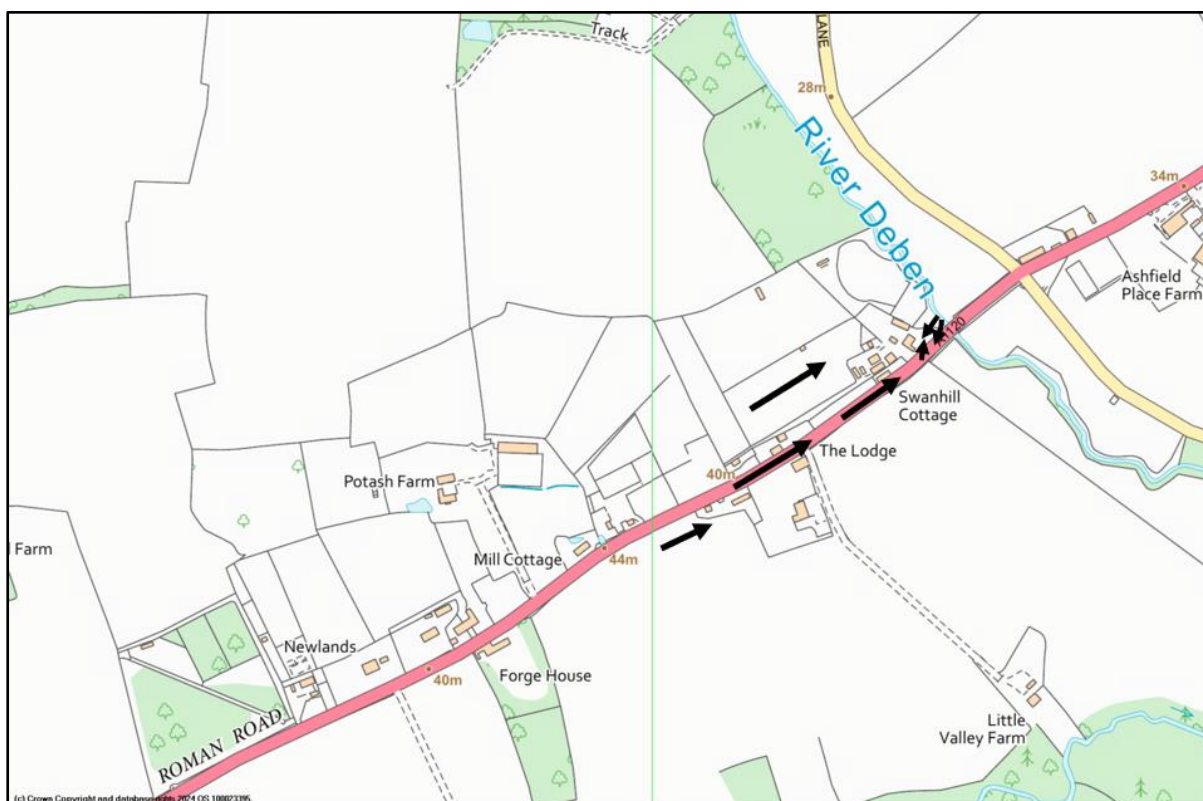
**Figure 11. Approximate floodwater flow paths Swan Hill, A1120**

Impacted properties in this area were located near the top and bottom of Swan Hill, A1120, to the west of the River Deben. Flooding near the top of the hill was attributed to surface water and groundwater flooding. At the bottom of the hill, property was affected by surface water and fluvial flooding.

- Surface water and groundwater caused internal flooding to properties close to the top of Swan Hill on the south side.
- Surface water on the A1120 flowed east down the highway on Swan Hill towards the River Deben, entering properties via driveways at the bottom of the hill. This was supplemented by surface water from fields.
- Storm drains on Swan Hill on the A1120 were unable to cope with the volume of surface water on the highway.
- The capacity of the bridge over the River Deben on the A1120 was exceeded, contributing to water overtopping the banks on the north side of the bridge which merged with surface water and flooded adjacent properties.

- Increase frequency and ensure completion of maintenance cycle for gullies on Swan Hill.
- Investigate/resolve non-operational gullies to west of river on Swan Hill.
- Report observed blockages of debris under the River Deben bridge to Suffolk Highways authority.
- Residents to install Property Flood Resilience (PFR) via grant funded scheme.
- Explore the potential for NFM measures to reconnect the River Deben with the floodplain between Debenham and the A1120 to allow for greater water attenuation on the floodplain.

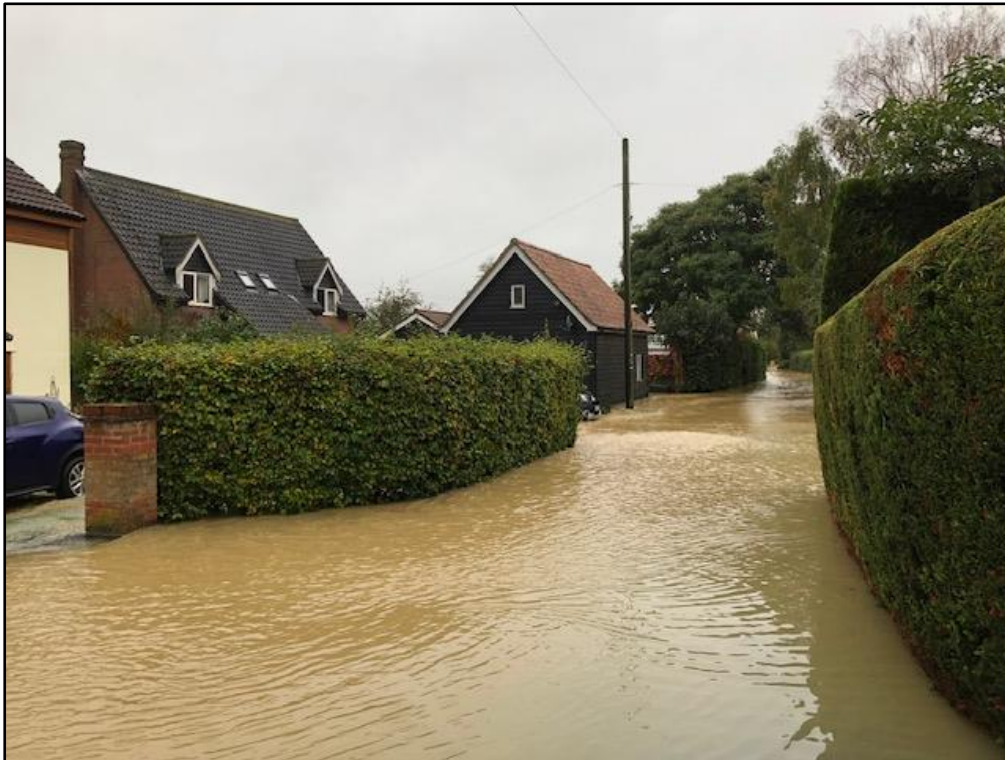
**Image 1. View west along The Street during Storm Babet**

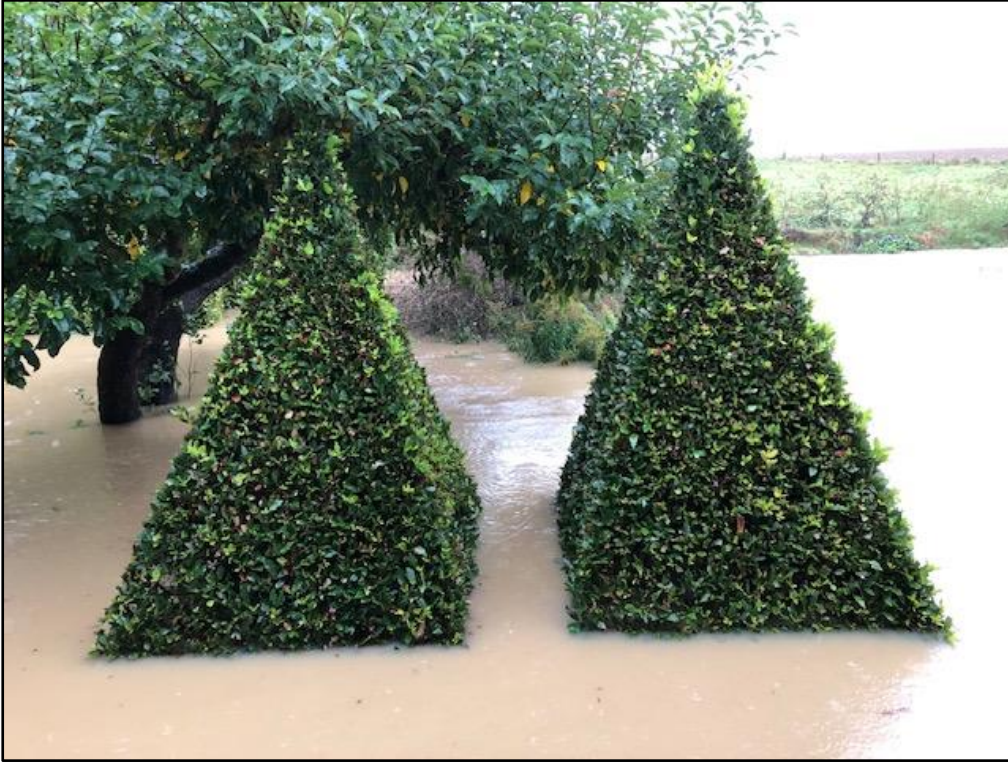
**Image 2. View looking south across gardens and Framsdén watercourse to the far bank of the watercourse from property on the south side of The Street during Storm Babet**

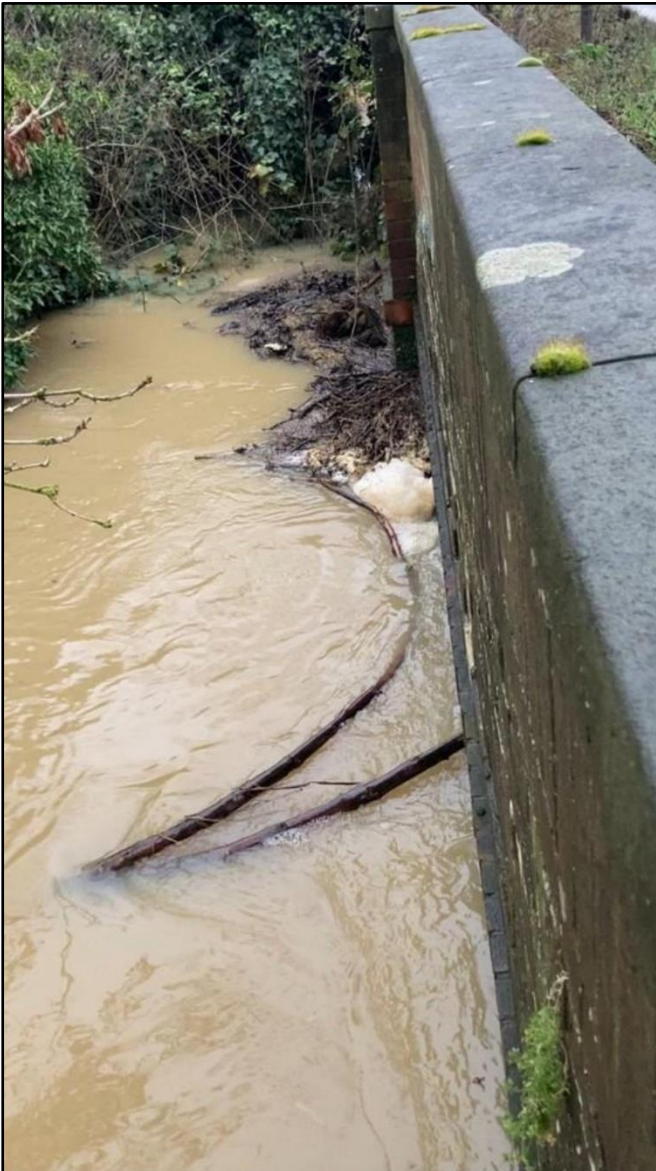
At 12.30pm water continued to rise in the River Deben and at 2.30pm property close to the River Deben was flooded, reported to be primarily from fluvial water from the River Deben overtopping its banks. The bridge on the A1120 over the River Deben was unable to accommodate all the river flow and was reported to have exceeded capacity. This caused water to back up on the north side of the bridge, with the river level close to the top of the wall. This contributed to flooding of property in the vicinity of the bridge whilst the flood plains to the south of the bridge remained relatively clear (see Image 3).

**Image 3. North side of River Deben bridge at the bottom of Swan Hill, A1120, during normal winter river flow**

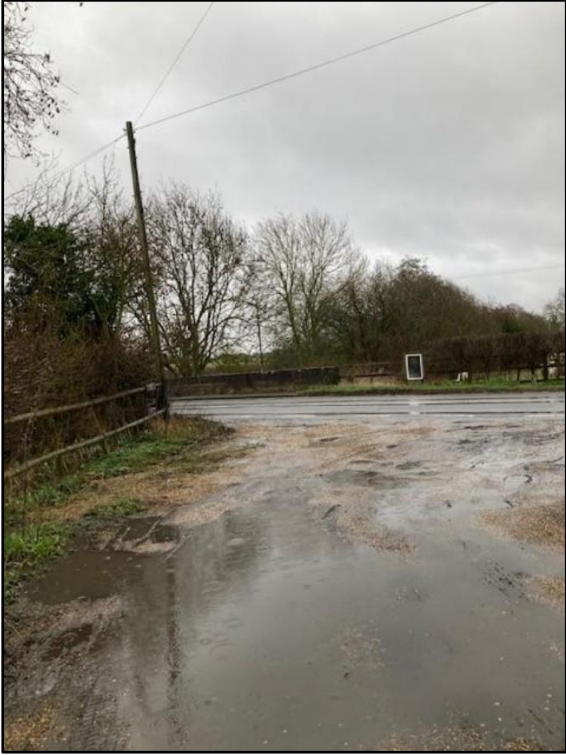
Property on the A1120, further west up the slope (Swan Hill) from the River Deben reported to have experienced internal flooding at approximately 9:30am, with flood water depths up to 15cm. Property in this location has since flooded again on 24<sup>th</sup> May 2024. The highway is elevated at this location and therefore surface water flowed from the highway towards the River Deben, entering property driveways which are at a lower elevation than the A1120 (Images 4 and 5).

**Image 4. Flooding from the highway entering a driveway at the bottom of Swan Hill, A1120 on 21st February 2023, after a couple of hours of light rain**

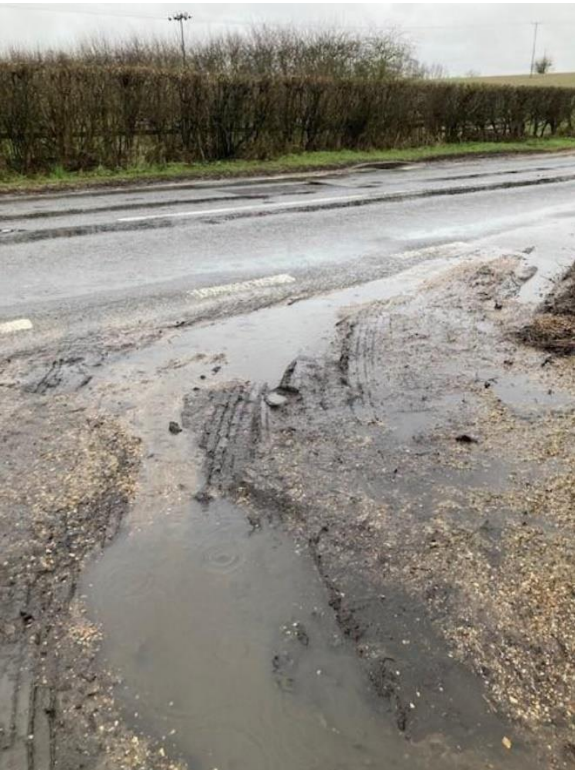
**Image 5. Surface water pathway from the A1120 on to property at the bottom of Swan Hill**

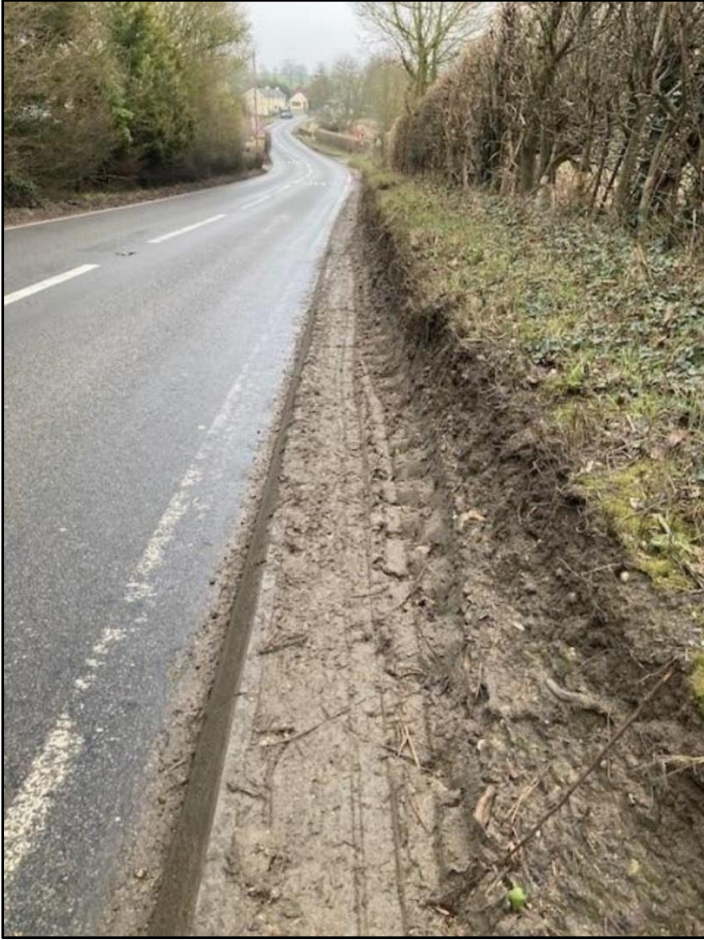
**Image 6. View down Swan Hill, A1120, showing erosion of verge**

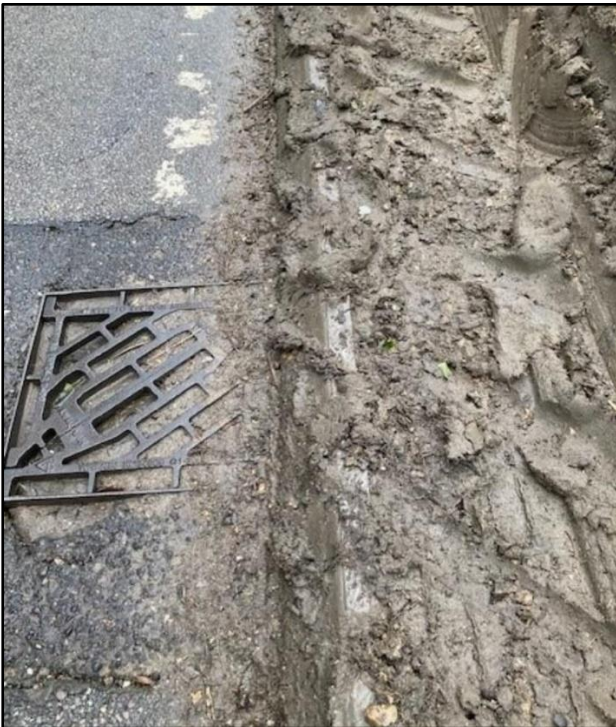
Fluvial floodwater was supplemented by surface water from the highway. Drainage assets were overwhelmed. Concerns have been raised by residents that gullies on this stretch of the A1120 are frequently blocked from mud deriving from heavy vehicles eroding the highway verges (Images 6 and 7). SCC Highways are aware of gullies on Swan Hill that are not fully functional and anticipate investigating and resolving this.

**Image 7. Gully on Swan Hill, A1120, blocked by erosion of verge**

Review cleansing frequency of gullies along Swan Hill, A1120	Suffolk County Council Highways Authority	Cycles have been reviewed and frequency increased so that all gullies are cleansed annually
--	---	---
