## Section 19 Flood and Water Management Act 2010

**Report Title: Ashcroft Road, Ipswich**

**Report Reference(s): CRNo 420364/ 141608 / 141674**

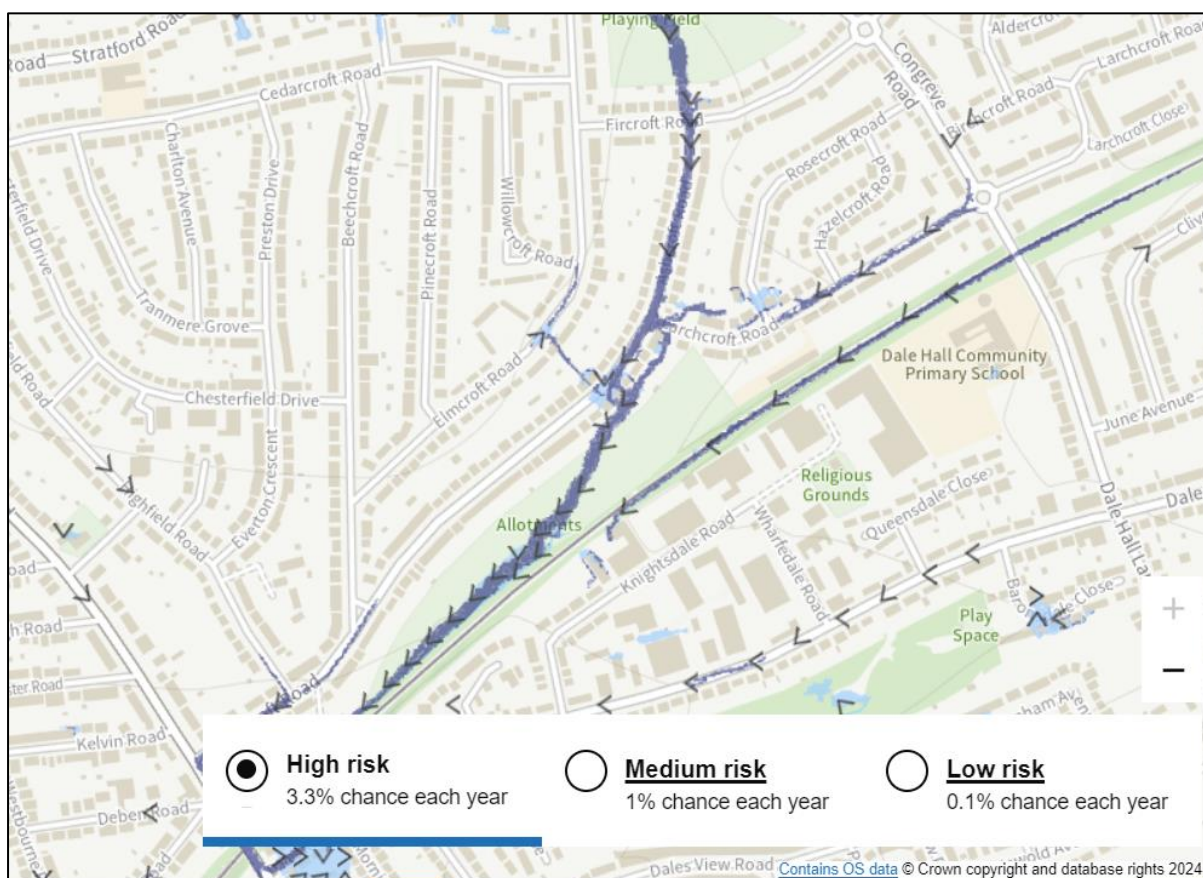
Figure 3: Worst case scenario for surface water flood hazard derived as a function of flood depth and velocity.

An extract of the pluvial (surface water) flood map is shown in Figure 3 for reference. This extract demonstrates the potential direction and speed of flow during the high risk scenario (more than 3.3% chance of happening in any given year). A flow route of surface water can be identified on both Ashcroft Road and Larchcroft Road in the figure below and is indicative of what was reported by residents. There is also a surface water flow path to the rear of the properties that correlates with residents' reports of separate flow paths occurring in the highway and rear gardens simultaneously.

The flow path in the rear gardens is likely a result of the natural topography instead of a result of failed drainage or sewer infrastructure. The national flood risk maps use LiDAR data, which highlights variances in ground levels and contours influencing where flow paths will develop. The mapping does not include below ground infrastructure in its model. Any lack of capacity in the drainage networks will therefore be in addition to the flows shown above. The resultant flood mapping is based on a national model and therefore a bespoke model of the Ipswich catchment would refine flows paths, locations and volumes.

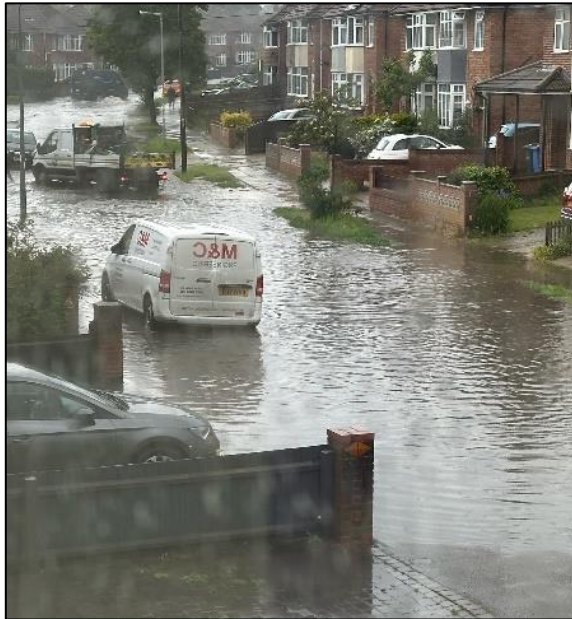
Anecdotal evidence indicates that during and shortly after an intense downpour, significant volumes of surface water flowed down Larchcroft Road (north-east of Ashcroft Road) and Ashcroft Road and overwhelmed the highway gullies and the combined (surface water and foul) sewer network. The manhole covers lifted due to the pressure in the system and floodwater from the sewers combined with surface water already accumulating in the highway flooded nearby driveways, gardens and properties. The properties on the south-eastern side of Ashcroft Road were impacted more severely due to the ground levels falling towards the properties.

Flooding in Ashcroft Road

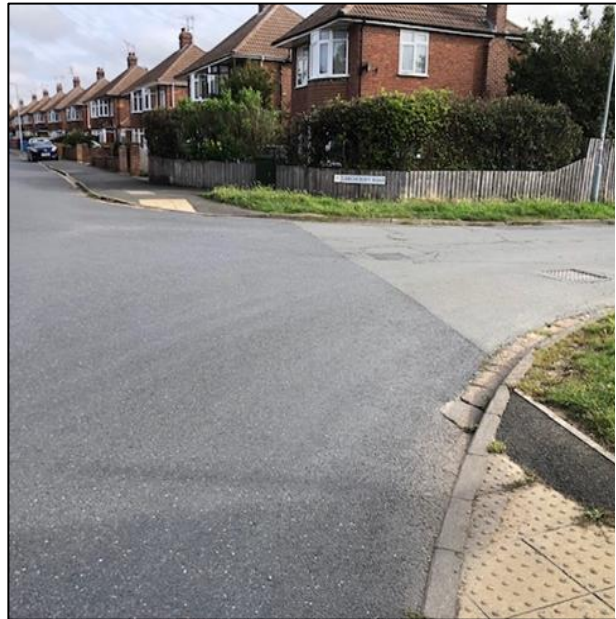
- Anecdotal evidence indicates that during the recent flood events, the pressure in the sewer network resulted in access chamber covers lifting and sewage mixing with surface water runoff in the road. The pressure in the combined sewer also resulted in household drains backing up and causing further flood damage within the properties.

Manholes in Larchcroft Road which were lifted during the flood event

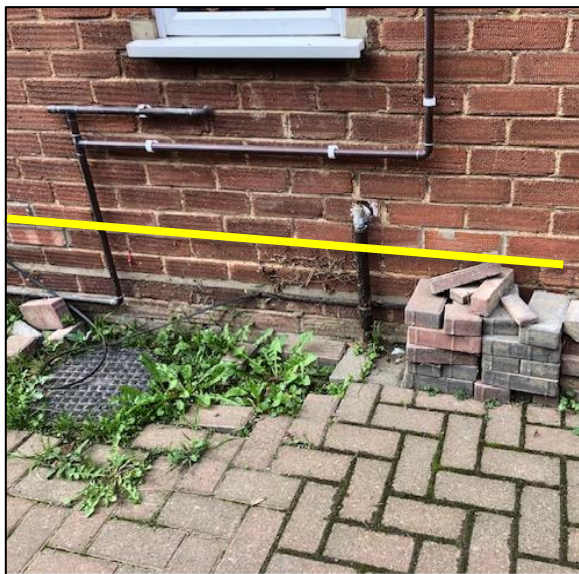
- Property A is located at the lowest topographic point on Ashcroft Road which means that when the gullies cannot accommodate the flows, excess water runoff flows towards the property.

Yellow line showing the height of inundation outside property A

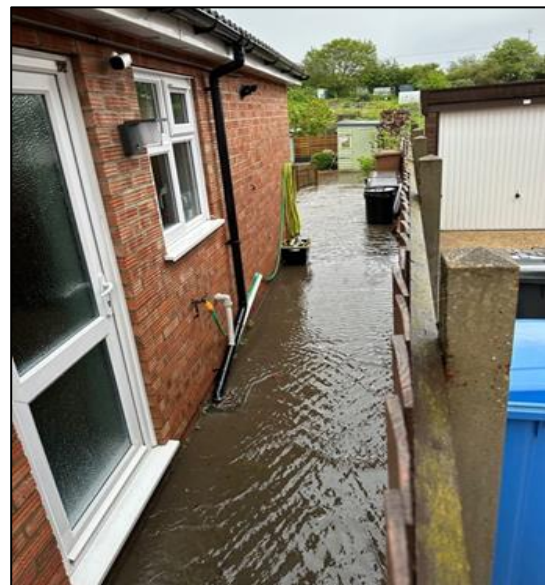
Flood water flowing from Ashcroft Road to the back garden of property B
