Section 19 Flood and Water Management Act 2010

Framlingham Flood Investigation – Storm Babet 2023

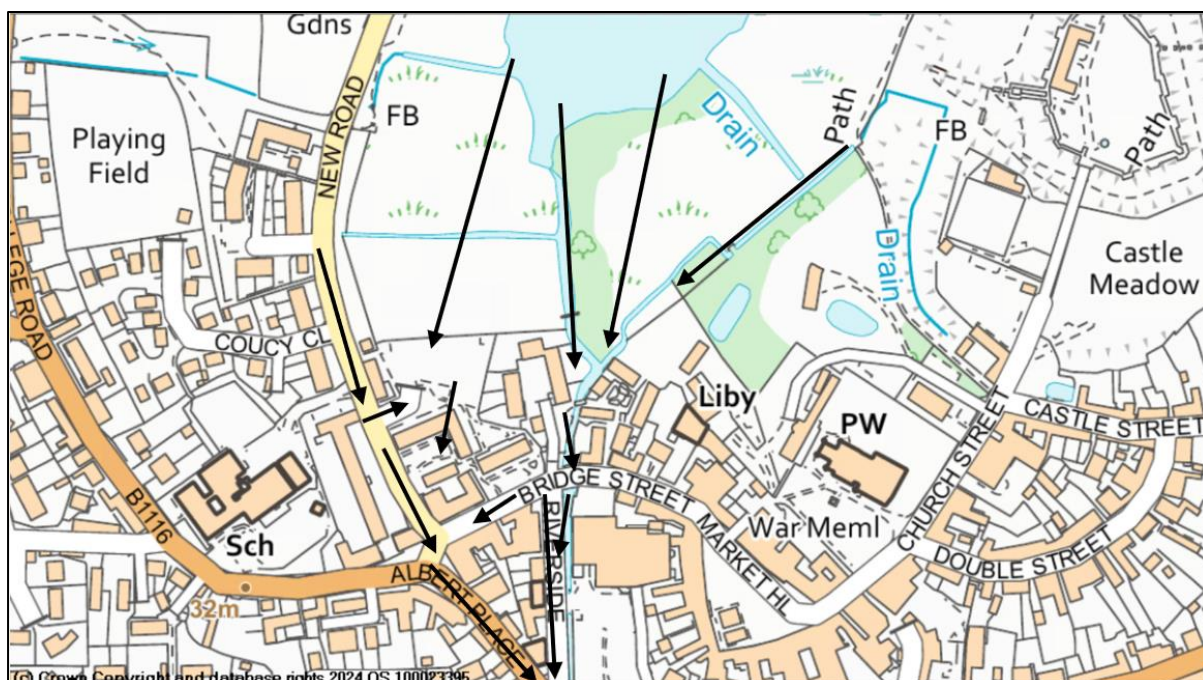
Figure 9 - Approximate flood water flow routes in North Framlingham

The primary source of flooding in the north of Framlingham was fluvial flooding, from the overtopping of the River Ore and the Mere through which the Ore flows. There are five overland flow paths that feed into the Mere from the Upper Catchment above Framlingham. Residents reported that the water flows in both the River Ore and Mere rapidly expanded on the morning of Friday 20th. After overtopping the banks, overland fluvial flows quickly moved towards The Elms car park where depths reached approximately 150cm (Image 1). The depths in the car park increased and the area of flooding was enhanced by pluvial flows coming from New Road.

Flood water continued through the car park to flood the Elms residential area from the rear, inundating the entire area. This was increased by the surface water run-off flowing eastwards off New Road towards the residential area and the car park from the west and northwards from Bridge Street. Residential housing was flooded internally to a depth of approximately 80cm. All ground floor premises are thought to have been flooded (approx. 10). Residential, commercial properties and the road on Bridge Street were also flooded as the river overtopped between the road bridge and the Mere. Reports from residents suggest that there were blockages, most likely woody debris from the Mere, under the bridges over the Ore in this area which may have contributed to overtopping of the river channel. The combined fluvial and pluvial flood water flowed South and West towards Riverside and Well Close Square respectively but was limited in the direction of Market Hill by the natural raising incline to the East (Image 2).

- High rainfall resulted in excess floodwaters flowing into the Mere from the upper catchment north of Framlingham.
- The Mere and River Ore exceeded capacity overtopping on to the roads.
- Pluvial flows from multiple pathways added to the floodwater.
- Drainage assets on the highway were overwhelmed beyond their design capacity.

- Investigate potential NFM projects and funding opportunities which aim to attenuate water and 'slow the flow' in upper catchment north of Framlingham.
- Framlingham College and Suffolk Wildlife Trust to review their maintenance/management of the Mere.
- Investigate potential new/additional highway drainage assets on New Road.
- Improve drainage system on The Elms carpark
- Remove any observed blockages within main river and ordinary watercourses where flood risk is increased.
- Ensure the completion of highway drainage asset maintenance and investigate if capacity and condition are sufficient.
- Investigate any capital interventions that can improve the flood resilience of the town.

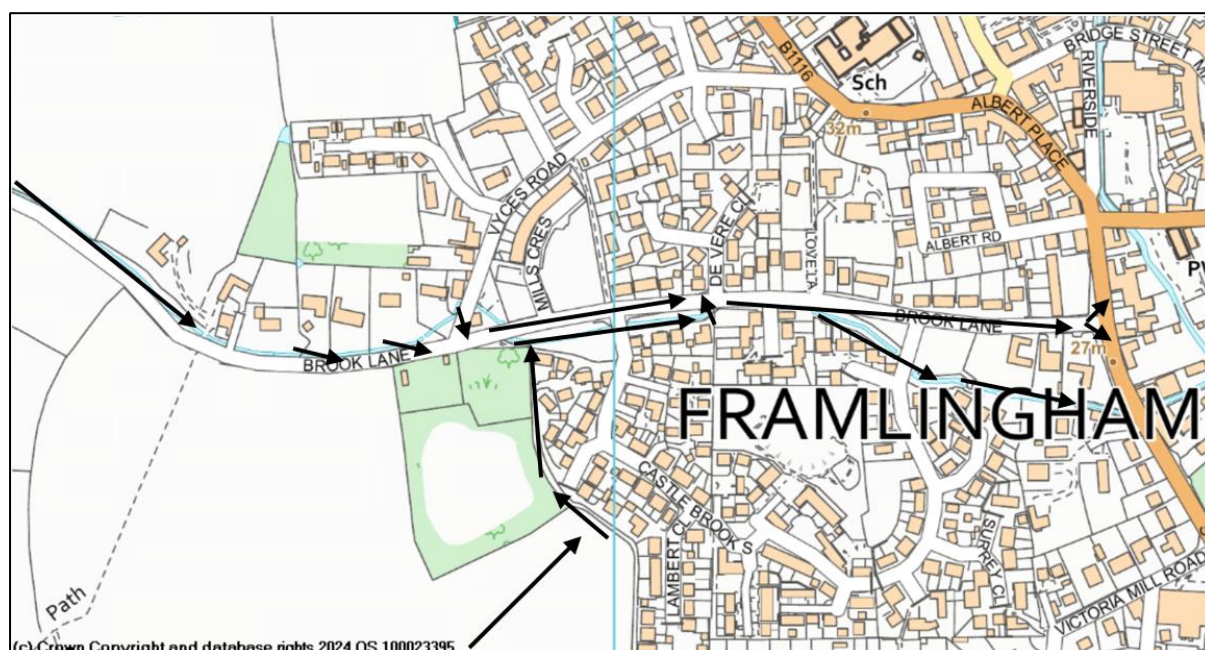
Figure 10 - Approximate flood water flow routes in West Framlingham

The primary source of flooding in the west of Framlingham was fluvial, with flood water overtopping the banks of the Cherry Brook watercourse. This was contributed to by surface water run-off from higher ground and the additional backing up of flood water from the culvert under The Mills. Brook Lane is aligned along the major flow path from the west coming into central Framlingham (Figure 5).

Simultaneously, surface water run-off was rapidly flowing towards Brook Lane from the fields to the south, adding to the floodwater. This was described as ‘a waterfall’ by residents. The full extent to which this added to the flooding is less well understood as this overland flow path is not well represented on the national mapping. However, it can be acknowledged that it added to the already full main river and the flooding of Brook Lane. This caused internal flooding of several residential properties, in addition to the flooding of several gardens along Brook Lane.

The main river runs into a culvert under The Mills, opposite the entrance to De Vere Close. This restricts the capacity of the main river channel, and several reports indicated the fluvial flood water was backing up at this location. As the channel overflowed, this was another contributor to the flood water on the road, in the gardens and inside properties close by. This is consistent with the predicted fluvial flood risk which is defined as High in this location.

- High rainfall resulted in excessive amounts of water flowing into Cherry Brook watercourse from fields to the west of Framlingham.
- Cherry Brook watercourse exceeded capacity and overtopped onto Brook Lane.
- Pluvial flows from multiple pathways added to the floodwater.
- The floodwater flowing along Brook Lane could not get back into the main river channel.
- The culverted section of the main river reduced capacity, backed up, overtopped and added to the floodwater on Brook Lane.
- Drainage assets on the highway were overwhelmed.

- Investigate potential NFM projects and funding opportunities which aim to attenuate water and 'slow the flow' in the catchments West of Framlingham.
- Remove any observed blockages within main river and ordinary watercourses where flood risk is increased.
- Ensure the completion of highway drainage asset maintenance and investigate if capacity and condition are sufficient.
- Investigate options to connect surface water flowing on Brook Lane back into the river.
- Investigate options to improve the capacity of the culvert below The Mills on Brook Lane.

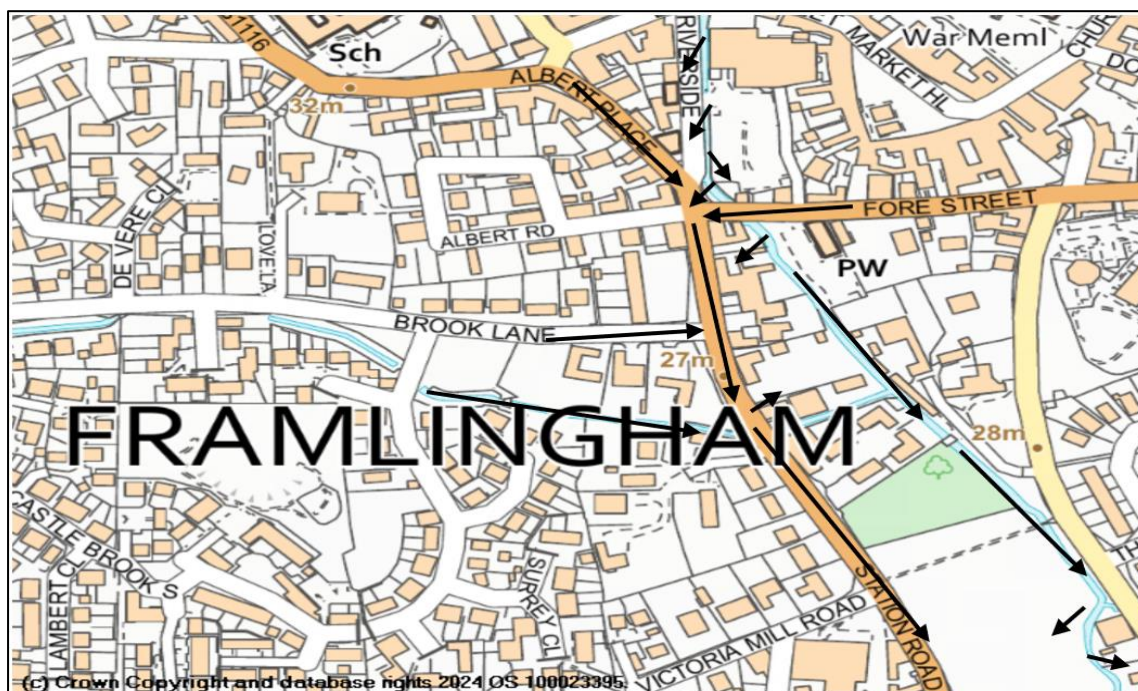
Figure 11 - Approximate flood water flow routes in Central Framlingham

The primary source of flooding in central Framlingham was a combination of fluvial and pluvial flooding, with flood water from the river and roads merging. The banks of the River Ore overtopped and combined with surface water flows from the north (Bridge Street, Well Close Square), the east (Fore Street) and west (Brook Lane).

The River Ore burst its western bank initially at the junction of Albert Place and Fore Street and then south of the Bridge Street and Riverside junction (Image 4). This flood water flowed along Riverside, with the road acting as a secondary river channel, carrying floodwater downstream, inundating Albert place (Image 5). Residential and commercial properties on Riverside were flooded internally to approximately 33cm. The flood waters were added to by surface water from Bridge Street and New Road, flowing into Well Close Square and toward Albert Place. Central Framlingham and Albert Place in particular, being amongst the lowest points in Framlingham, acted as the central basin into which a combination of pluvial and fluvial floodwater accumulated. The roadside drainage assets were completely overwhelmed. Outfalls for highway drainage were quickly submerged as they fell below the peak river level, were unable to discharge fully into the river and caused water to back up.

The flood water continued to flow south from Albert Place where the road and river diverge. At this point, the road became the primary channel for flood water flows, further building up through lateral pluvial inflows from Fore Street (coming downhill), Albert Road and multiple gardens. This merged with flood water flowing from the west along Brook Lane, flooding properties adjacent to Station Road between Albert Place and the junction with Brook Lane. Evidence suggests that the primary direction of flooding was from the front, i.e., from the road.

The Ore also broke its Western bank downstream of the B1119 road bridge, flooding gardens to the rear of properties on Station Road. These properties were impacted by the flood water flowing down the road at the front of the houses and the flood flows from the Ore to the rear.

The Environment Agency measured an external wrack mark (a line of debris left following a flood) of 102cm, and an internal wrack mark of 57cm on Station Road. At one commercial property, internal flooding of 63cm was recorded, while the level on the back fence of the garden was 85cm high.

- Investigate potential NFM projects and funding opportunities which aim to attenuate water and 'slow the flow' in the catchments surrounding Framlingham.
- Remove any observed blockages within main river and ordinary watercourses where flood risk is increased.

- Ensure the completion of highway drainage asset maintenance and investigate if capacity and condition are sufficient.
- Investigate any capital interventions that can improve the flood resilience of the town.

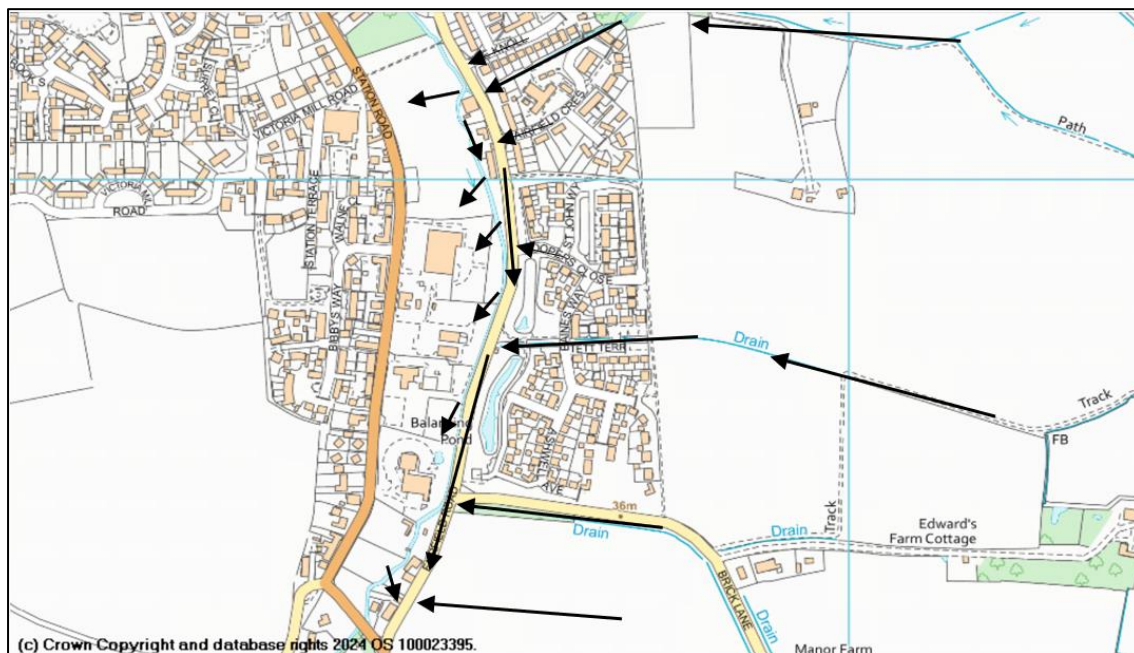
Figure 12 - Approximate flood water flow routes in East Framlingham

The flooding in the Fairfield Road area was caused by a combination of fluvial flooding from the River Ore overtopping its banks and pluvial flooding, with water flowing off fields from the east. Flood water originating from the fields to the east rapidly flowed down the watercourse between 'The Knoll' and 'Fairfield Crescent' where it would ordinarily pass under Fairfield Road via a culvert and discharge into the Ore. The capacity of this culvert was exceeded due to the sheer abundance of rainfall and surface run off flowing through the watercourse. As the flow backed up and overtopped the channel bank, flood water flowed along Fairfield Road in a southerly direction. The road was described by residents as becoming 'a river' within minutes (Image 6). Surface water also flowed down a combination of roads to the east of Fairfield Road, including The Knoll, Fairfield Crescent, Coopers Close and Brick Lane, all of which brought additional flood water. The extensive flood water accumulating on Fairfield Road flooded commercial and residential buildings along from the front. This sequence of events closely matches the flow paths and extents shown in the predicted surface water flood mapping.

Additionally, the Ore exceeded its Eastern bank and fluvial water flowed towards properties along Fairfield Road from the rear. Consequently, as the drainage assets on the highway were overwhelmed, the flood water on the road could not discharge into the river, creating a large expanse of water around the properties. The Ore also overtopped its Western bank, flooding the public open space and commercial buildings to the west of the river.

The open watercourse adjacent to Tett Terrace filled to the top of bank but did not exceed its capacity. The drainage system in place at this location is designed to flow into the Ore via a culvert under Fairfield Road, but the capacity of the culvert was rapidly exceeded. The water from the channel spilled out onto Fairfield Road mirroring what was happening at the culvert in the channel between The Knoll and Fairfield Crescent to the north. This may have been compounded by a tree growing at the inflow / inlet. Fairfield Road experienced flooding again on 8th February 2024. On that occasion the floodwater was restricted to the road surface before making its way back into the main river channel.

- Investigate potential NFM projects and funding opportunities which aim to attenuate water and 'slow the flow' in the catchment East of Framlingham.
- Remove observed blockages within the man river channel along Fairfield Road.
- Create a ditch/improved drainage assets at the bottom of the field east of Fairfield Road
- Ensure the completion of highway drainage asset maintenance and investigate if capacity and condition are sufficient.
- Investigate options to improve the capacity of the culverts below Fairfield Road connecting the watercourses with the main river
- Investigate any capital interventions that can improve the flood resilience of the town.

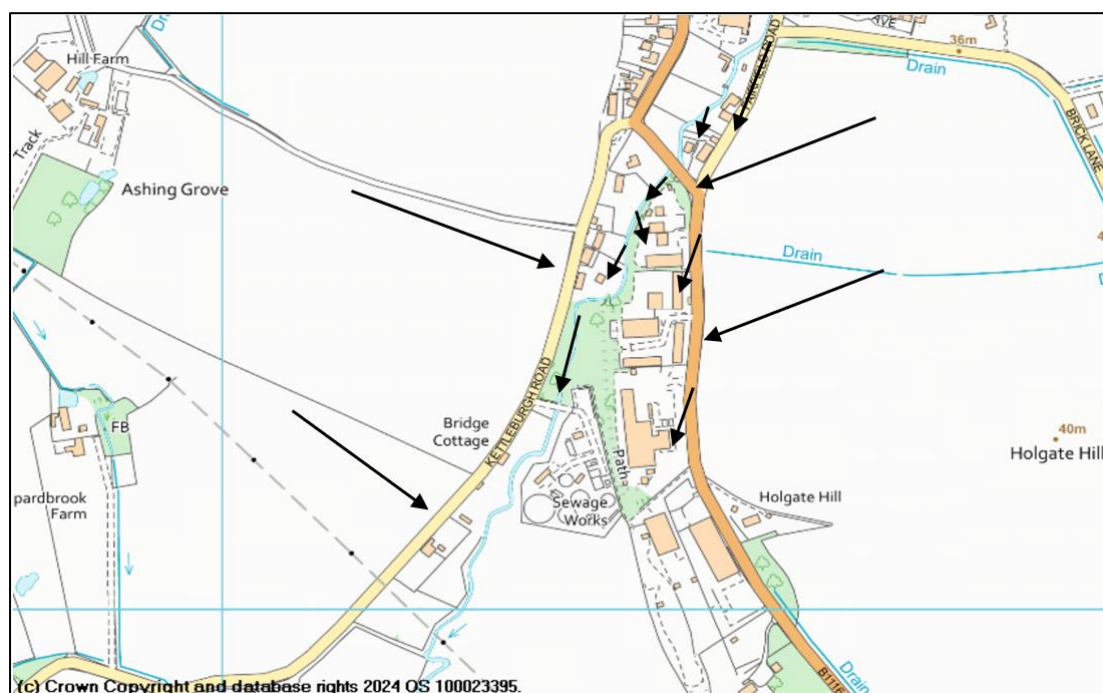
Figure 13 - Approximate flood water flow routes in Central Framlingham

Multiple commercial properties on the north end of Woodbridge Road suffered pluvial flooding from the front, as flood water flowed south-west from Fairfield Road and merged with substantial surface water runoff from the fields to the east. The observed flow paths and flood extents closely match the national predicted surface water flood risk mapping. The River Ore was at full capacity and overtopped in places to the rear. Blockages and in channel debris may also have slowed the conveyance of the flood water in the river channel at this location.

Several residential properties also flooded on Kettleburgh Road. Pluvial flows coming across the fields from the west, overwhelmed the drainage ditches and spilled onto the road impacting properties from the front. There have also been reports of water backing up from assets associated with the sewage works on Kettleburgh Road. Water was emerging from manhole covers on the road and caused internal flooding from a backed-up toilet in one property.

- High rainfall resulted in large amounts of pluvial flows coming from fields to the East and West.
- Flood water flowed along Woodbridge Road and Kettleburgh Road impacting properties from the front.
- Drainage assets on the highway were overwhelmed.

- Investigate potential NFM projects and funding opportunities which aim to attenuate water and 'slow the flow' in the fields to the East and West.
- Remove observed blockages within ordinary watercourses and main river.
- Investigate options to improve drainage / water storage at the bottom of the field east of Woodbridge Road.
- Ensure the completion of highway drainage asset maintenance and investigate if capacity and condition are sufficient.
- Investigate any capital interventions that can improve the flood resilience of the town.

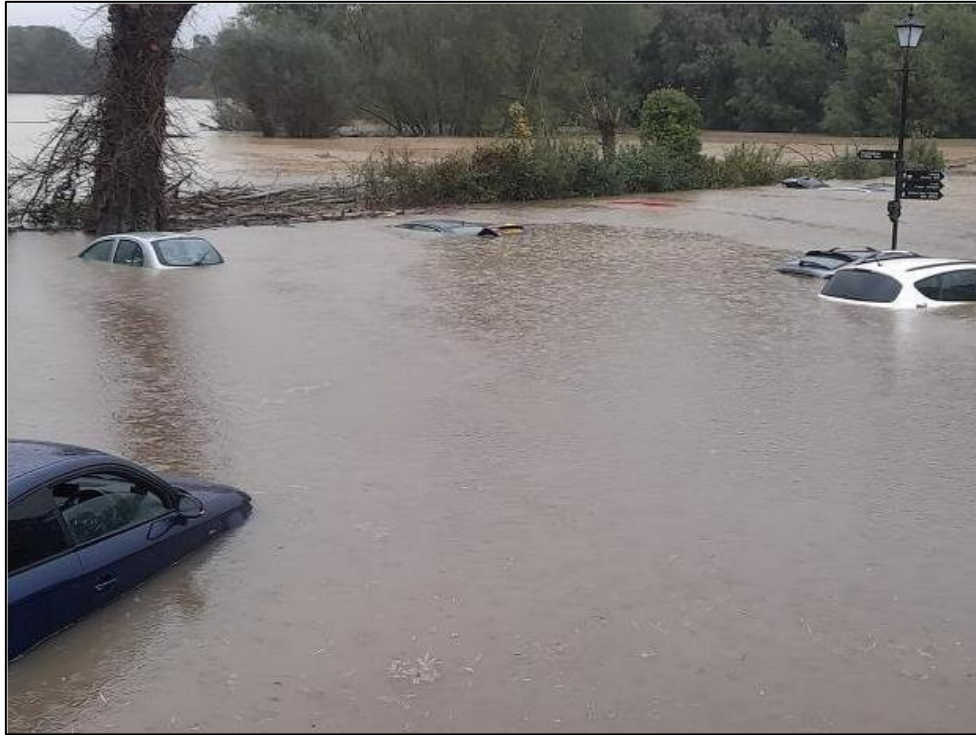
Image 1 - Flooding of The Elms car park and The Mere

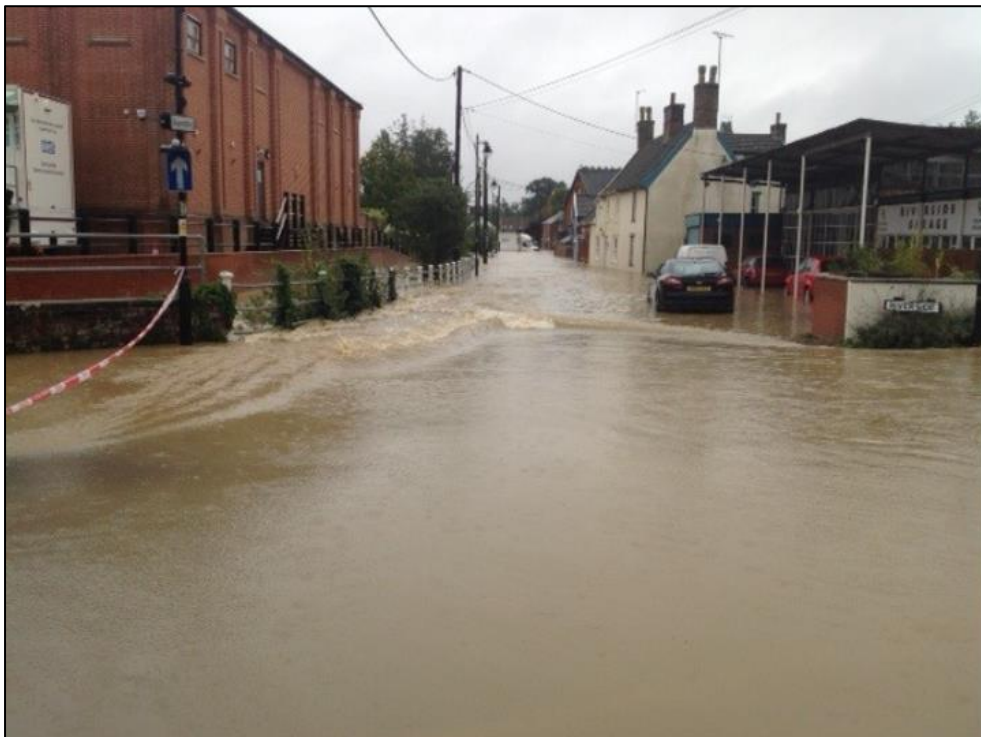
Image 2 - Flooding on Bridge Street looking towards Riverside

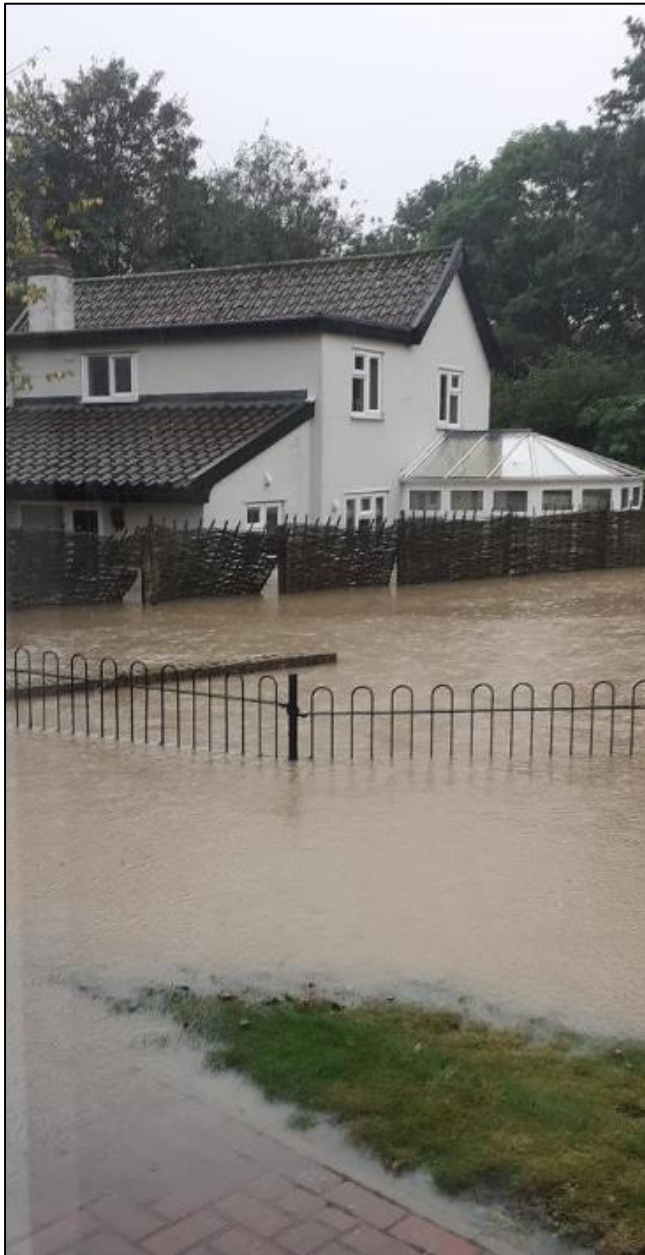
The Cherry Brook watercourse breached its banks early on 20th October and caused flooding of the adjacent Brook Lane (Image 3). The overtopping of the watercourse effectively creating a second flow path along the road, following the natural gradient towards Station Road (Image 9). This substantial amount of flood water is likely to have been greater than the design capacity of the highway gullies. This correlates closely with the predicted flood risk maps, with fluvial risk being categorised as Medium to High and the pluvial flood risk categorised as high along the length of Brook Lane.

Image 3 - Flooding on Brook Lane

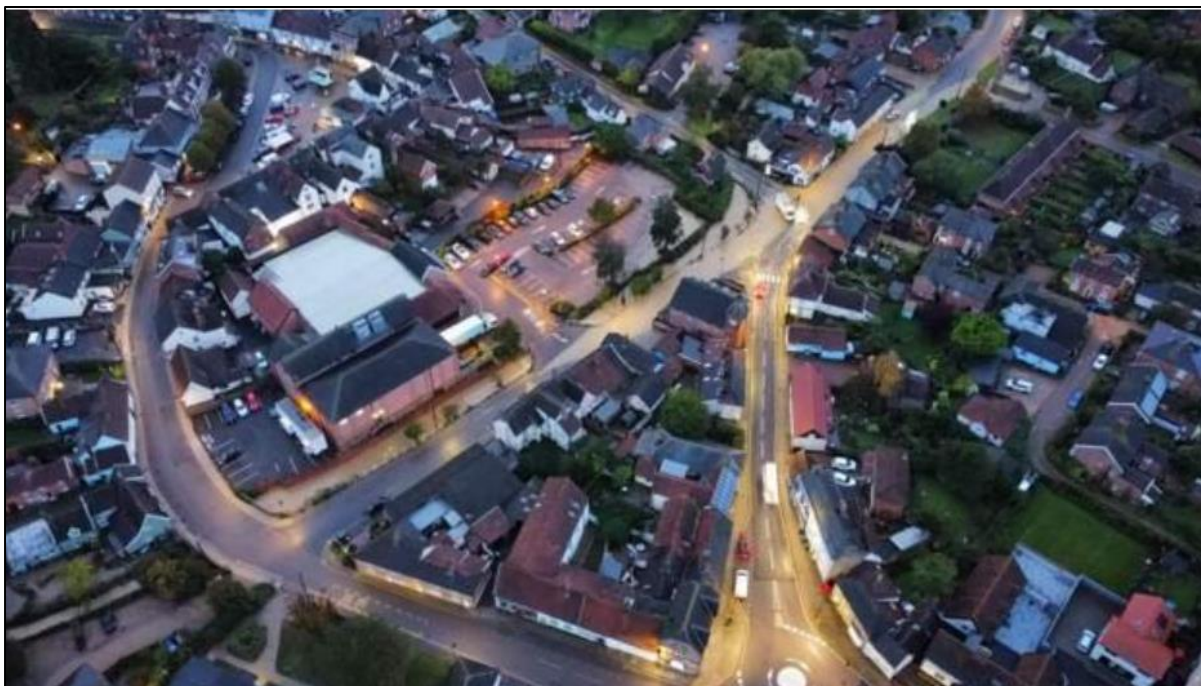
Image 4 - River overtopping at Riverside / Albert Place corner, early on the morning of 20th Oct

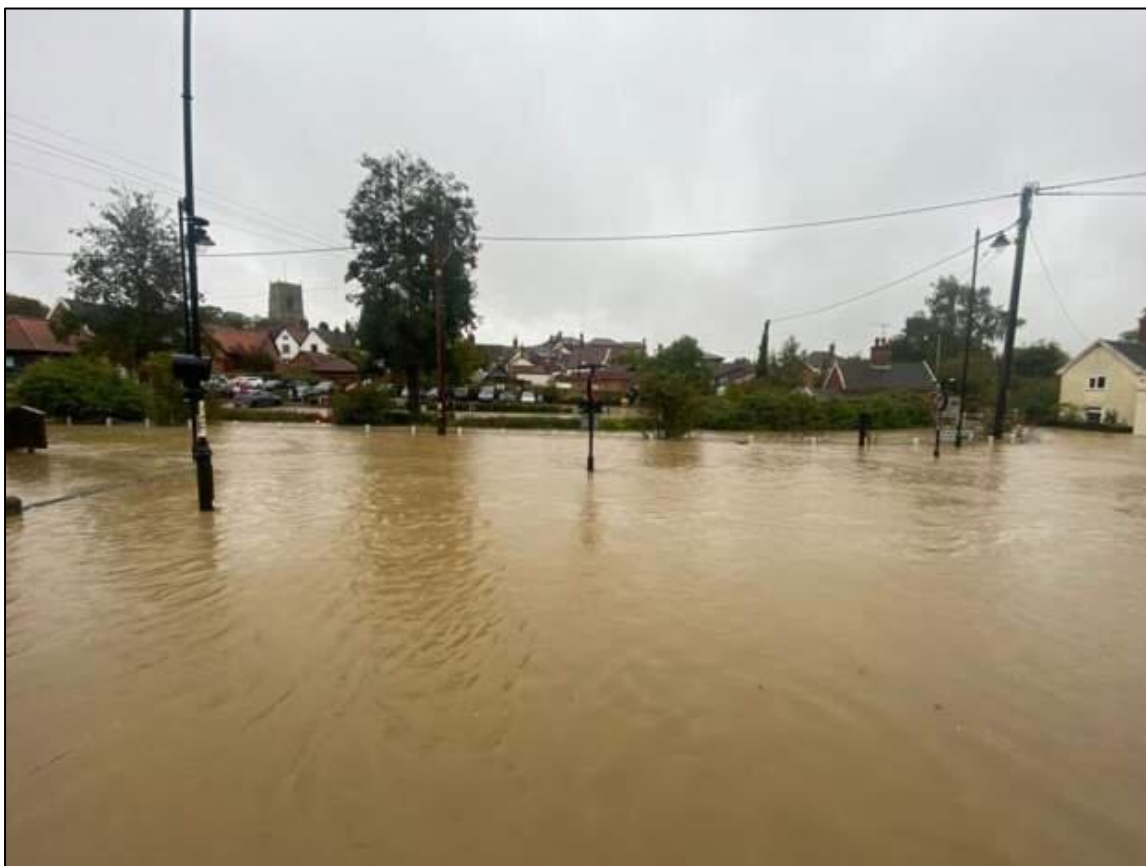
Image 5 - Extensive flooding on Albert Place

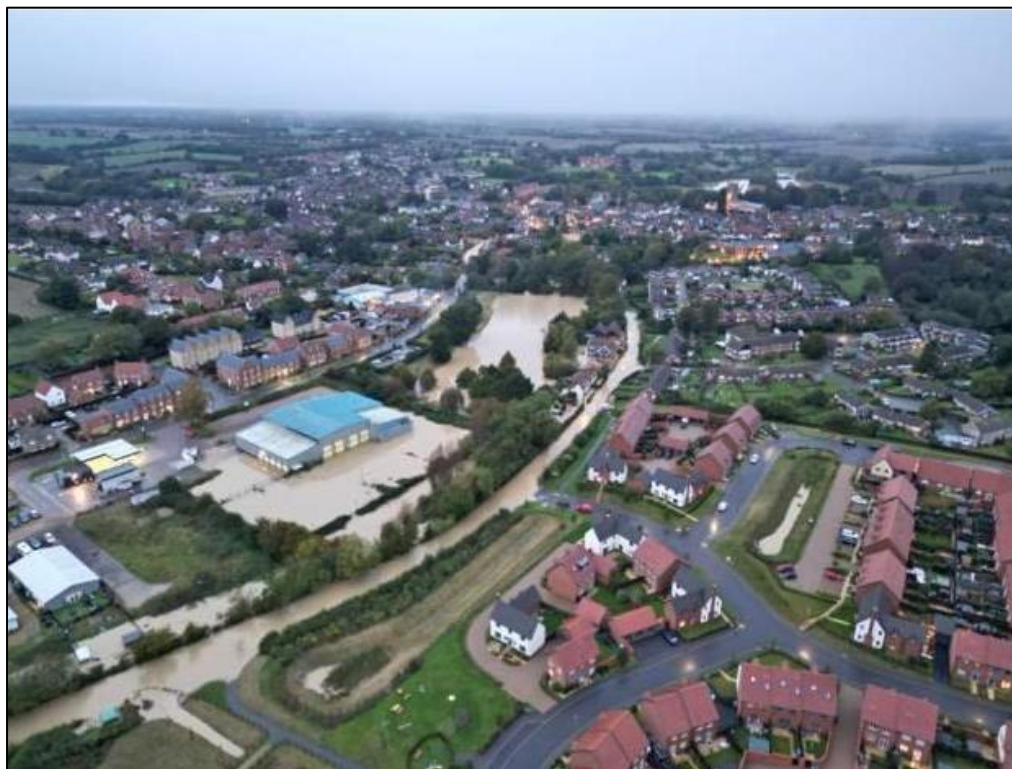
Image 6 - Flooding along Fairfield Road

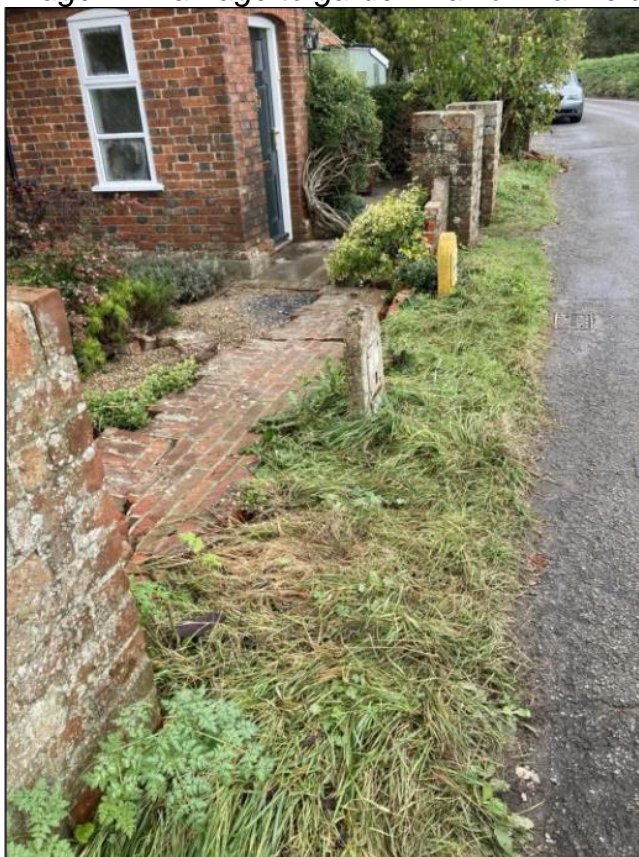
Flood water continued to flow along Fairfield Road and further impact residential properties from the front. The velocity of the water damaged fencing at the front of one property. Again, this was in addition to fluvial flooding to the rear from the Ore which had overtopped its Eastern bank, leading to combined source flooding.

Image 7 - Damage to garden wall on Fairfield Road

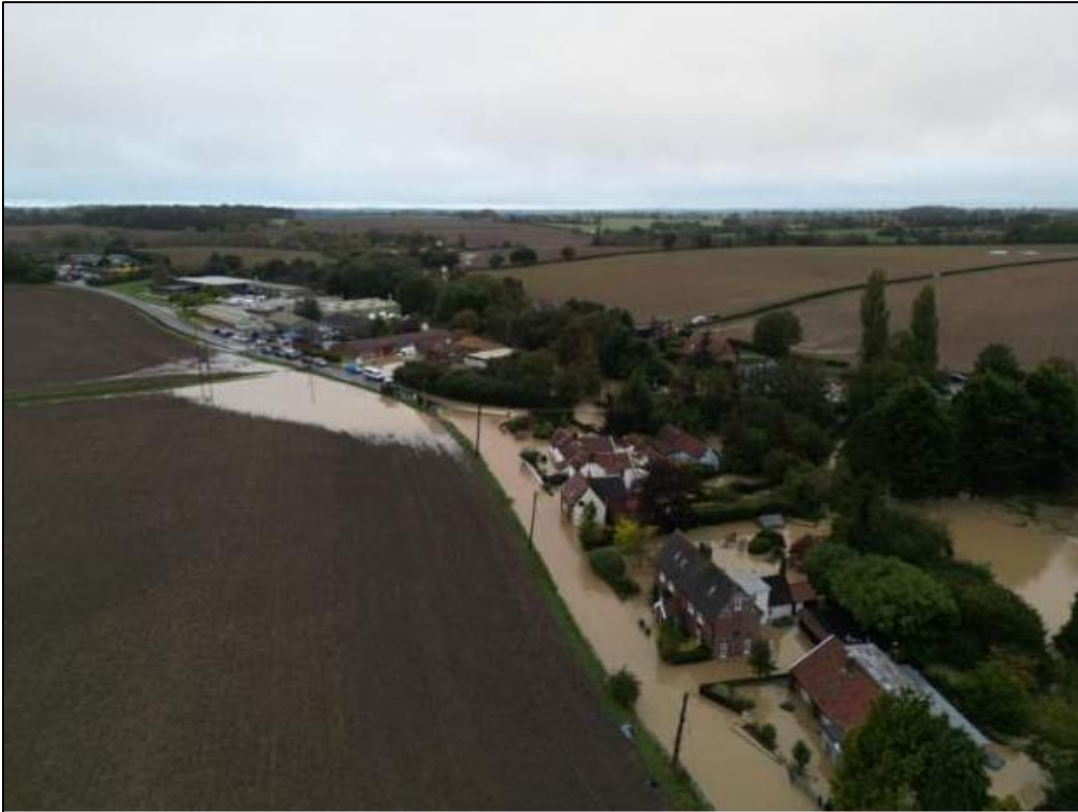
Image 8 - Flooding on Fairfield Road looking towards Woodbridge Road

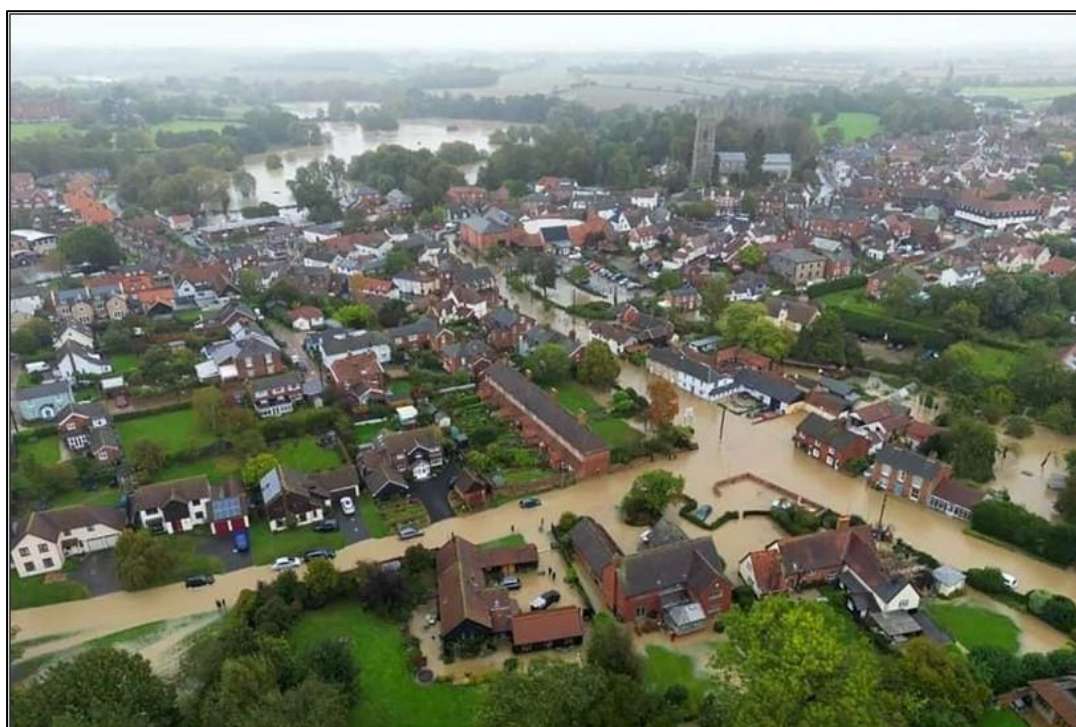
Image 9 - Flooding on Brook Lane and Station Road
