## Section 19 Flood and Water Management Act 2010

### Report Title: Elm Close, Hazel Close, Greenwood Close & Harewood Terrace, Haverhill

CRNos 330018, 329910 & 330025

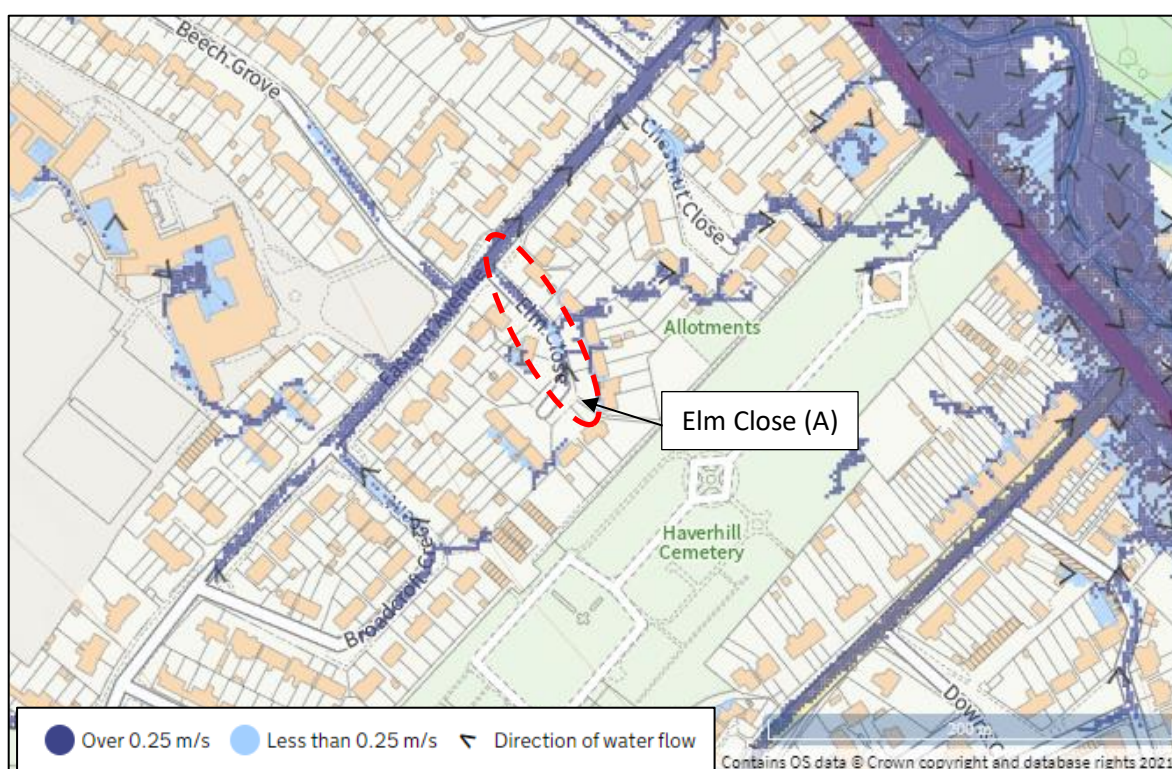
Figure 6 - Surface water flood risk: water velocity in low-risk scenario (GOV.UK mapping)

The flow path through Elm Close towards Property A, can clearly be seen in the above figure. Likewise, the flow path can clearly be identified past and through Property B, in Hazel Close, in figure 7 overleaf.

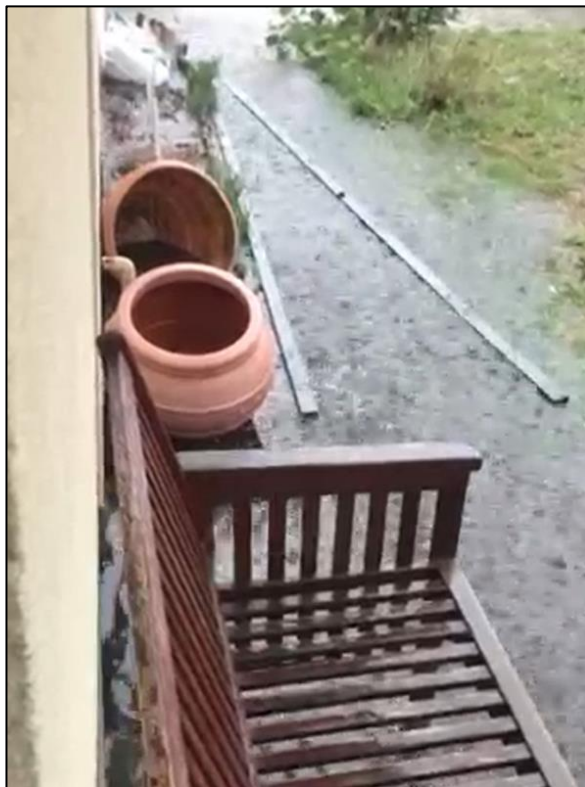
Property A, in Elm Close, flooded internally. Flood waters accumulated in low spots immediately outside the property adjacent to the front wall (to depths of 300-450mm) and entered through the front door. Water also seeped through the brick work walls. Flooring materials and furniture were damaged in the living room and hallway.

- **Elm Close** is served by a single gully, which is located at the lowest point in the cul-de-sac, immediately adjacent to Property A. When this gully cannot accommodate the flows, excess surface water runoff travels towards Property A, following the lie of the land. Property A is situated at a lower elevation than the highway and so surface water accumulates in front of the property and leads to internal flooding. It should also be noted that many of the front gardens have been covered in hard surfacing over time to facilitate parking requirements for the properties. This has significantly increased the contributing area and thus increased the pressure on the existing drainage.

Floodwater accumulating outside Property A, Elm Close

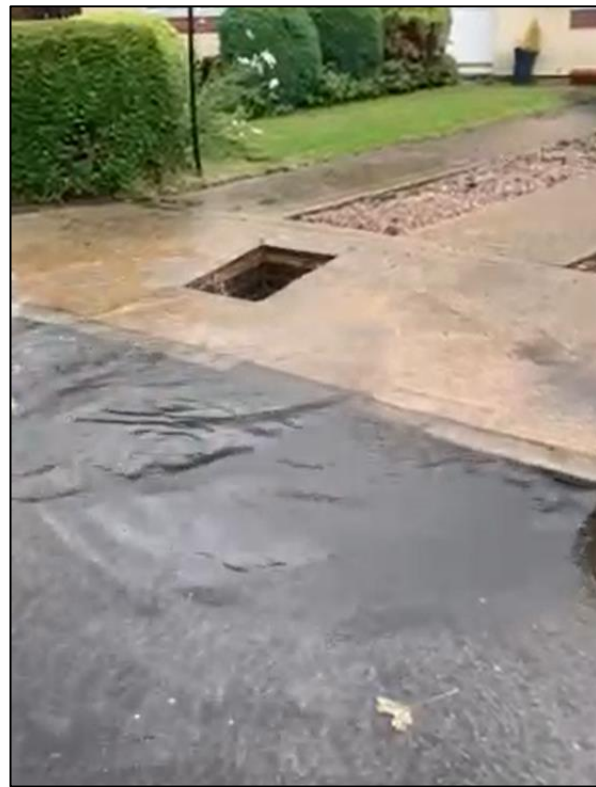
Surface water accumulating in the highway outside Property A, Elm Close.

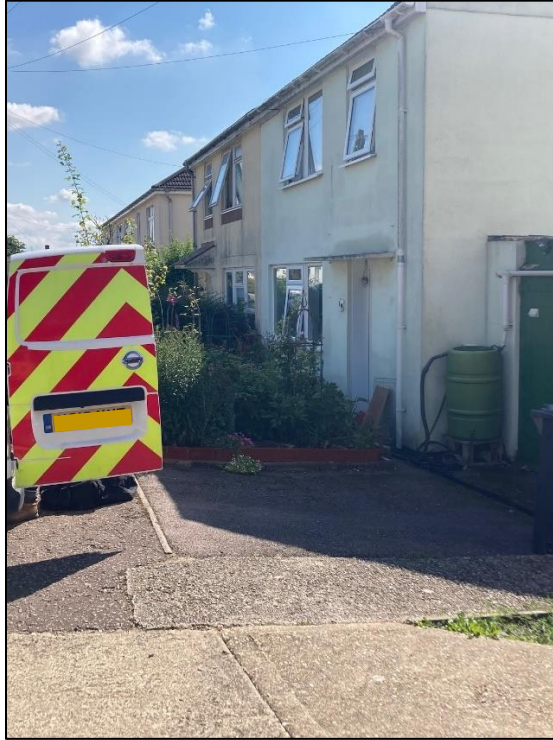
Property B, in Hazel Close, flooded internally via the front door. Flooring on the ground floor was damaged and the elderly resident had to be rehoused for health reasons as a result of the water ingress. The rest of the occupants had to be rehoused for a week while the property was dried out/redecorated etc. The garage was also inundated.

Slope down from highway towards Property B, Hazel Close directing runoff into the front of the house

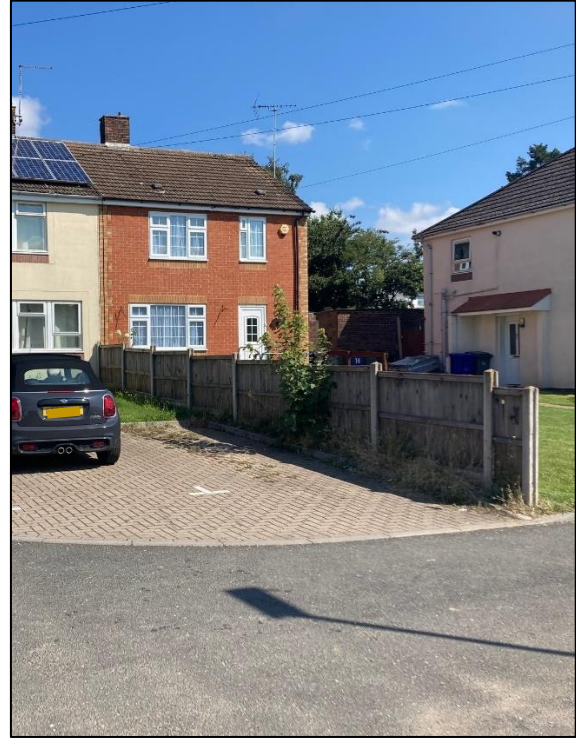
located adjacent the turning head which would have originally been surrounded by grassed areas, however many of these have been covered in hard surfacing over time to facilitate parking requirements for the surrounding properties. This has significantly increased the contributing area and thus increased the pressure on the gullies.

Areas that were previously laid to grass, now paved over to provide parking areas and contributing to runoff

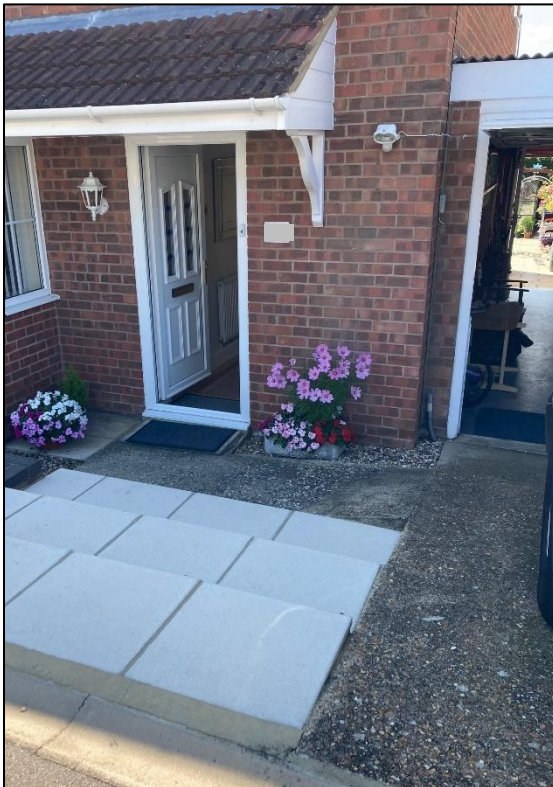
Property C, in Greenwood Close, flooded internally with the living room, hallway and part of the kitchen experienced ingress and damage. Depths were not very great, reaching 50-100mm but spread throughout the ground floor. Externally, depths of surface water accumulations reached 450-600mm adjacent the front door and front wall of the house. The garage was also inundated.

Sloped driveway/steps down from highway towards Property C, Greenwood Close directing runoff into the front of the house

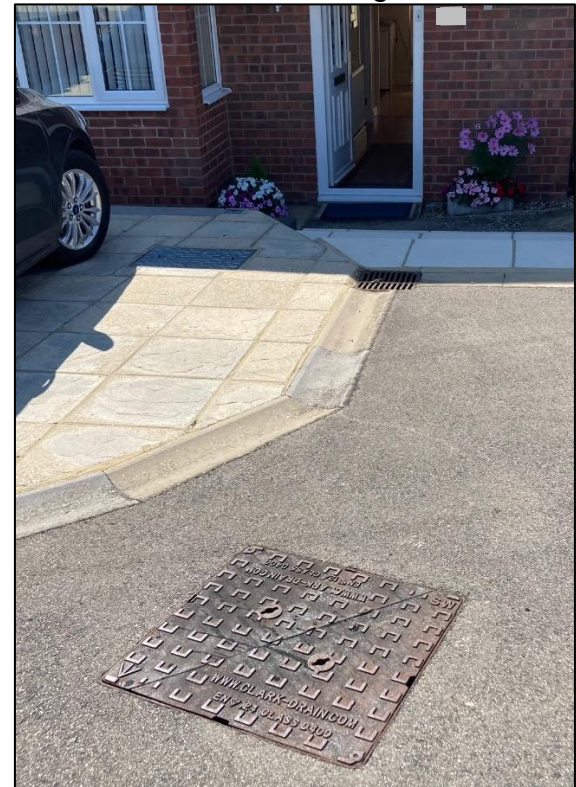
- In comparison, **Greenwood Close** is served by six gullies. Anecdotal evidence indicates that the surface water runoff backed up within the sewer network in the highway and lifted the manholes/gully grates outside Property C. The pressure within the network created a fountain of water several feet high which flooded the highway and property.
- **Harewood Terrace**, the driveway and garage of Property D are situated at the end of Buckingham Drive which slopes down towards the property. Whilst there are three gullies recorded in the junction, the contributing area is larger than can be easily accommodated by the gullies. The gully nearest the property is not located at the low point in the highway so water naturally accumulates in front of the garage doors.

Manhole immediately outside Property C, Greenwood Close, that was reported to have blown

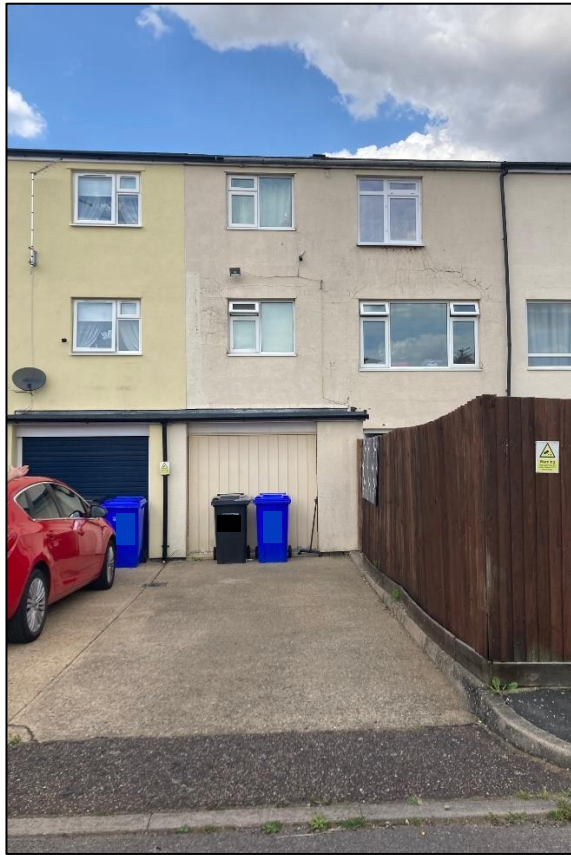
Property D, in Harewood Terrace, flooded internally via the rear garage door with internal depths reaching of up to 450mm. Flooring was damaged along with tools and decorating materials stored on the ground floor in the garage.

View of rear of Property D, Harewood Terrace showing slope down drive towards garage

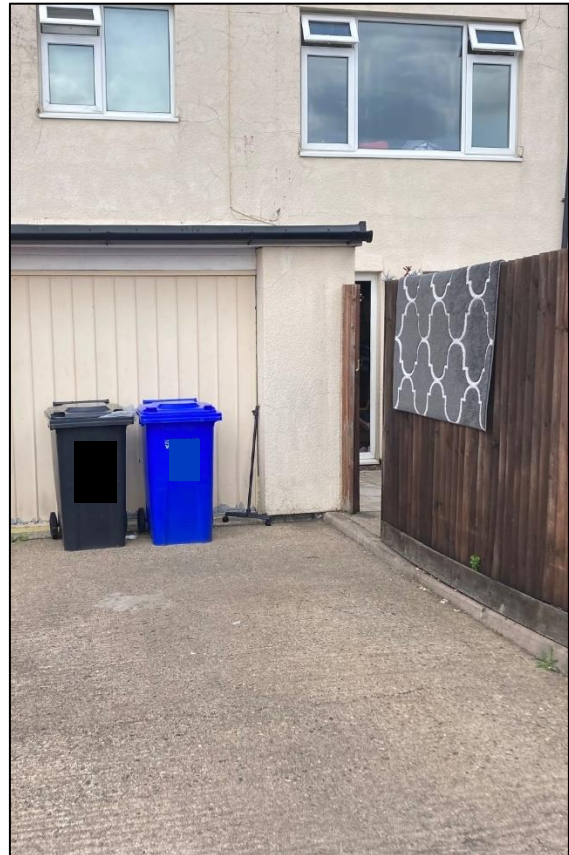
Access gate through fence where surface water travelled into property from the rear
