Section 19 Flood and Water Management Act 2010

Report Title: Sturmer Road, Haverhill

CRNos 288982 & 329959

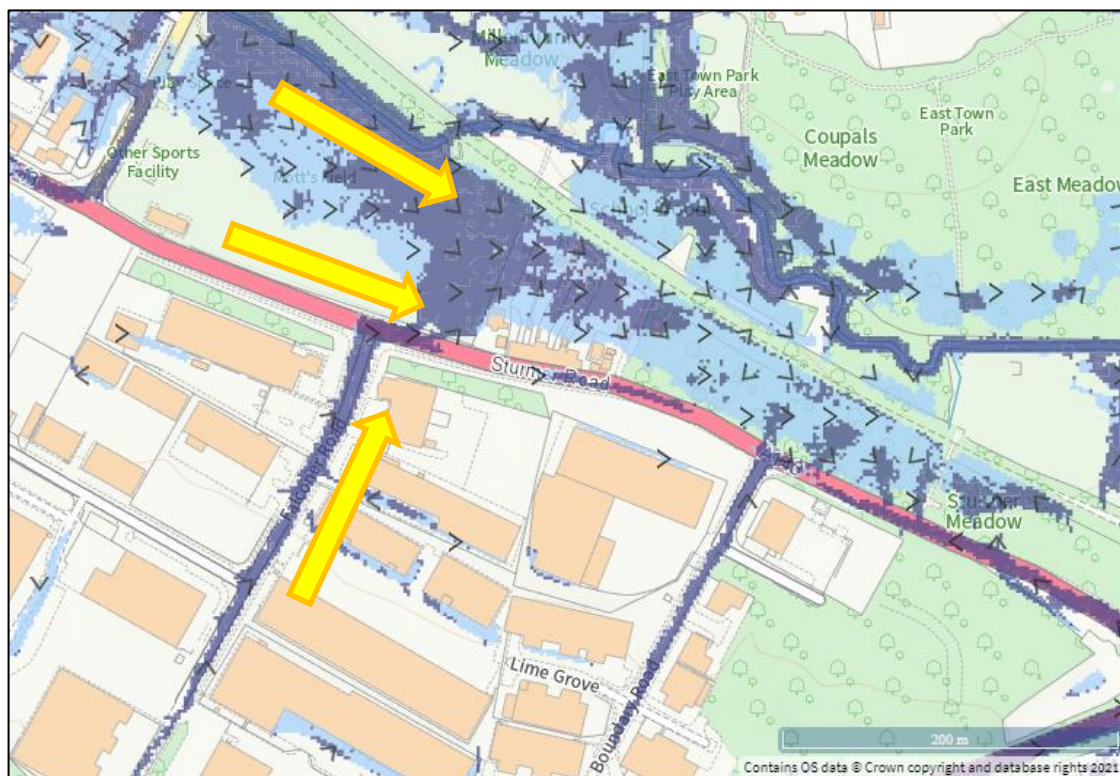
Figure 3 - Surface water flood risk: water velocity in low-risk scenario (main flow paths denoted by yellow arrows)
©Crown copyright and database rights, Suffolk County Council Licence No. 100023395 2021

Medium to High risk (each year this location has a risk of flooding of between 1 - 3.3%) in Sturmer Road and within the rear gardens of the properties.

An extract of the pluvial flood mapping is shown below for reference. This demonstrates the direction and speed of flow during the worst-case scenario. Dark blue is flows over 0.25m/s with light blue denoting speeds of less than 0.25m/s. The small black arrows denote direction of flow.

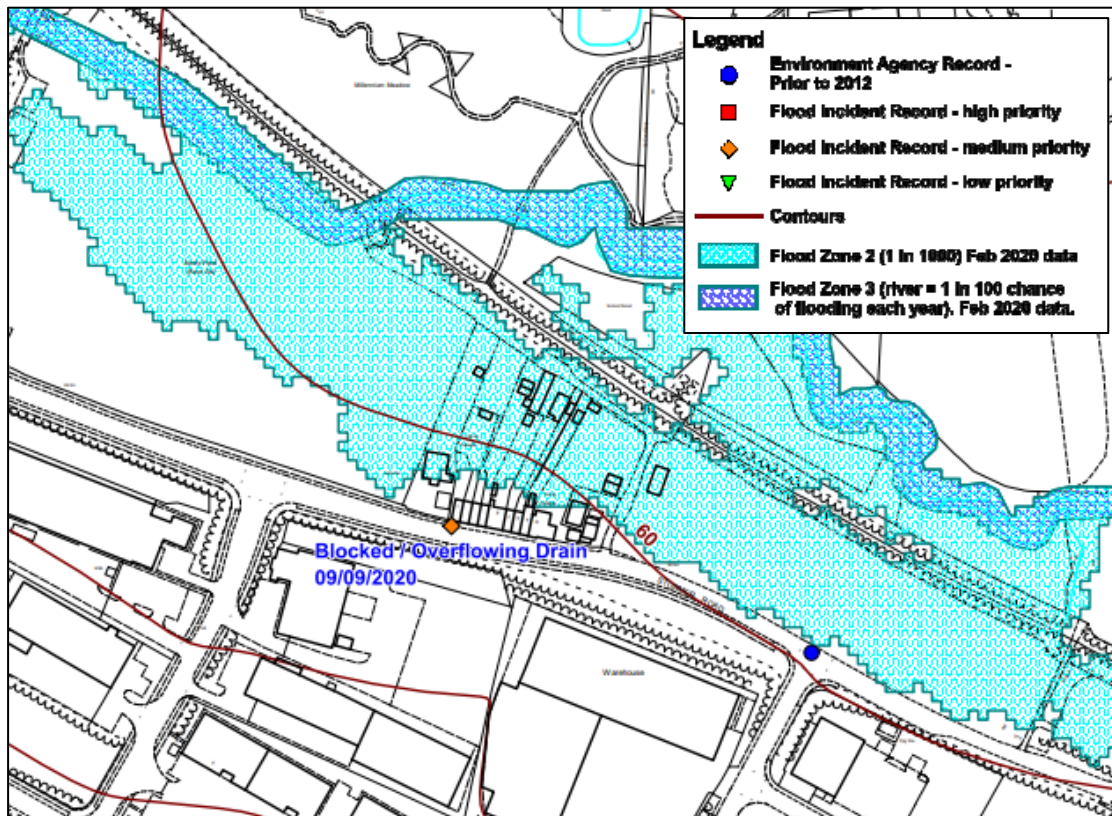
Figure 4 – Fluvial Flood Risk Mapping & Historical Pluvial Flood Incidents
 (to be updated once the 2021 events have been mapped)

Fluvial (river flooding) is also identified to be a factor in the flood risk at this location. Whilst the properties themselves are located in Flood Zone 1 (less than 0.1% chance of flooding in any given year), the playing field to the west and the rear gardens are largely located in Flood Zone 2 (between 1% and 0.1% chance of flooding in any given year). See Figure 4 overleaf.

Whilst the internal flooding experienced within the properties was not directly attributable to fluvial flooding, it inundated the rear gardens and may have reduced the available capacity within this area to accommodate the surface water flows running off the highway.

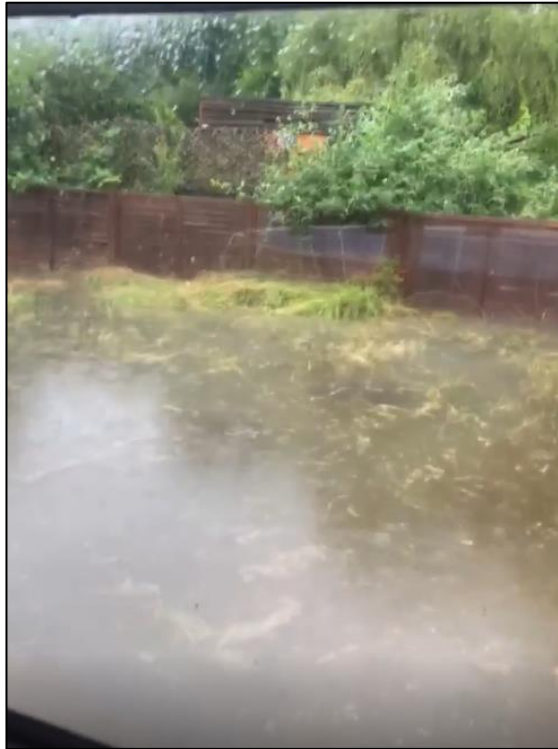
- **Fluvial flooding from the Stour Brook:** accumulations of floodwaters in the recreation ground to the west flowed through rear gardens adding to the flood volumes coming off Sturmer Road.

Depth of flooding in rear gardens of the properties

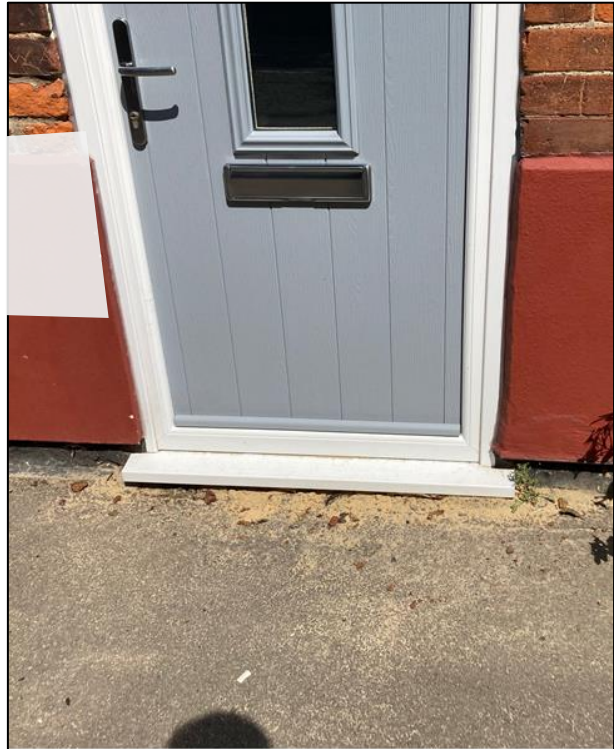
The intense nature of the rainfall resulted in a large volume of surface water flowing down Falconer Road and Sturmer Road, accumulating in the low spot immediately in front of the properties that were worst affected. The highway drainage was overwhelmed and surface water accumulated to a depth of approximately 400-500mm in places.

Water entered at least three of the properties through the front doors. Internal flooding only reached a depth of 15-20mm due to the residents acting quickly. The flood event occurred on a Sunday, so the majority of the occupants were at home and on hand to mitigate the effects, sweeping out the water and mopping it up with towels etc. An interruption to power supply was reported to have been experienced in one of the properties.

Depth of flooding externally, water reported to have reached lower edge of the letter box

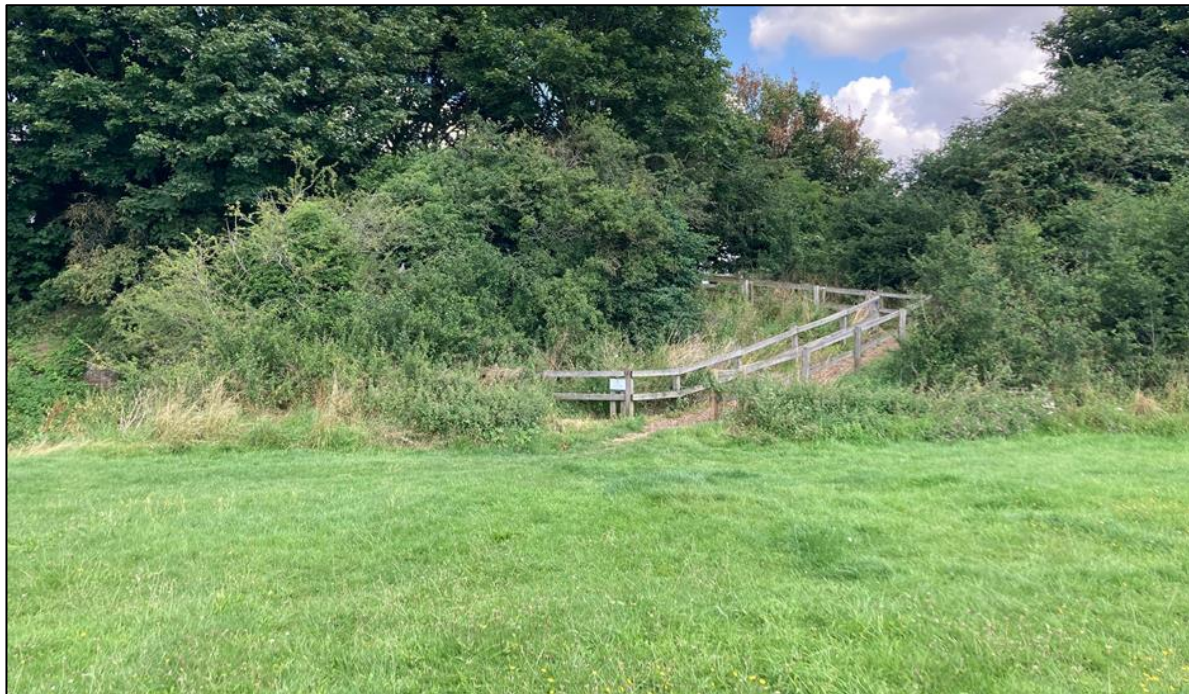
Surface water flows also accumulated within Motts Field Recreation Ground to the west, which flowed eastwards through the rear gardens, funnelled between the embankment and the properties. Whilst this is not likely to have contributed to the internal flooding, it caused damage to outbuildings, garden areas and vehicles.

Motts Field (looking north), at point where Stour Brook is culverted under embankment and excess flows combined with surface water overland flows travel eastwards through rear gardens

Raise power points to reduce likelihood of further power outages/issues	Property Owners	September/ October 2021	Pending
Consider creating a low bund/embankment along eastern edge of recreation ground to temporarily hold accumulations of floodwater to avoid though flow into rear gardens	West Suffolk Council	May 2022	Pending
Under duties as riparian owner, ensure maintenance of Stour Brook is up to date and watercourse is flowing well with no blockages etc	West Suffolk Council in conjunction with the EA	January 2022	Pending
Install replace septic tank covers with secure lids which will not become displaced during a flood event	Property Owners	September/ October 2021	Pending
