Section 19 Flood and Water Management Act 2010

Long Melford Flood Investigation – Storm Babet 2023

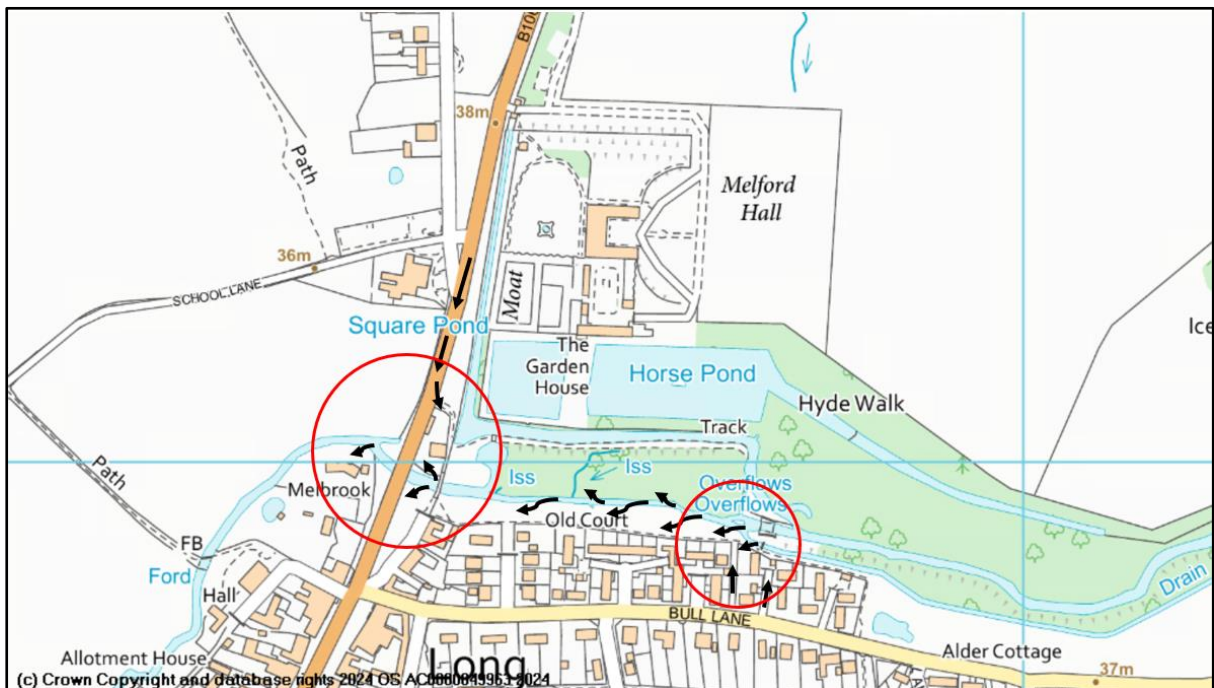
Figure 10 Approximate flood water flow paths in Bull Lane and north Hall Street indicating areas of affected property

Affected property on Bull Lane was located to the north of Bull Lane and adjacent to the drain parallel to Chad Brook. During Storm Babet, the drain and Chad Brook exceeded capacity and overtopped their banks to the rear of property on Bull Lane. Low-lying property began to experience internal flooding at approximately 7.30pm, reaching an internal flood level of about 13cm. Surface water also flowed from higher ground on the south of Bull Lane northwards towards the drain and Chad Brook.

Vegetation and fallen trees were reported to be obstructing flow due to a lack of maintenance in Chad Brook adjacent to Bull Lane. Affected property was projected to be at low risk of surface water flooding and high risk of flooding from river water.

- Chad Brook overtopped its banks, flooding property in Bull Lane from the rear.
- Surface water flowed northwards from higher ground on the south of Bull Lane, contributing to floodwater on the north side of Bull Lane.
- Vegetation and fallen trees were reported to be obstructing flow due to a lack of maintenance in Chad Brook adjacent to Bull Lane.

Affected property was located in close proximity to the bridge over Chad Brook on the east and west sides of the bridge and on both sides of the river. Property was reported as being flooded to approximately 36cm internally from ground floor level from Chad Brook. Floodwater levels were reported to have peaked at approximately 10pm on the 20th October and subsided by 7am on the 21st October.

On the north side of the river, surface water flowed south down Hall Street, including down a lower level driveway. This flow of water was reported to be increased by blocked drains on Hall Street and the south of the High Street. Subsequent investigations have shown that highway drainage has been damaged and consequently blocked in the vicinity and repairs are currently being commissioned. It should be noted however, that the capacity of the drains would have been limited in such extreme rainfall. On the south side of the bridge a gully was reported as slow running during routine cyclical maintenance prior to Storm Babet. However, this presumably drains to Chad Brook so more efficient functioning would also have contributed further floodwater to Chad Brook.

Silt build up either side of the bridge on the north side of Chad Brook may have contributed to flooding of property in the vicinity of the bridge. However, the original design of the bridge may exceed the natural width of the river, causing the river to flow more slowly in the past and the corresponding slow flows would have allowed more silt to settle. Therefore, future removal of silt on the north bank may again cause the

- Chad Brook overtopped its banks, flooding property on the east and west sides of the bridge over Chad Brook and on the north and south sides of the river.
- Surface water flowed southwards from higher ground north of the bridge. The volume was increased by damaged and blocked highways drainage.
- Vegetation and trees were reported to be obstructing flow due to a lack of maintenance in Chad Brook adjacent to Bull Lane.
- The role of silt build up on the west and east side of the bridge in flood risk would need further investigation to be determined.

- Residents to install Property Flood Resilience (PFR) via grant funded scheme.
- Landowners to carry out watercourse maintenance to reduce flood risk as necessary in accordance with their riparian responsibilities.
- Explore potential natural flood management measures (eg. leaky dams, attenuation ponds and flood plain reconnection) to “slow the flow” and attenuate water upstream in the Chad Brook catchment.

- Residents to install Property Flood Resilience (PFR) via grant funded scheme.
- Landowners to carry out watercourse maintenance to reduce flood risk as necessary in accordance with their riparian responsibilities.
- Suffolk Highways to conduct repairs to damaged highways drainage and clear blocked drains on the north and south sides of the bridge over Chad Brook.
- Explore potential natural flood management measures (e.g. leaky dams, attenuation ponds and flood plain reconnection) to “slow the flow” and attenuate water upstream in the Chad Brook catchment.
- Investigate the potential benefits and harms of removing silt deposits adjacent to the Hall Street bridge on the northern side of Chad Brook.

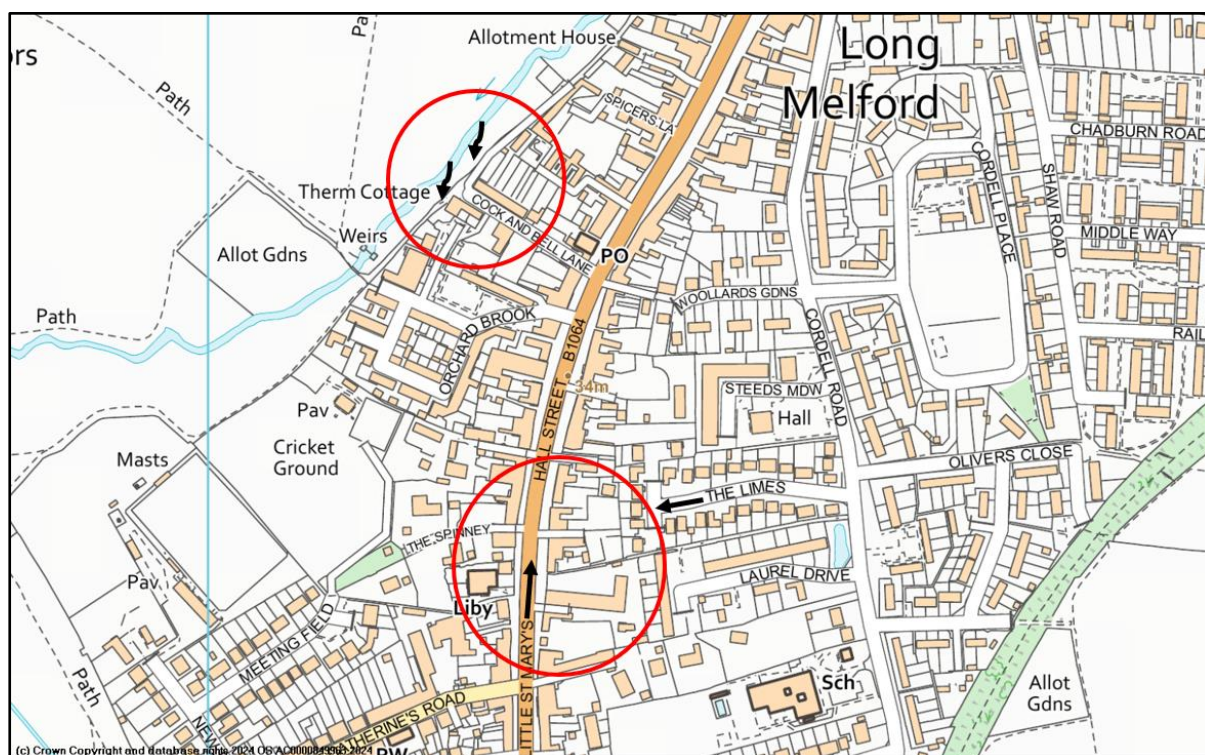
Figure 11 Approximate flood water flow paths in central Hall Street and Cock and Bell Lane indicating areas of affected property

Property in this area reported being internally flooded due to surface water flowing off roads into a low-lying area of Long Melford. Blocked drains in the vicinity were also reported to be a frequent issue. Many of the historic surface water drainage pipes and culverts in this area of Long Melford have relatively small capacities, contributing to water backing up and surcharging from drainage systems. Highways drainage at a low-lying location to the rear of affected property is reported to be free of blockages but to exceed capacity relatively frequently due to water collecting in this area. Two gullies in this area of Hall Street which could not be confirmed as running in May 2024 will be reviewed and jetted as appropriate. Affected property was projected to be at low risk of surface water flooding, i.e. it is at risk of flooding in the more extreme events.

- Surface water flowed down roads towards affected property which was at a lower level.
- Highways drainage in the vicinity exceeded capacity.
- Gullies in this area of Hall Street which are not confirmed as running to be reviewed and jetted as appropriate.
- High groundwater levels may also have been a contributing factor to flooding.

In this location, affected property was in close proximity to and on the east side of Chad Brook. The river was reported to have overtopped its banks and flooded property to an internal depth of approximately 15cm. This was compounded by surface water flowing down Cock and Bell Lane towards the river. Concerns were reported about the lack of maintenance of the river and the functioning of highway drains in the vicinity. There are no gullies in Cock and Bell Lane. Two gullies in Hall Street close to the entrance of Cock and Bell Lane could not be confirmed as functioning and need further investigation.

- Chad Brook overtopped its banks, flooding property on the east side.
- Surface water flowed down Cock and Bell Lane towards affected property which was at a lower level.
- Highways drainage in the vicinity exceeded capacity.
- Gullies in Hall Street at the junction with Cock and Bell Lane which are not confirmed as running to be reviewed and jetted as appropriate.
- Vegetation growth resulting from a lack of maintenance, was reported to be obstructing flow in Chad Brook.

- Residents to install Property Flood Resilience (PFR) via grant funded scheme.
- Highways to ensure completion of cyclic maintenance of highway gullies.
- Suffolk Highways to jet blocked gullies in the area of Hall Street and investigate the condition of the existing drainage assets.

- Residents to install Property Flood Resilience (PFR) via grant funded scheme.
- Suffolk Highways to jet blocked gullies in the area of Hall Street and investigate the condition of the existing drainage asset.
- Landowners to carry out watercourse maintenance to reduce flood risk as necessary in accordance with their riparian responsibilities.
- Explore potential natural flood management measures (eg. leaky dams, attenuation ponds and flood plain reconnection) to “slow the flow” and attenuate water upstream in the Chad Brook catchment.

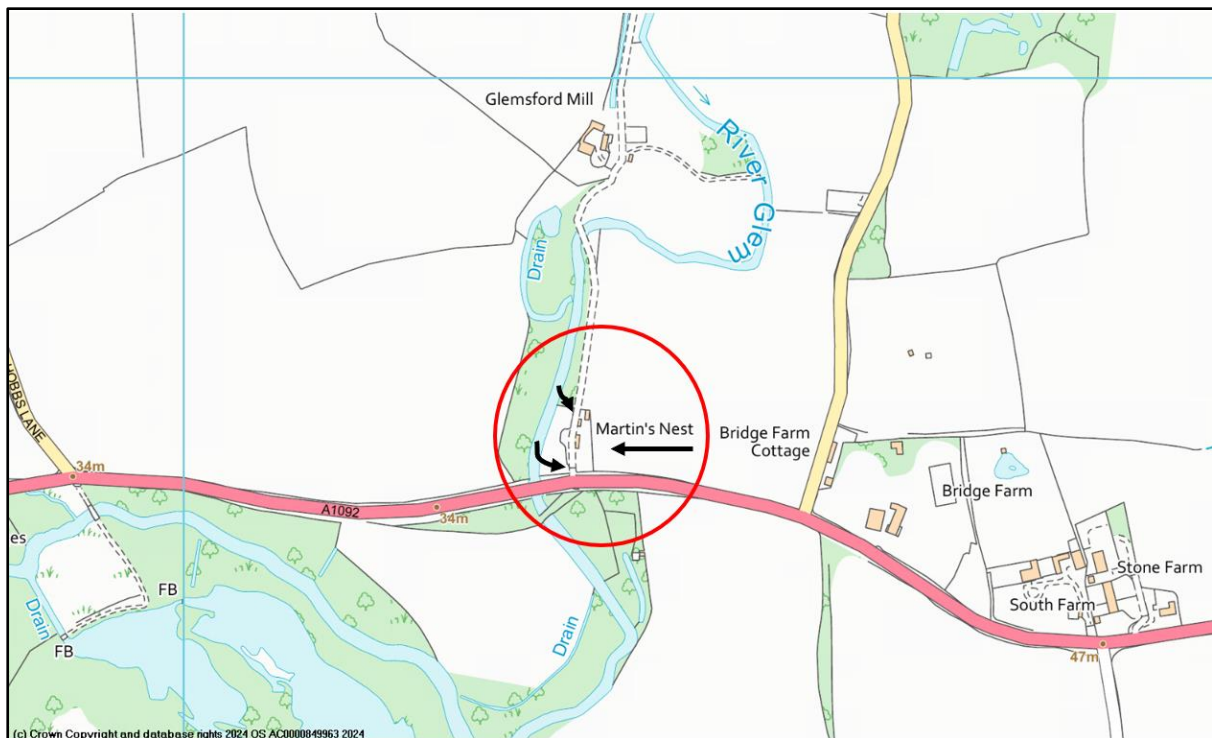
Figure 12 Approximate flood water flow paths in Clare Road indicating area of affected property

Impacted property in this area was on the north side of the A1092, in close proximity to and east of the River Glem. The river was reported to have overtopped its banks, causing internal property flooding. Surface water also flowed west down field slopes towards affected property, contributing to further flooding. Planting of cricket bat willow in the banks of the river was reported to have resulted in cut branches collecting in the river south of the A1092 bridge over the River Glem, hindering flow. Affected property is projected to be at medium river water flood risk and high surface water flood risk.

- The River Glem overtopped its banks, flooding property on its east side.
- Surface water flowed west down fields from the east towards affected property, which was at a lower level.

- Residents to install Property Flood Resilience (PFR) via grant funded scheme.
- Landowners to carry out watercourse maintenance to reduce flood risk as necessary in accordance with their riparian responsibilities.

- Explore potential natural flood management measures (eg. leaky dams, attenuation ponds and flood plain reconnection) to “slow the flow” and attenuate water upstream in the River Glem catchment.

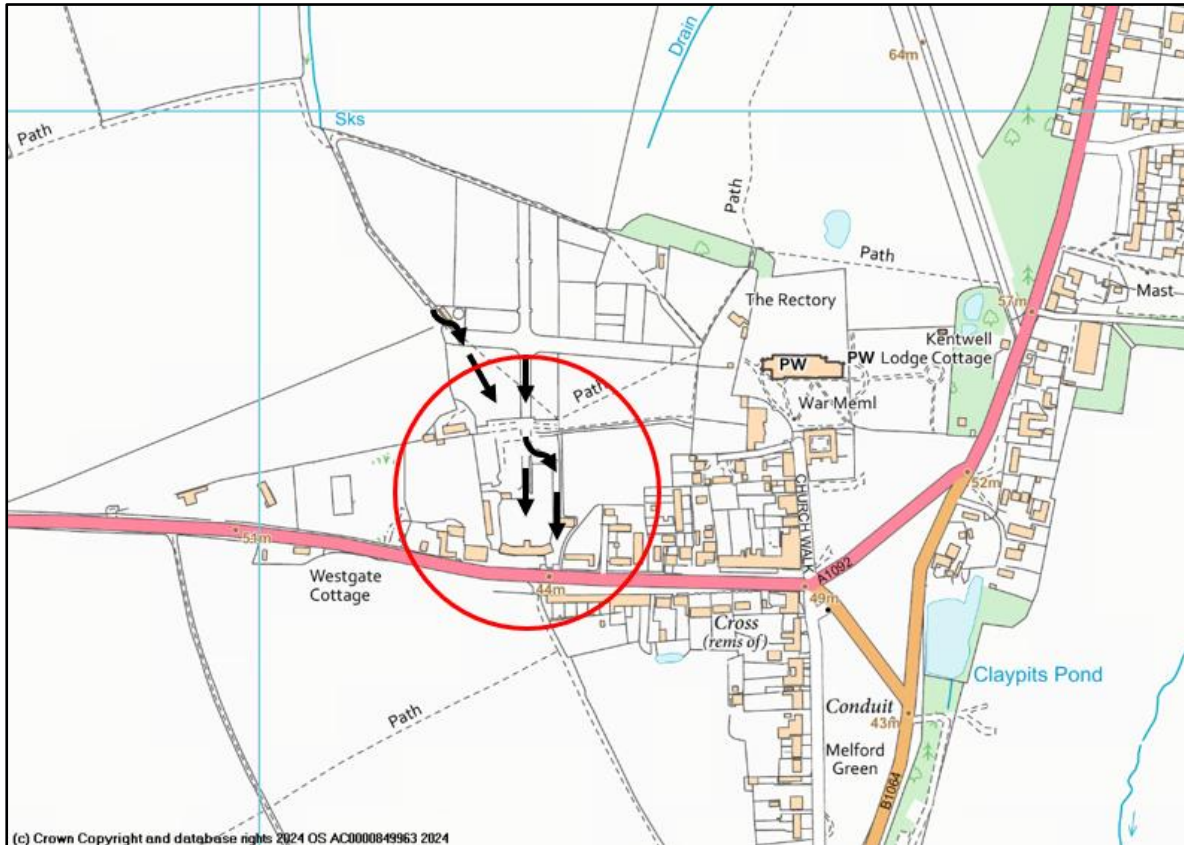
Figure 13 Approximate flood water flow paths in Westgate Street indicating area of affected property

On the north of Westgate Street, impacted property was reported to have been flooded from the rear by surface water flowing south from a ditch. The ditch becomes a piped watercourse as it flows south and the piped capacity was exceeded in the extreme rainfall conditions, causing the ditch to overtop above the piped section and floodwater to flow south down the slope towards the rear of impacted property. This was compounded by surface water also flowing from the fields to the rear. Subsequent investigations are reported to have identified blockages in the piped watercourse which connects with a brick culvert passing under the A1092 and emerges in a ditch on the south side of the highway.

- A ditch flowing south towards the rear of impacted property overtopped upstream of a piped section.

- Blockages in the piped section of the watercourse contributed to the capacity of the watercourse being exceeded.
- Surface water flowed south directly off fields towards the rear of impacted property.

- Residents to install Property Flood Resilience (PFR) via grant funded scheme.
- Riparian owner to carry out piped and open watercourse maintenance to reduce flood risk as necessary in accordance with their riparian responsibilities.
- Explore potential natural flood management measures (eg. leaky dams and attenuation ponds) to “slow the flow” and attenuate water to the north of impacted property.

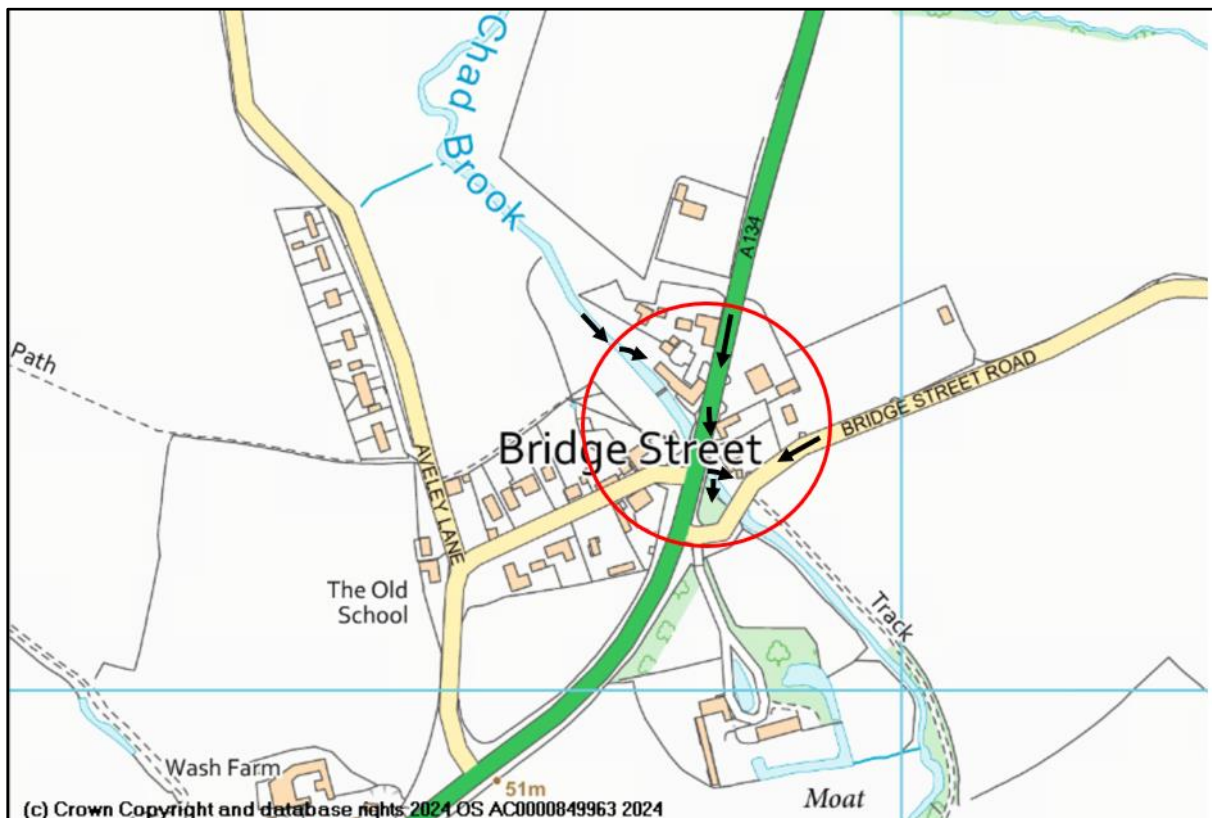
Figure 14 Approximate flood water flow paths in Bridge Street indicating area of affected property

Chad Brook was reported to have overtopped its banks, flooding property on the north side of the river and on both the east and west sides of the bridge adjacent to the

A134. Affected property was reported to have flooded to a maximum level of 90cm internally. Floodwater levels were reported as subsiding by 10pm. on 20th October.

- Residents to install Property Flood Resilience (PFR) via grant funded scheme.
- Riparian owner(s) to carry out piped and open watercourse maintenance to reduce flood risk as necessary in accordance with their riparian responsibilities.
- Explore potential natural flood management measures (eg. leaky dams and attenuation ponds) to “slow the flow” and attenuate water in the upstream Chad Brook catchment.
