## Section 19 Flood and Water Management Act 2010

### Needham Market Flood Investigation – Storm Babet 2023

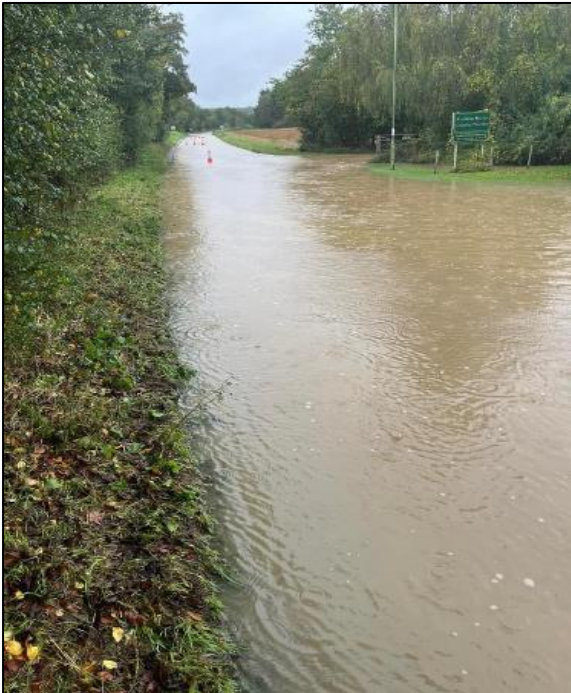
On the morning of 20 October 2023, a number of tributaries in the rural upper catchment directed water into the town. Floodwater flowed along Barking Road towards Foxglove Avenue originating from fields to the east around Grinstead Barn, before emerging onto the carriageway. There were additional overland (surface water run-off) flow paths merging onto Barking Road from fields to the south either side of Priestly Wood close to Barking. Outside the pharmacy entrance on Barking Road, water was starting to pool from 09:00am onwards and by 11:00am water was observed to be coming into the car park from the road (Image 1).

*Image 1 - Flooding along Barking Road*

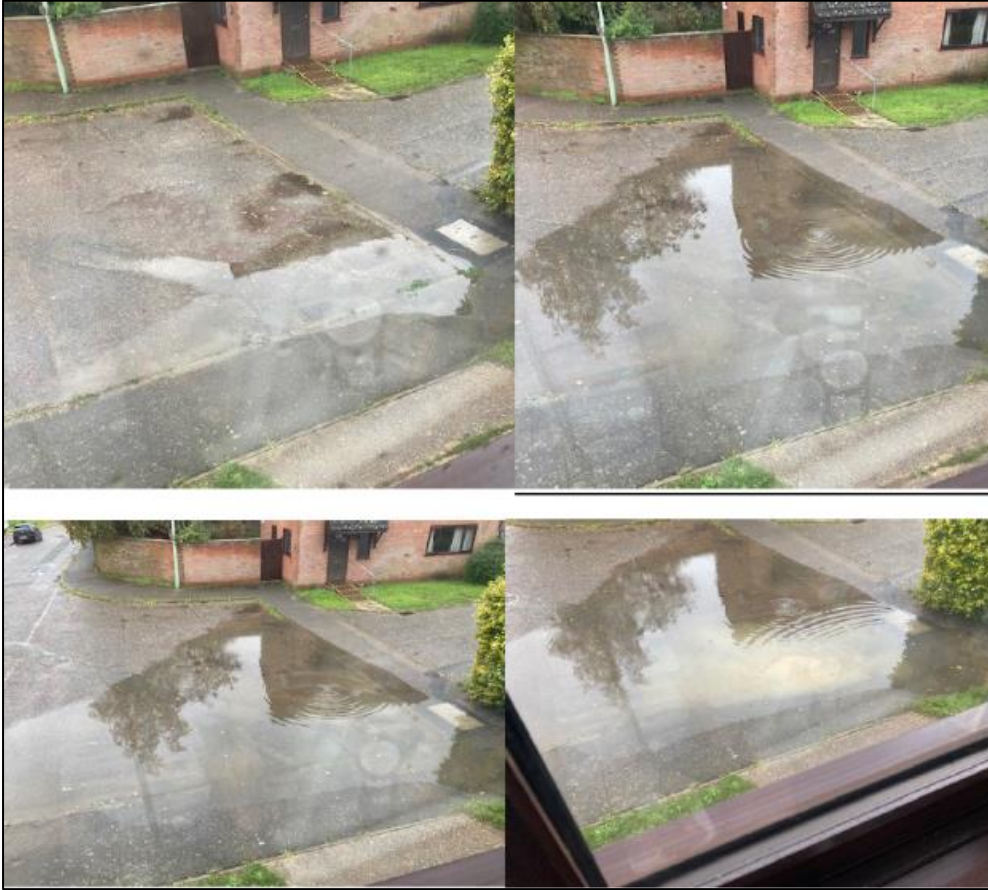
During Storm Babet, water initially came up through the road gullies on Pinecroft Way. These gullies outfall into the Lion Barn drain and the majority of the outfall pipes do not have non-return flaps, which could have mitigated the volume of water returning up the drains from the watercourse.

*Image 3 - Sequence of flooding from a drainage gully on Pinecroft Way*

- Investigate potential NFM projects to ‘slow the flow’ and attenuate water on overland flow paths (leaky dams, restoration of watercourses, etc.) to the west and south of Needham Market.
- Fit non-return flaps on the outfalls along the Lion Barn drain through Pinecroft Way.
- Investigate capacity of the culvert under Lion Lane / Coddenham road corner. Carry out a de-silt / cleanse if required.
- Investigate options to enhance the flood risk benefit of the bund between Pinecroft and Coddenham way to allow drainage from the estate and defence from flooding from the main river Gipping.
- Investigate highway drainage infrastructure to ensure capacity and condition are sufficient.

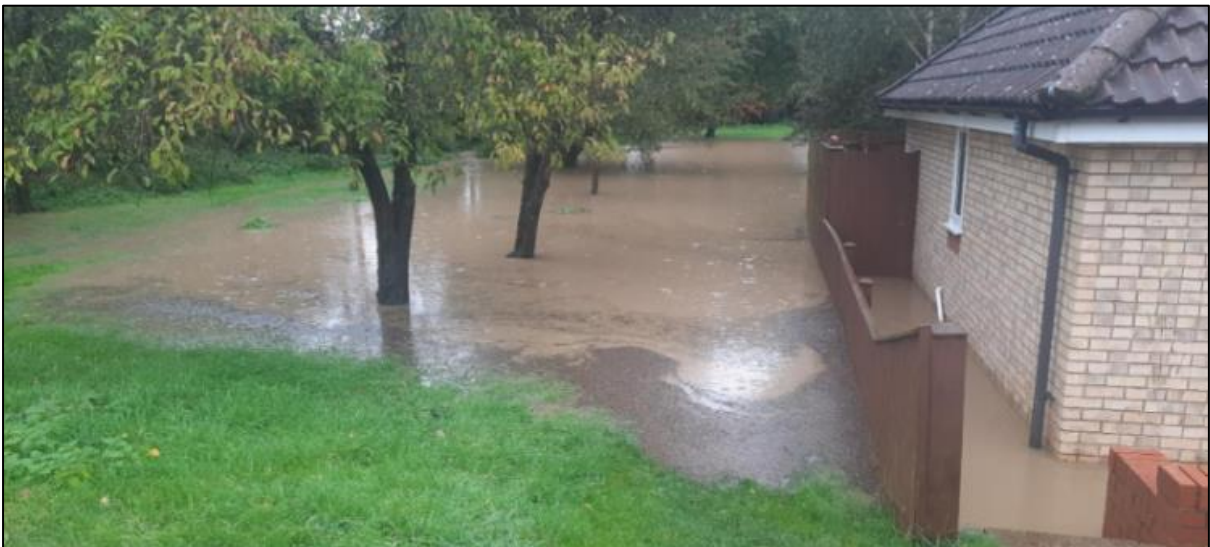
*Image 4 - Flooding on Limetree Close next to the Lion Barn drain*

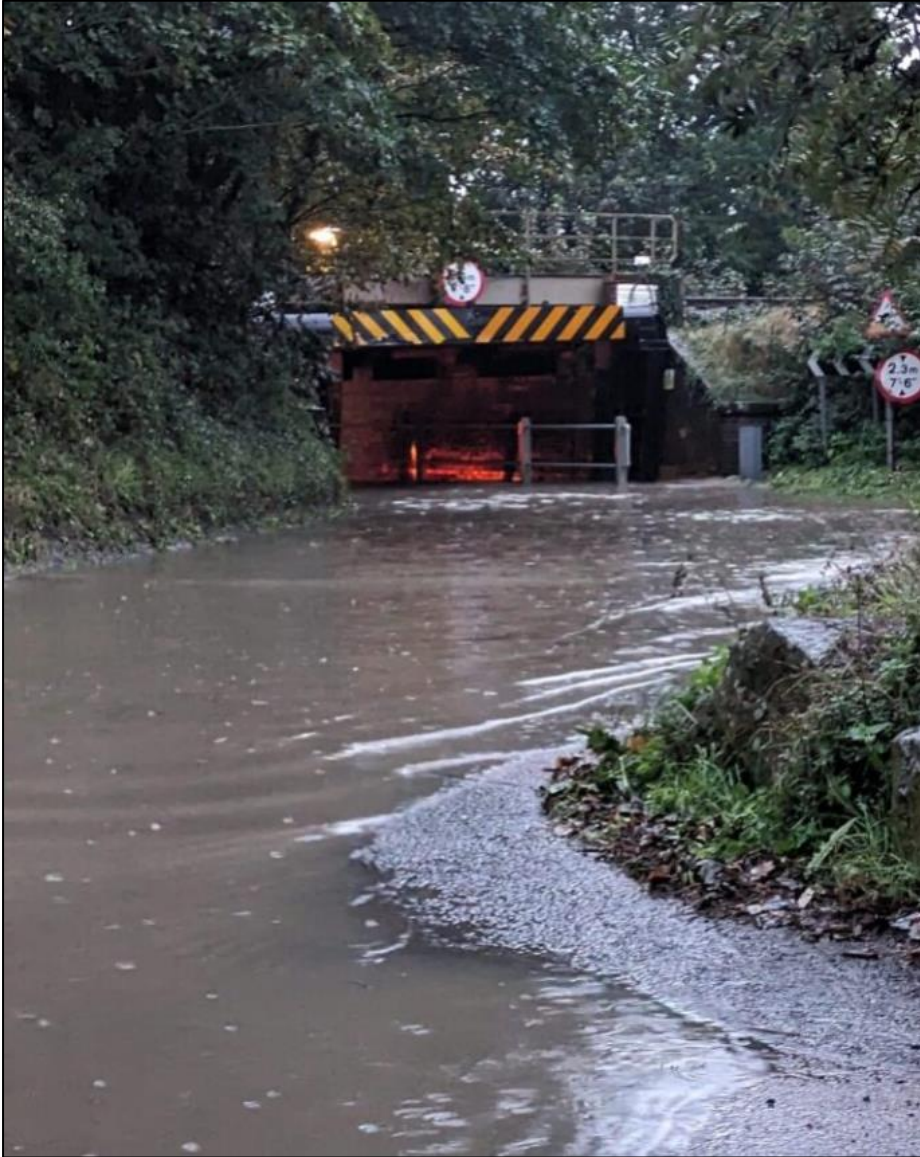
*Image 7 - Flooding under Coddanham Road railway bridge*

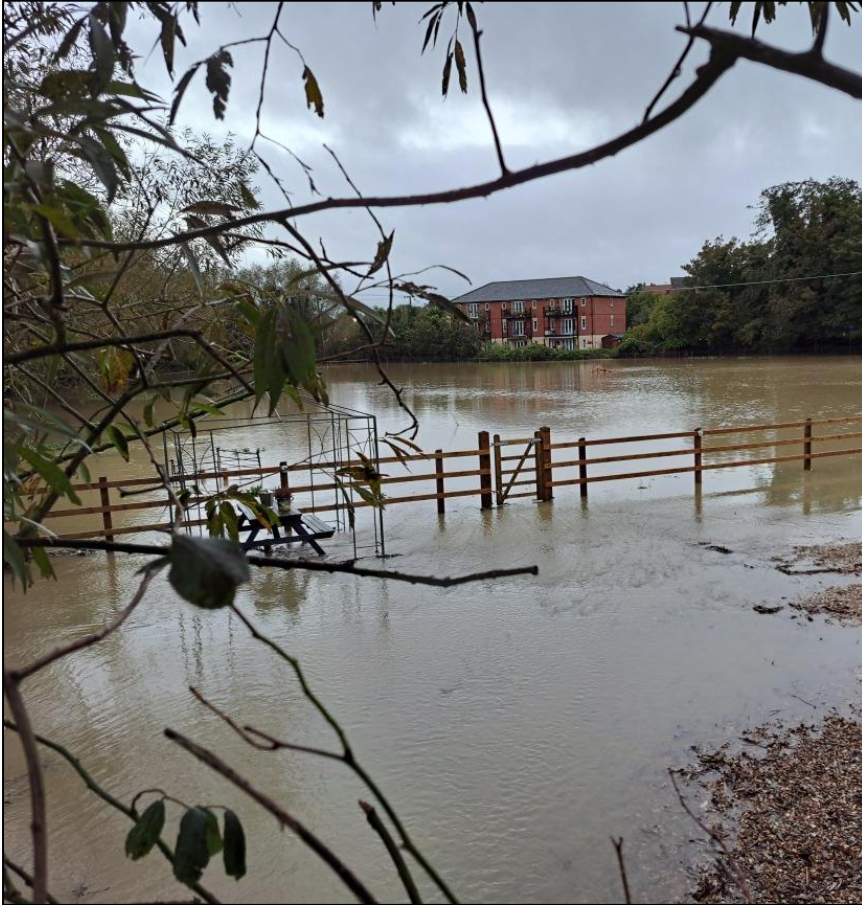
The primary source of flooding in the Hawks Mill and St Mary’s Road area was fluvial flooding, with flood water from the river merging with overland flows already on the fields and roads. The banks of the River Gipping overtopped upstream of Hawks Mill and combined with surface water flows and river tributaries coming across the fields from the Northwest. This meant much of the River Gipping flood plain was inundated and remained in flood for a considerable period of time (Image 8). The sluice gate

*Image 8 - Flooding on Hawks Mill meadow*

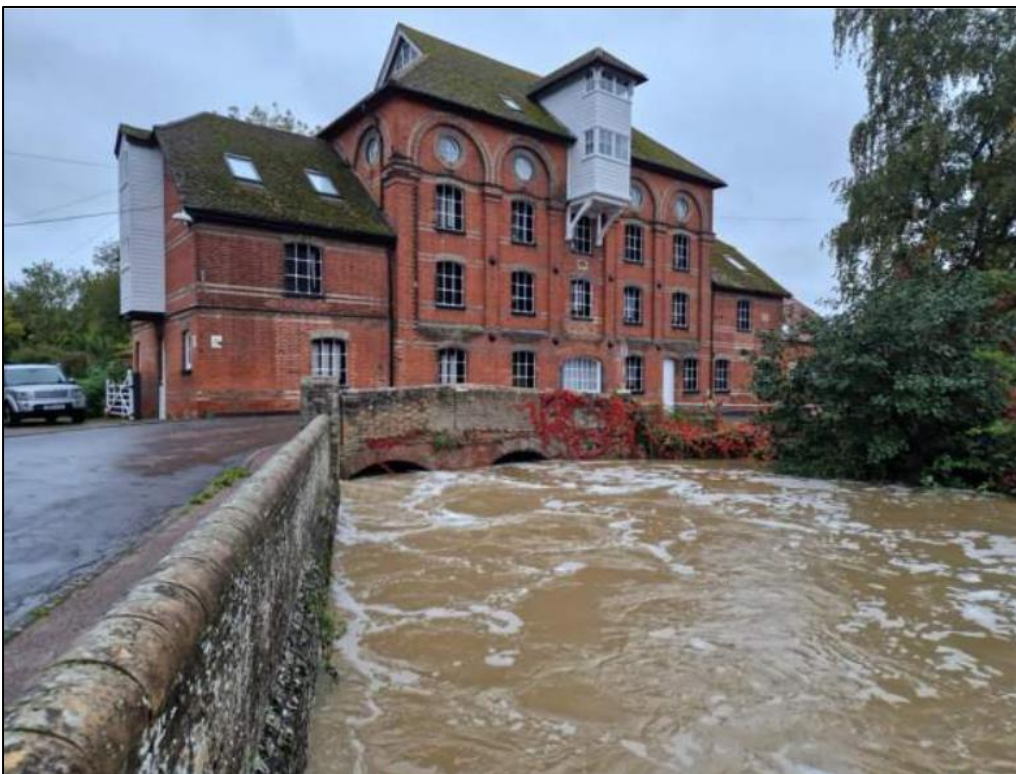
upstream of Hawks Mill which is operated and maintained by the Environment Agency was opened fully and functioned correctly throughout Storm Babet. The privately owned and operated gate below the mill was opened and operated at full capacity also (Image 9).

*Image 9 - High river level in the Mill Pond on Hawks Mill Street*

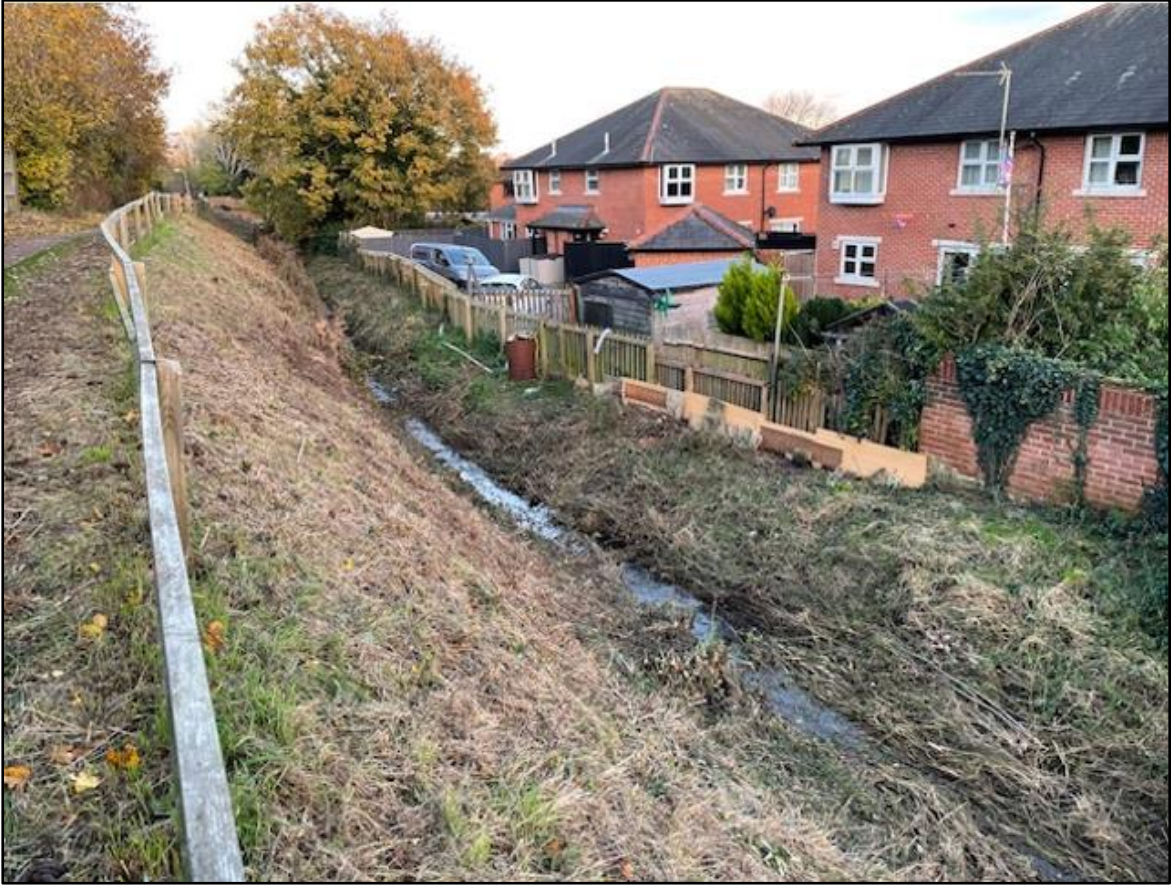
Upstream of the footbridge, the watercourse sits in a deep channel. The northern bank with the public footpath, is much higher than the southern bank. During site visits, Environment Agency officers noted an apparent low spot on the southern bank, potentially providing a flow pathway for the floodwater into the rear gardens on Highlands Close. There is also a low section of the southern bank to the rear of John Swain Close. At this location residents had created makeshift barriers to try to prevent water overtopping from the watercourse into their gardens post Storm Babet (Image 10).

*Image 10 - Makeshift defences against floodwater overtopping from Orchard Gate watercourse*

- Investigate potential NFM projects to 'slow the flow' and attenuate water on overland flow paths (leaky dams, restoration of watercourses, etc.) to the west of Needham Market before entering the Orchard Gate watercourse.
- Ensure there is a channel maintenance regime in place for the upper section of the Orchard Gate watercourse (ordinary watercourse) in the urban areas.
- Ensure any observed blockages to bridges or culverts are reported to the relevant authority and removed.
