Section 19 Flood and Water Management Act 2010

Worlingworth Flood Investigation – Storm Babet October 2023

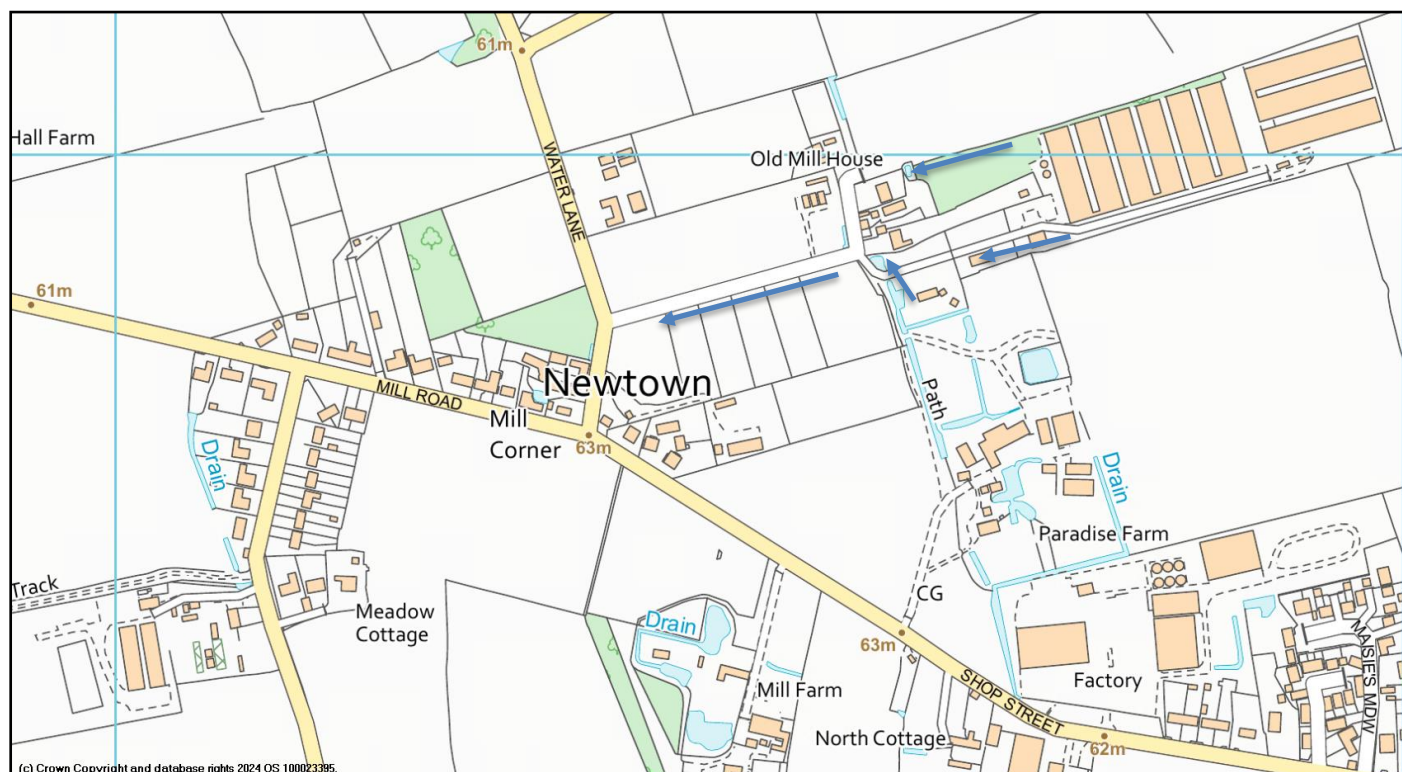
Figure 12 - Flow routes of water in west Worlingworth

- Significant rainfall onto already saturated ground caused high levels of overland surface water flow, resulting in ponding of water in isolated low spots.
- Overwhelmed water management features, such as ponds, watercourses and wetlands caused and added to surface water flows.
- Poorly maintained water management features in the area may have exacerbated the issue.

- Report issues to relevant RMA or landowner/parish where known blockages or issues have occurred for relevant RMA/landowner to carry out remedial works where required.
- Highway authority to resolve slow draining gully asset on the junction with Water Lane and Newtown.
- Increase maintenance frequency of water management features in the area.
- Residents to install Property Flood Resilience (PFR) via grant funded scheme.

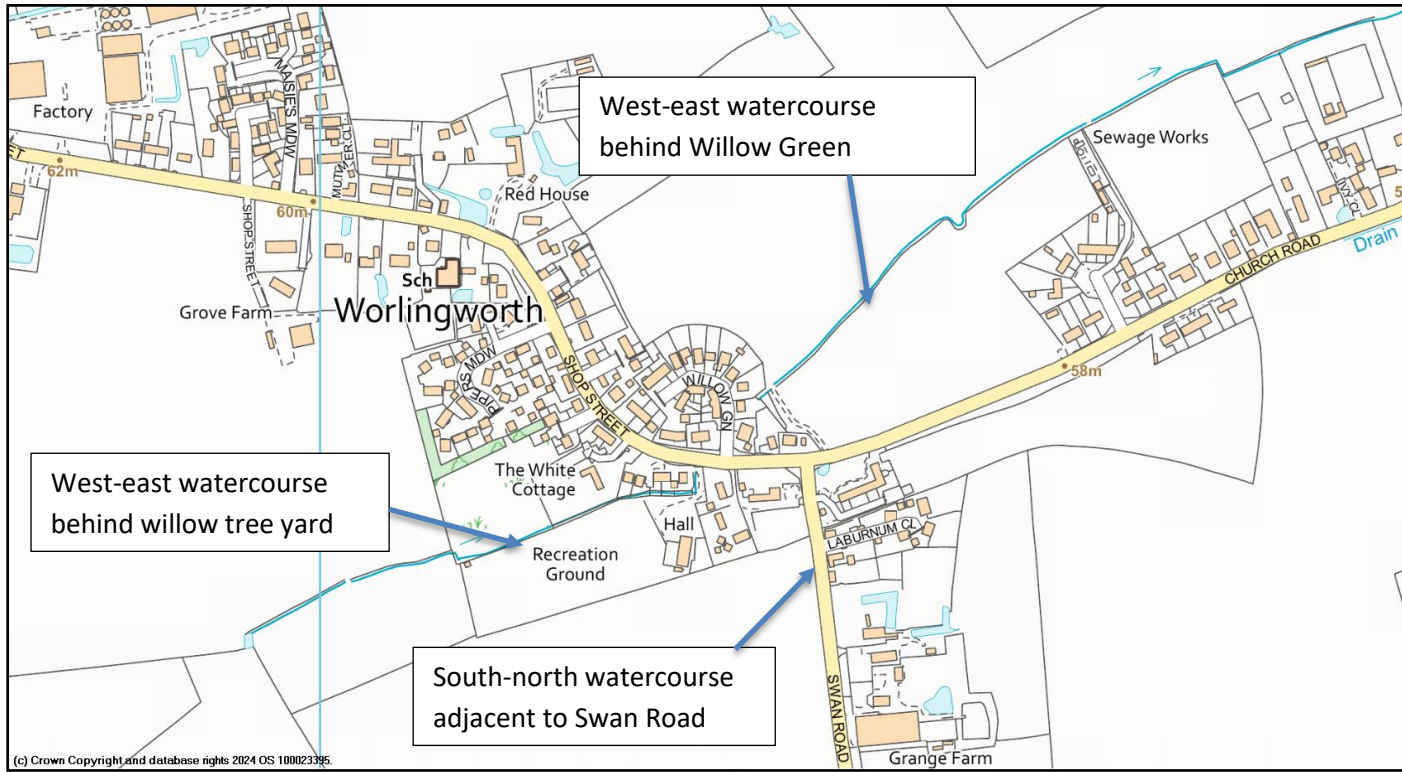
Figure 13 - Map of local watercourses

Where the watercourse reaches the highway, it is then culverted and flows towards Willow Green. Reports from the day suggest this culvert was very quickly overwhelmed with volume of water, causing significant overtopping, which added to the flood water on the highway already coming up through the drainage infrastructure. The current outfall of this piped section of watercourse is not clear, although there are outfalls located north of Willow Green in the watercourse which appear to be likely. The watercourse then continues to the east although the gradient of the land is much shallower this way and as such the waterflow is slower.

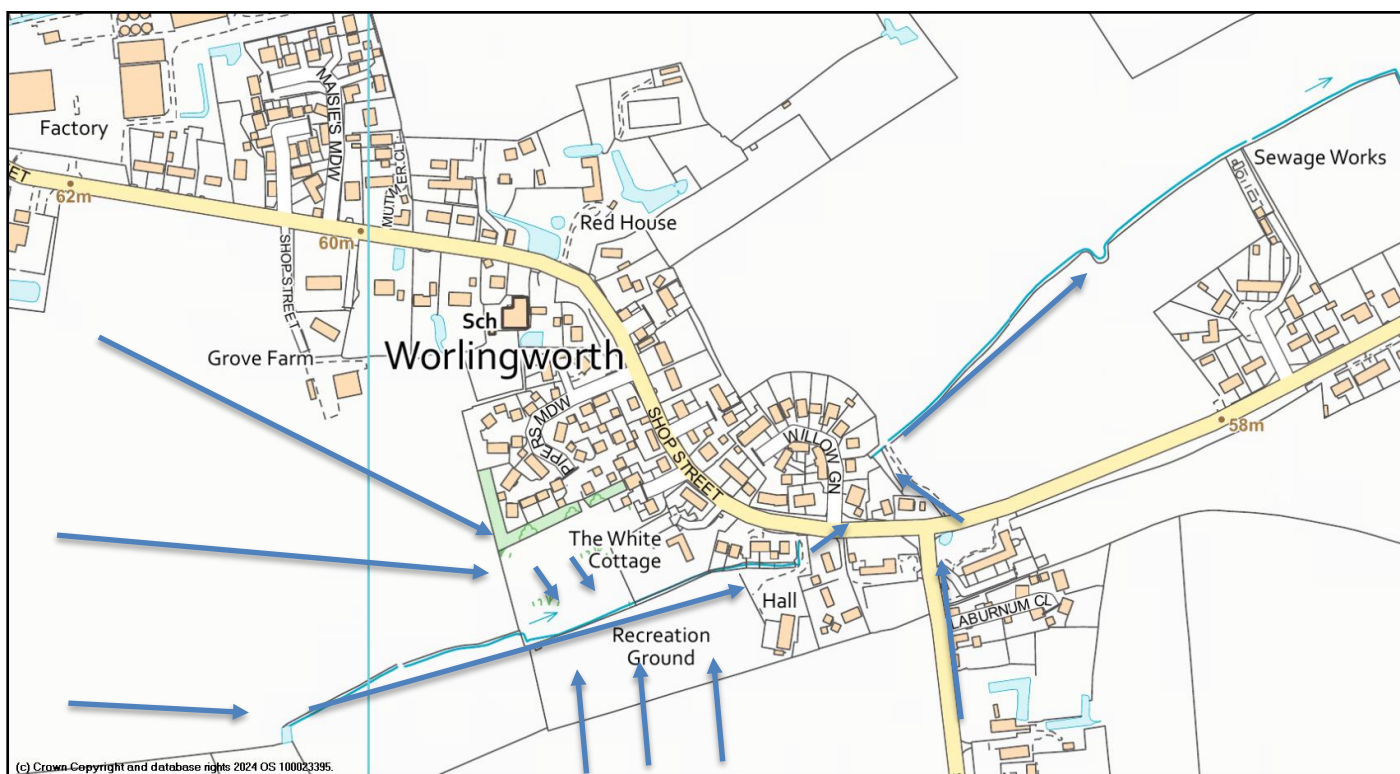
Figure 14 - Flow routes of water in central Worlingworth

- Significant rainfall and saturated ground caused high-level of overland flow towards the centre of the village, overwhelming water management features and spilling out at the pinch points near the community centre.
- Change in topography in the village centre causes water flow to slow down at this point adding to the overcapacity systems.
- Watercourses exceeded capacity and saw water flow out of bank, contributing to overland flows within the area.
- Highways and Anglian water assets were overwhelmed, and water was forced back up manhole covers adding to the flood water.

- Investigate possibility of natural flood management scheme in watercourses to the east and south of the village to try and slow the rate at which the water reaches the village centre.
- Investigate the possibility of attenuation/infiltration 'overspill' areas on the recreation ground (south of Shop Street) and agricultural land (east of Willow Green).
- Investigate the possibility of incentivising the retrofit of SuDS or rainwater harvesting systems for properties which currently drain roof water into the foul system. These can reduce surface water runoff and help to ensure the foul system is not overwhelmed during rainfall events.

- Anglian Water to investigate potential ground water intrusion into the foul sewer and plan works to reduce the occurrence of any related foul water flooding.
- Investigate the feasibility of increasing the capacity of existing drainage networks belonging to both highways and Anglian Water.
- Residents to install Property Flood Resilience (PFR) via grant funded scheme.

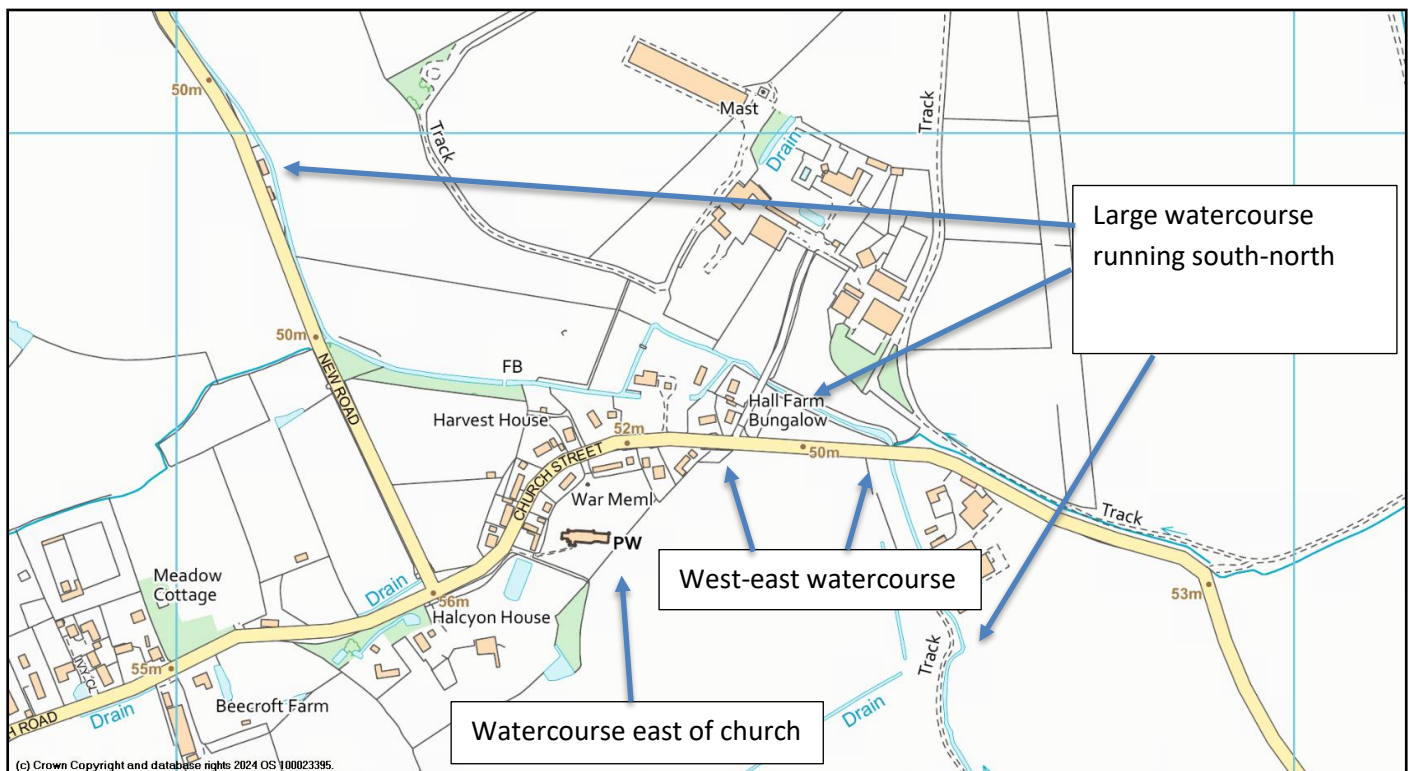
Figure 15 - Map of watercourses in east Worlingworth

According to residents there is a watercourse which runs south to north along the eastern edge of the church grounds. This comes to an abrupt stop as it meets the properties north of the church and there is no visible sign of a piped continuation of the watercourse. Reports from the event suggested that as surface water runoff from the surrounding fields to the south and east flowed down this feature, it pooled at the northern end and eventually overtopped, and water flowed south through the gardens and outbuildings of the surrounding properties. Once it reached the highway it pooled at the lowest point and flowed into properties off the highway. There are several highway drainage assets in the area all of which were recorded as working on the inspection prior to the event (September 2022), these were again inspected in December of 2023 and said to be working, it is therefore likely that the drainage system was overwhelmed due to significant rainfall rather than a localised blockage being an issue.

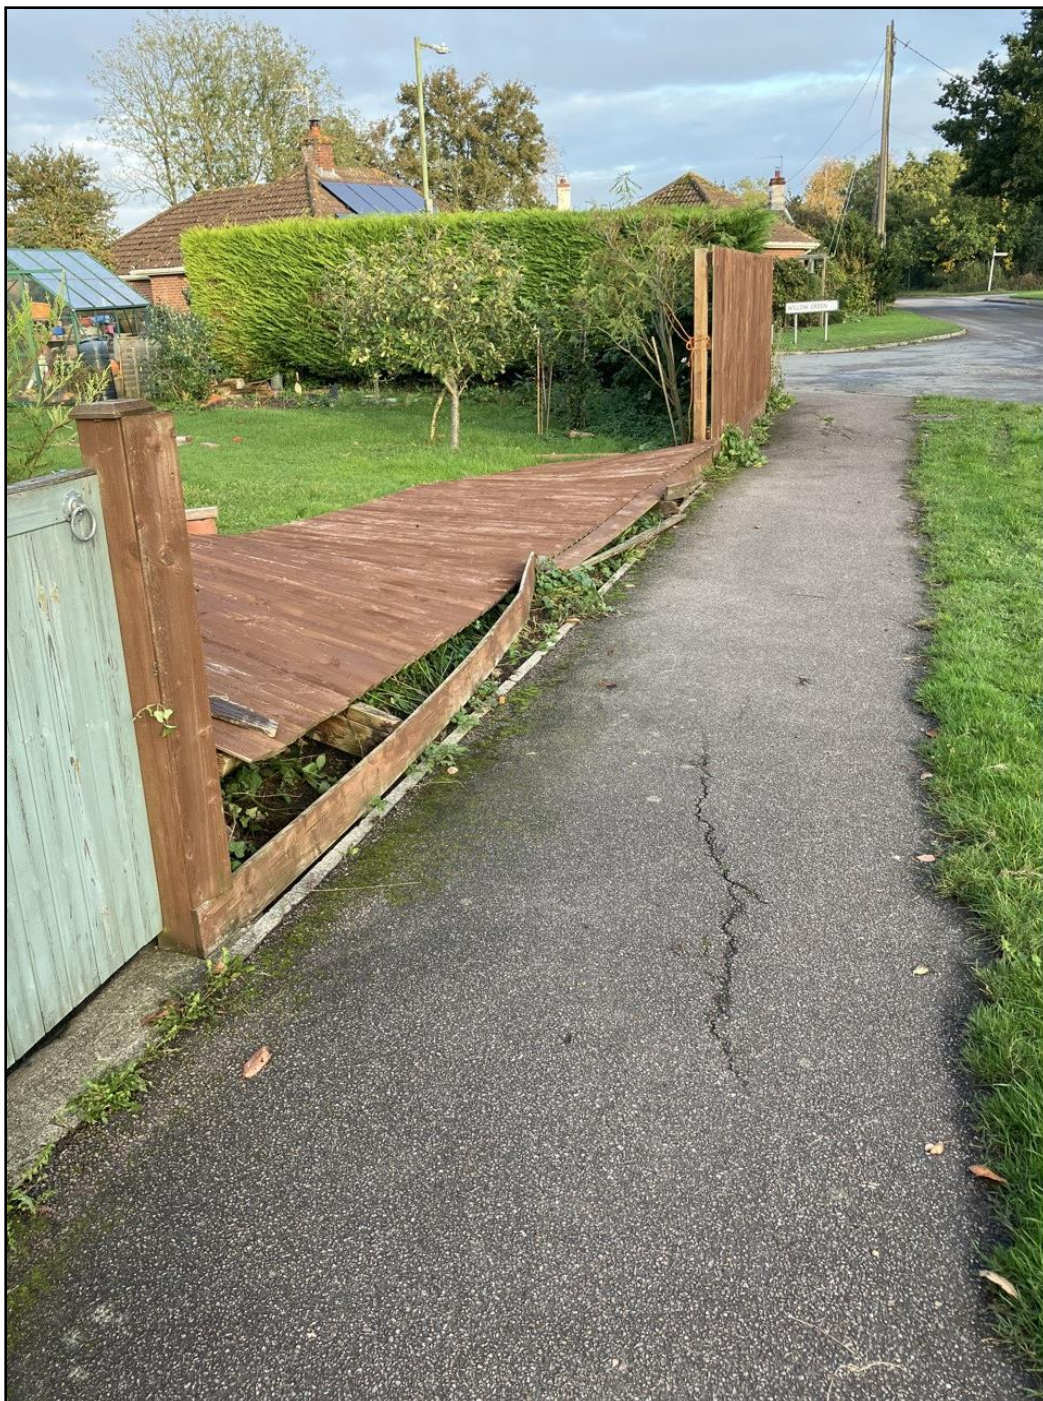
Post event damage to property

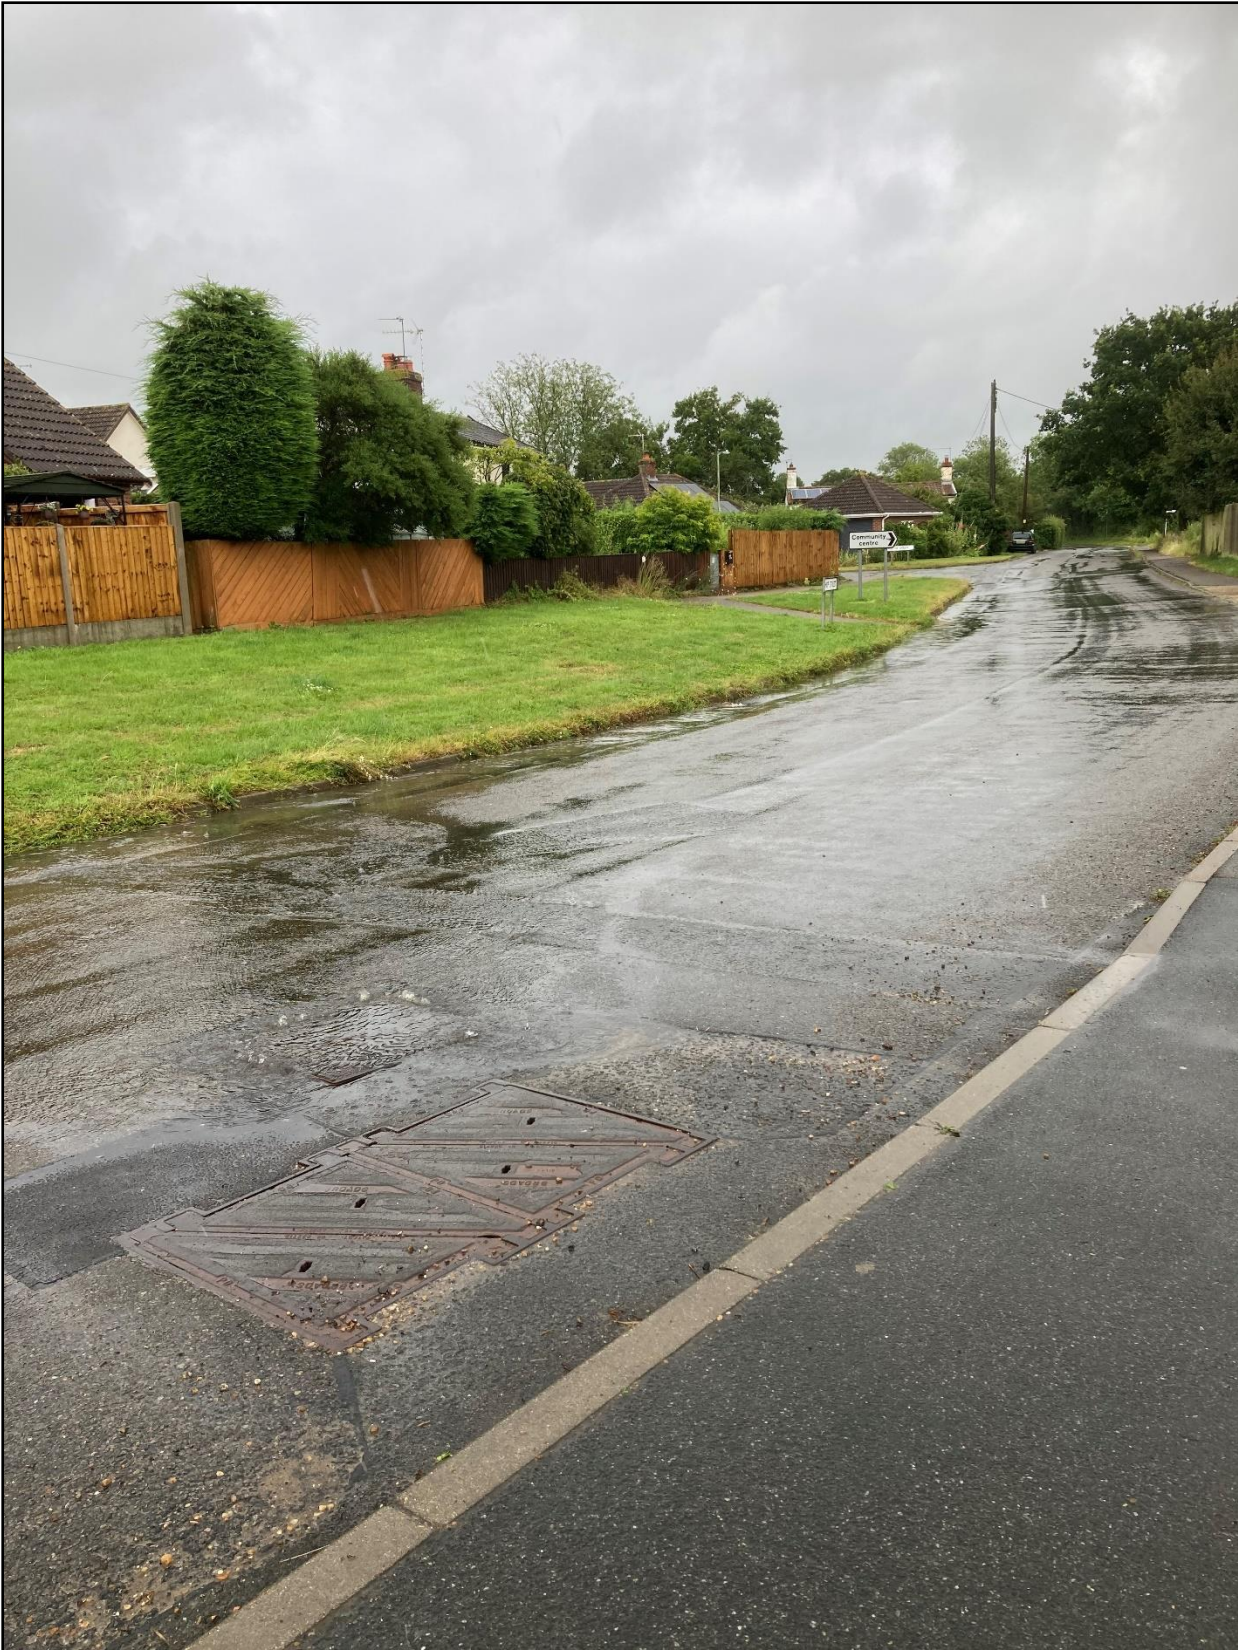
Image of the Sewerage network being overwhelmed by surface water (not taken during Babet)
