Sea Link Grid Reinforcement
Pre-Submission Engagement
Suffolk County Council Response

January 2025

Sea Link Pre-Submission Engagement
Suffolk County Council Response
Appendix C: Benhall Railway Bridge
Principal Inspection Report

**BENHALL RAILWAY BRIDGE
BRIDGE No. 59/42
(BRIDGE CODE 1717)
BENHALL**

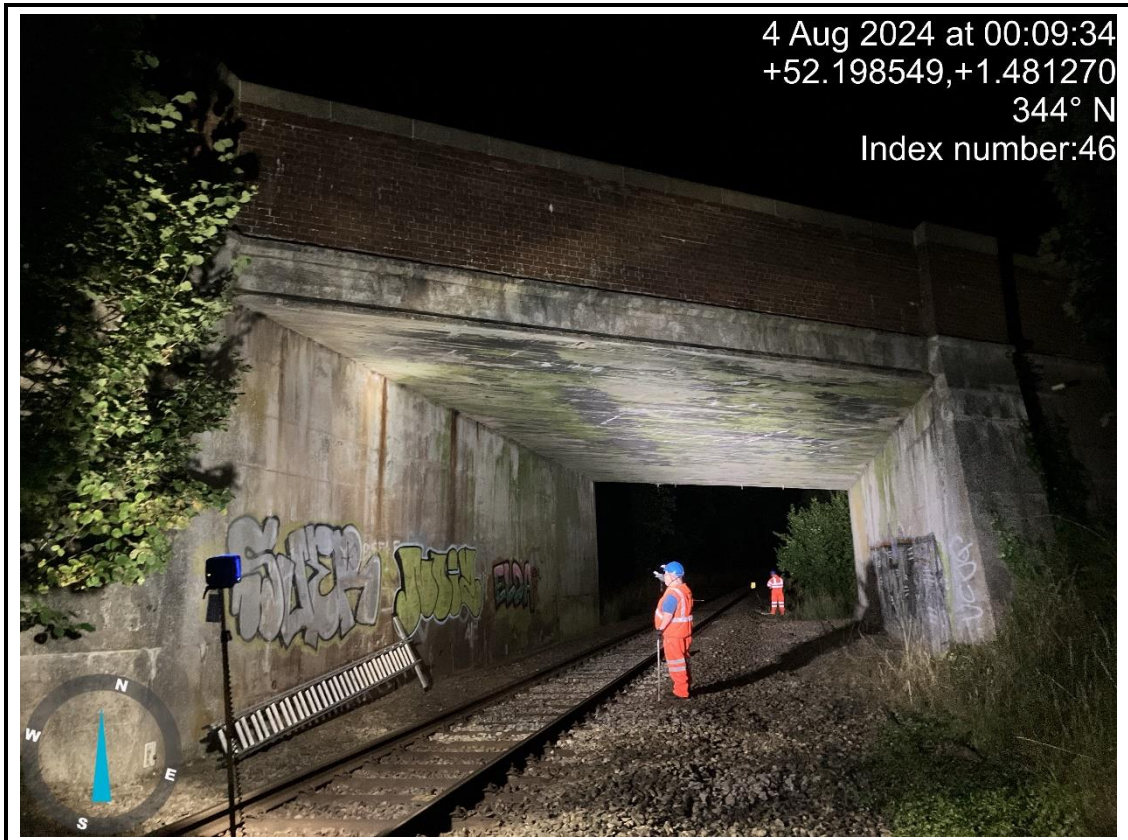
1717_P1_2024 South Elevation

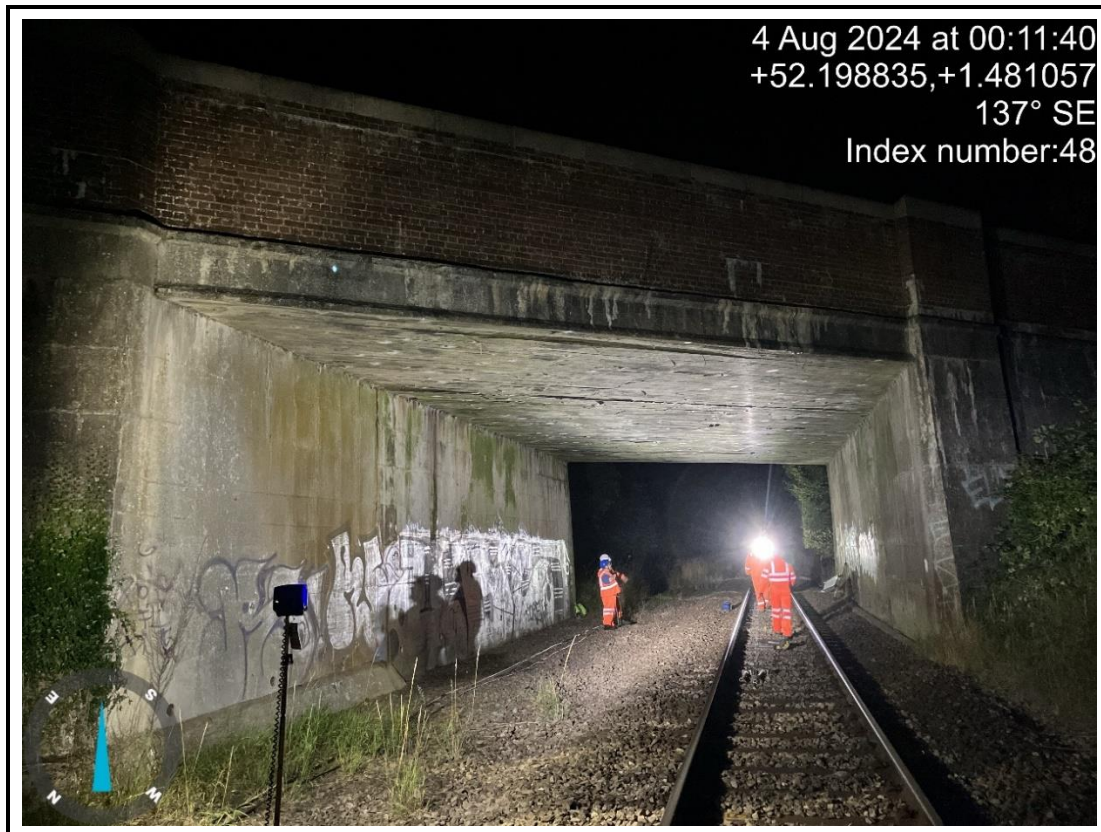
1717_P2_2024 North Elevation

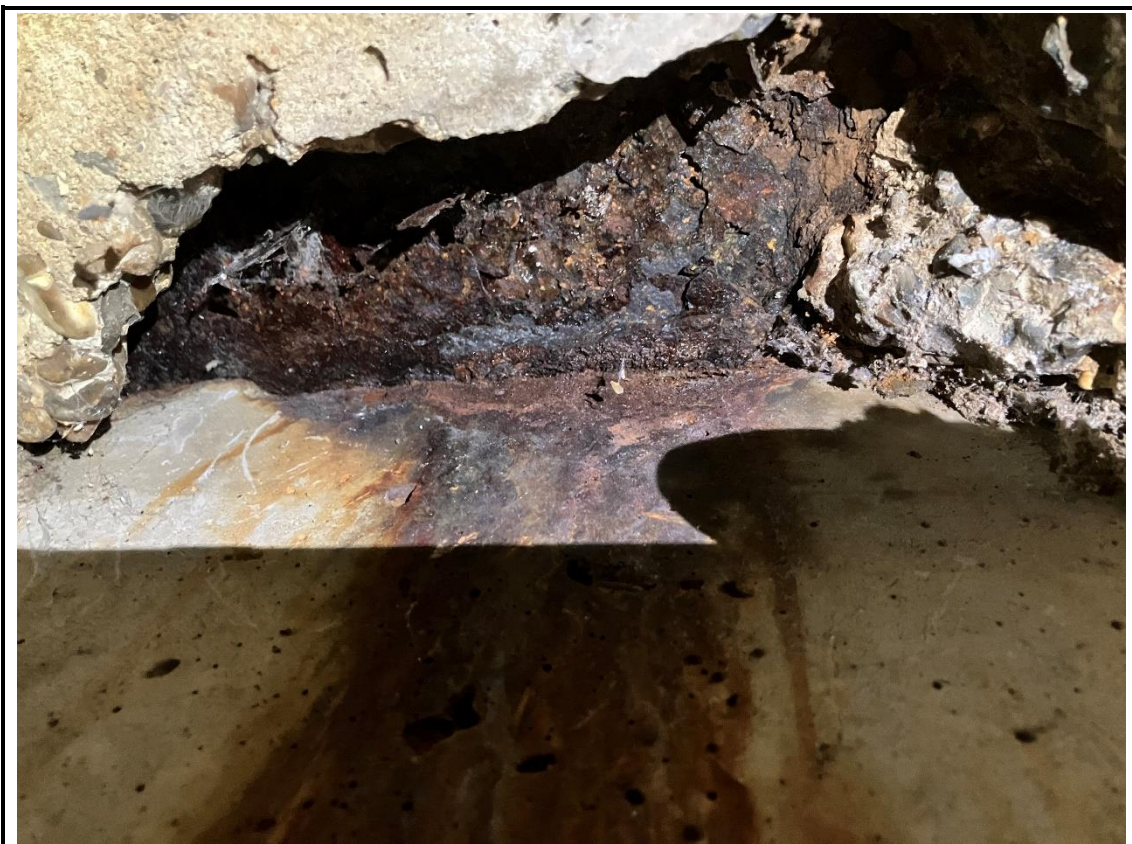
1	<p>There are two areas of exposed steel beam bottom flange identified to the West end of the deck. One area was approximately 200x150mm and the second area 200x100mm, both of which were in the South half of the deck adjacent the West abutment. The exposed areas are showing heavy corrosion and laminated corrosion product flaking off the bottom flange approx. 1mm thick (P5-P7, P9).</p> <p>It should be noted that this corrosion is at the support location and the exact depth and extents of the corrosion along the beam is unknown.</p> <p>There are isolated areas of spalled concrete concentrated at the deck edge adjacent the soffit/abutment interface (P9). The west side of the deck is the most affected compared to the east abutment. The depth of spalling ranges from a depth of 5mm to 75mm exposing the beam flanges (see Element 1). An isolated area of honeycombing was noted running along the full length of a construction joint (P14) and an isolated area of corroded threaded bar to the middle of the soffit (P15).</p>

1717_P6_2024 West abutment/soffit interface - Exposed steel beam flaking corrosion

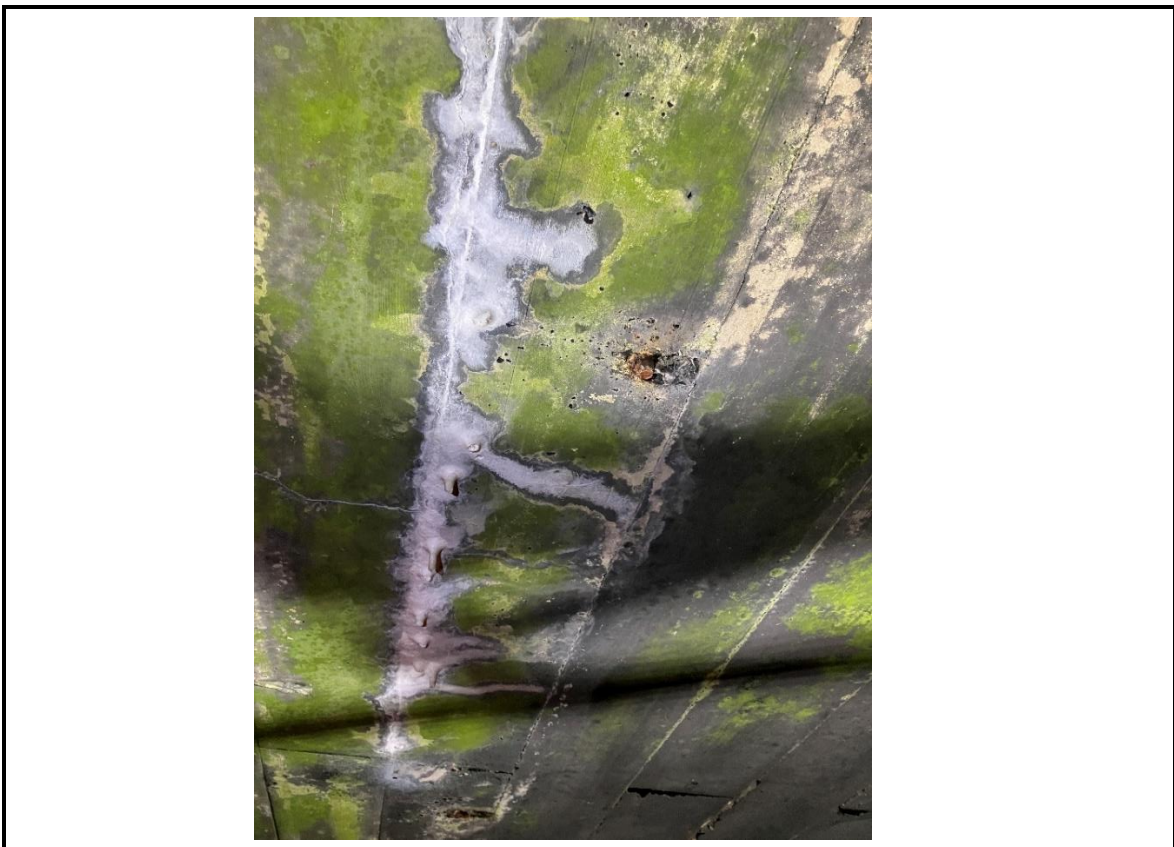
1717_P8_2024 Bridge soffit - Stalactites buildup along longitudinal cracks

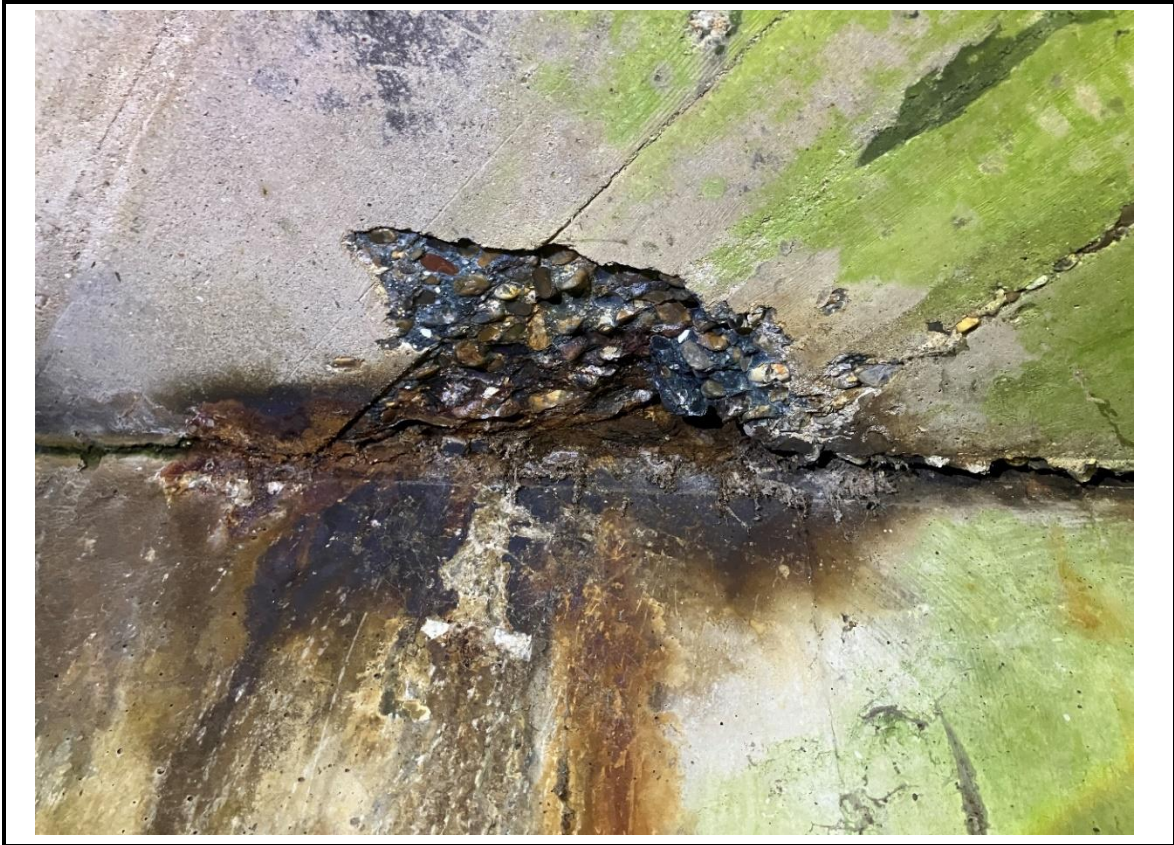
1717_P9_2024 Abutment/soffit interface - Concrete spalling

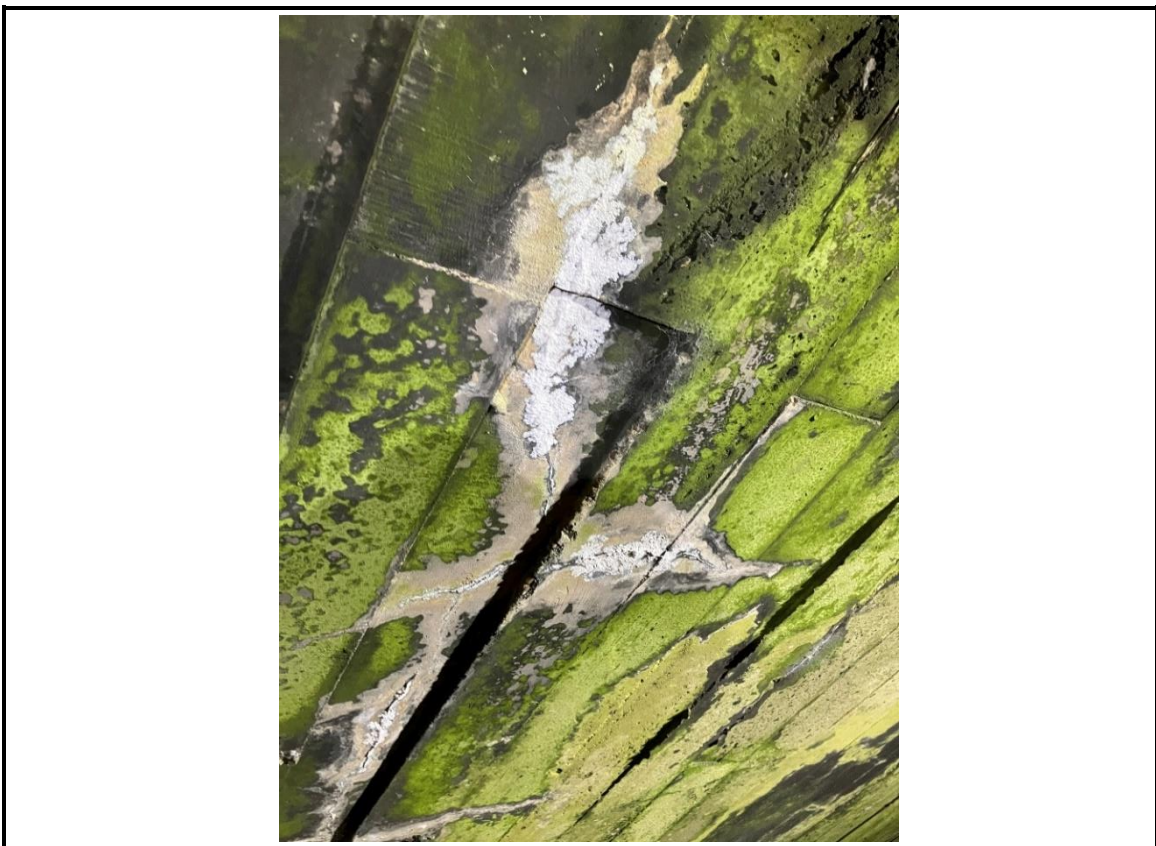
1717_P10_2024 Bridge soffit - Cracking and minor spalling

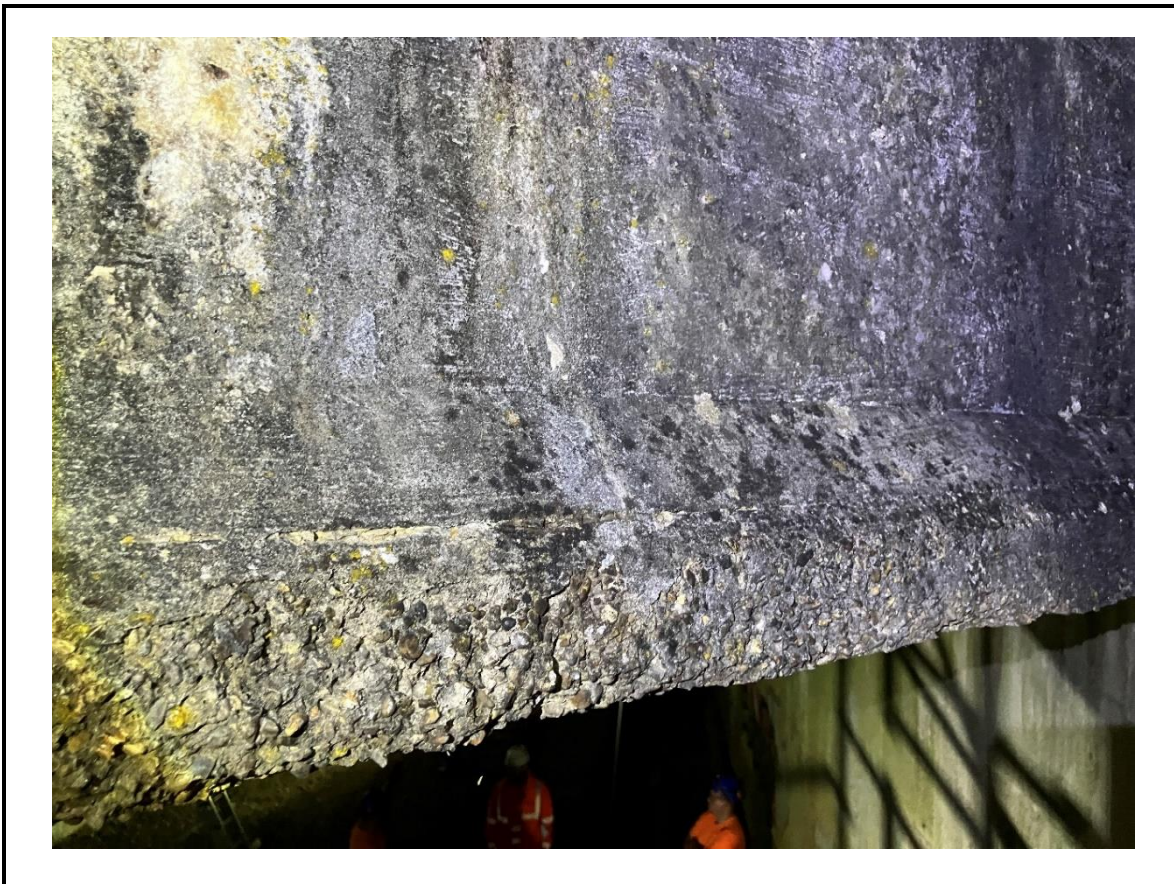
1717_P12_2024 North deck edge – Minor concrete spalling

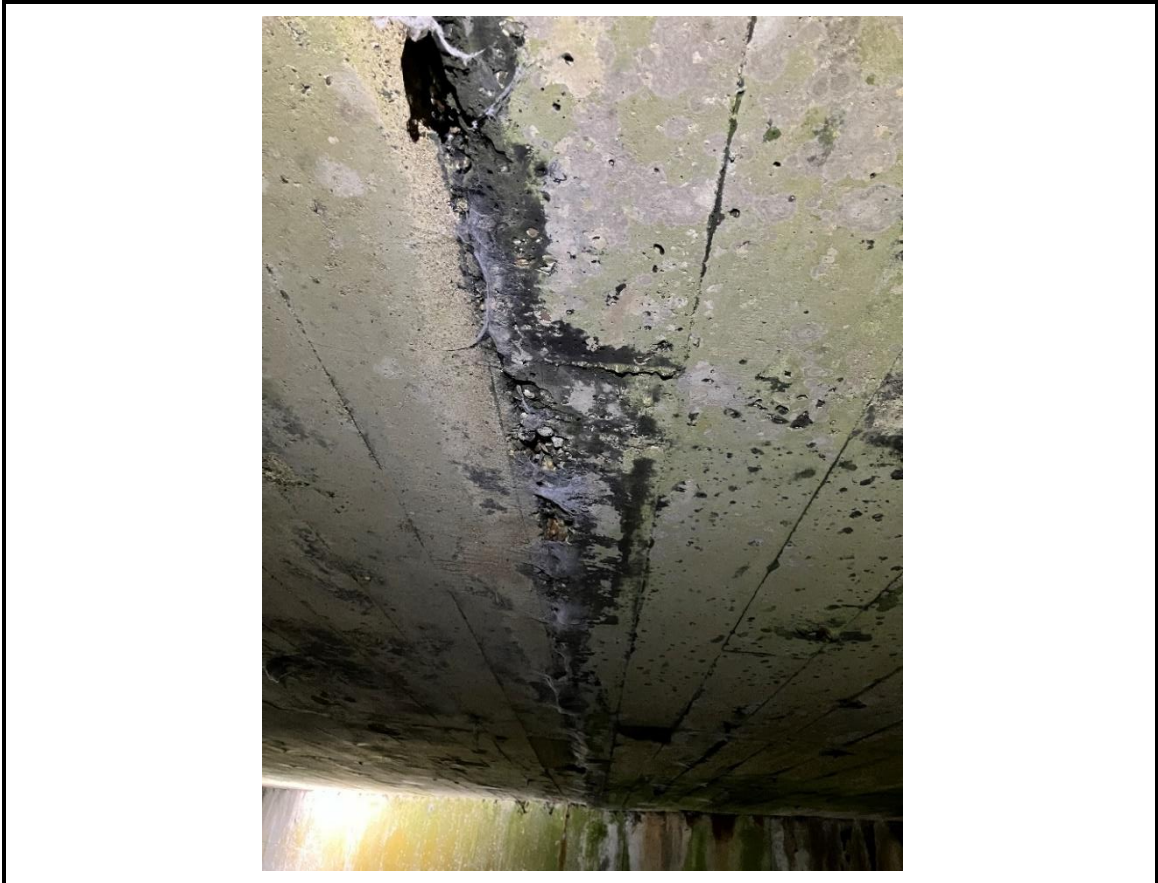
1717_P14_2024 Bridge soffit – Concrete spalling & honeycombing

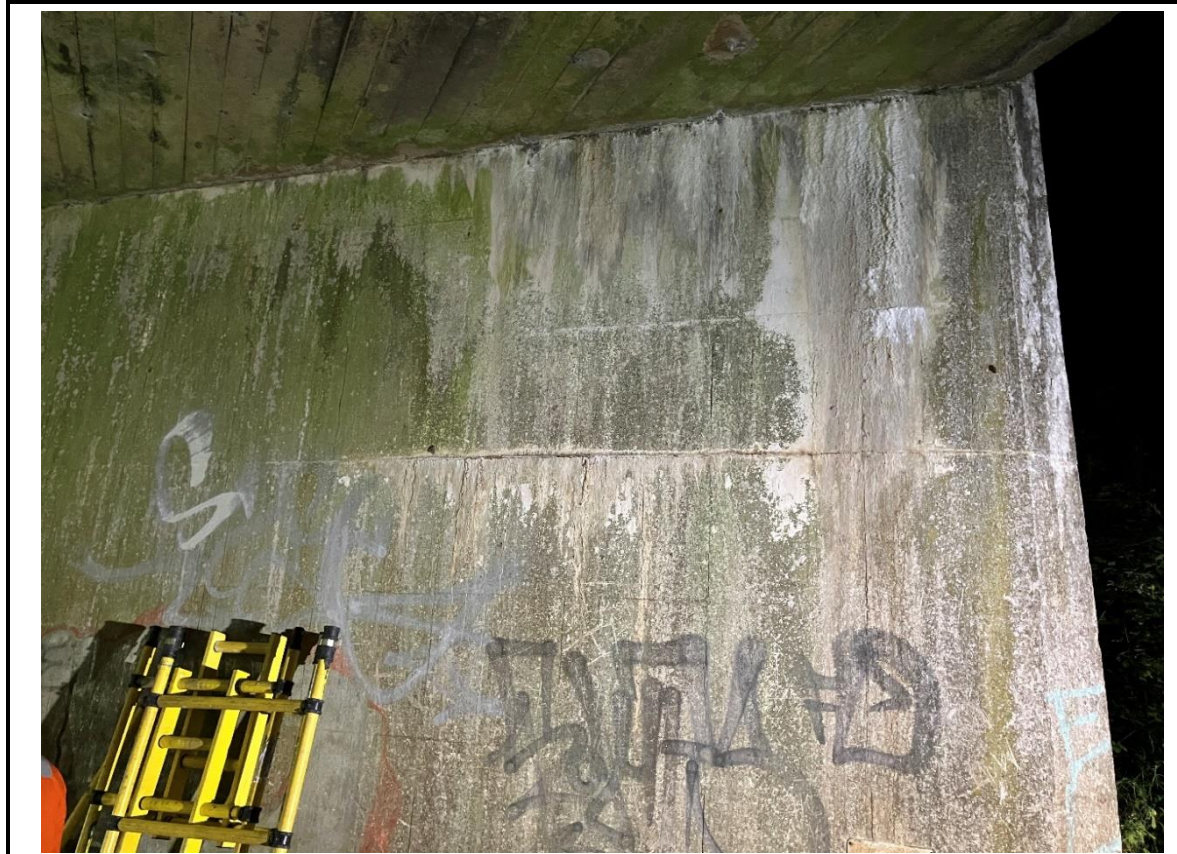
1717_P18_2024 West Abutment – Saline leaching (<30mm at the top)

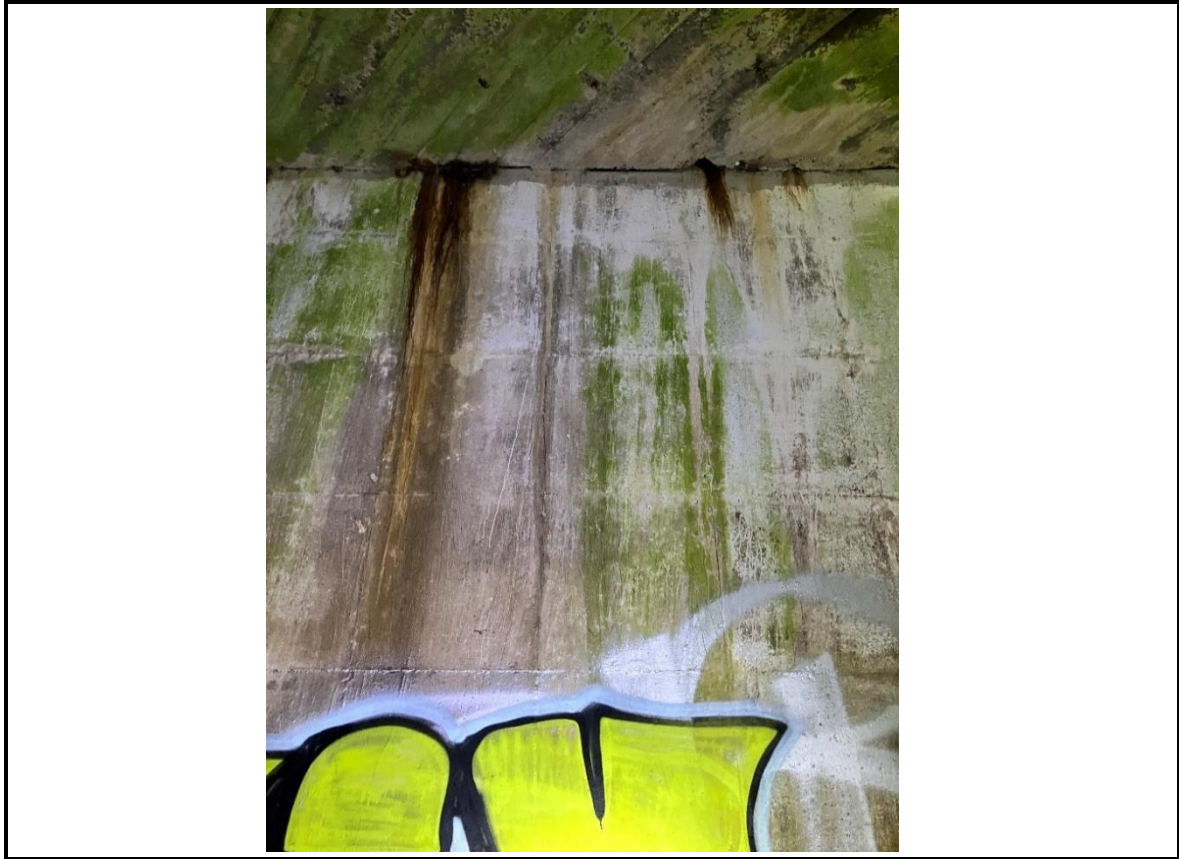
1717_P19_2024 West abutment - Saline leaching and corrosion staining

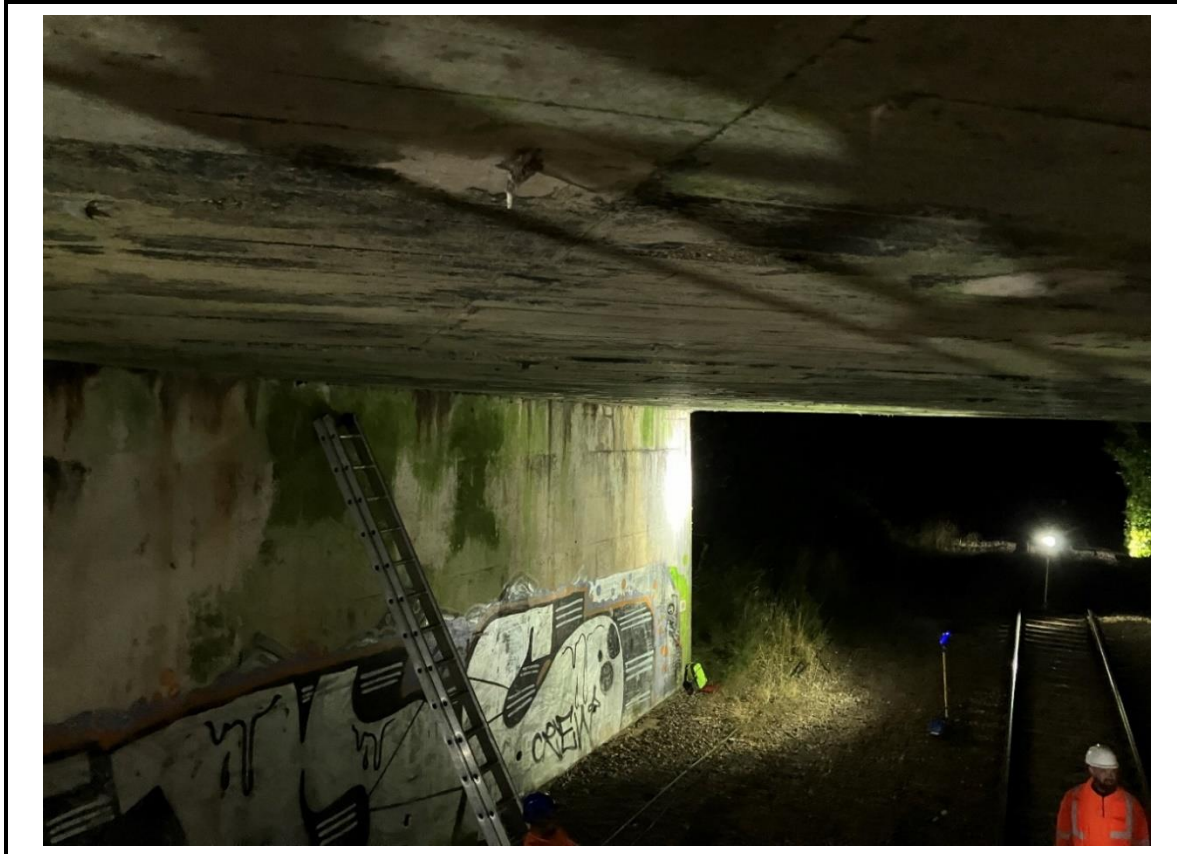
1717_P21_2024 East abutment - Saline leaching, corrosion staining and graffiti

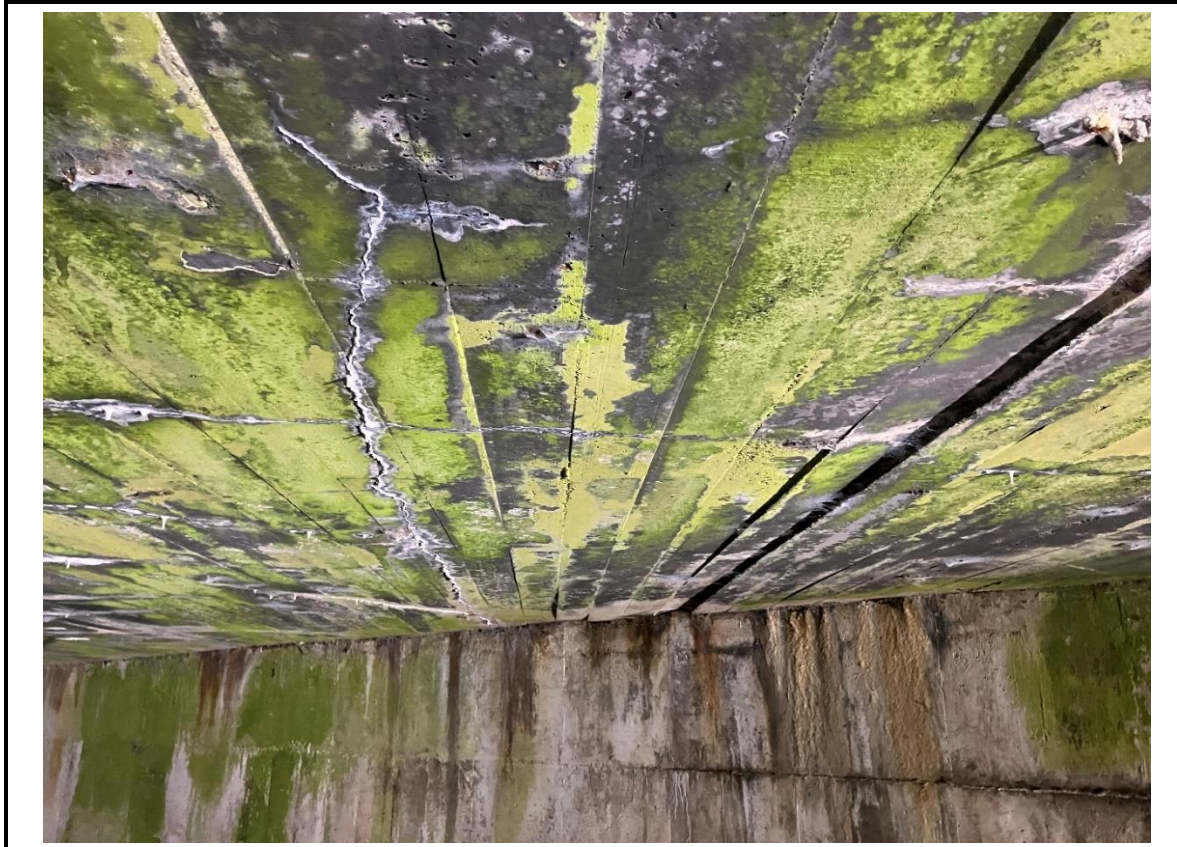
1717_P22_2024 East abutment - Saline leaching and corrosion staining

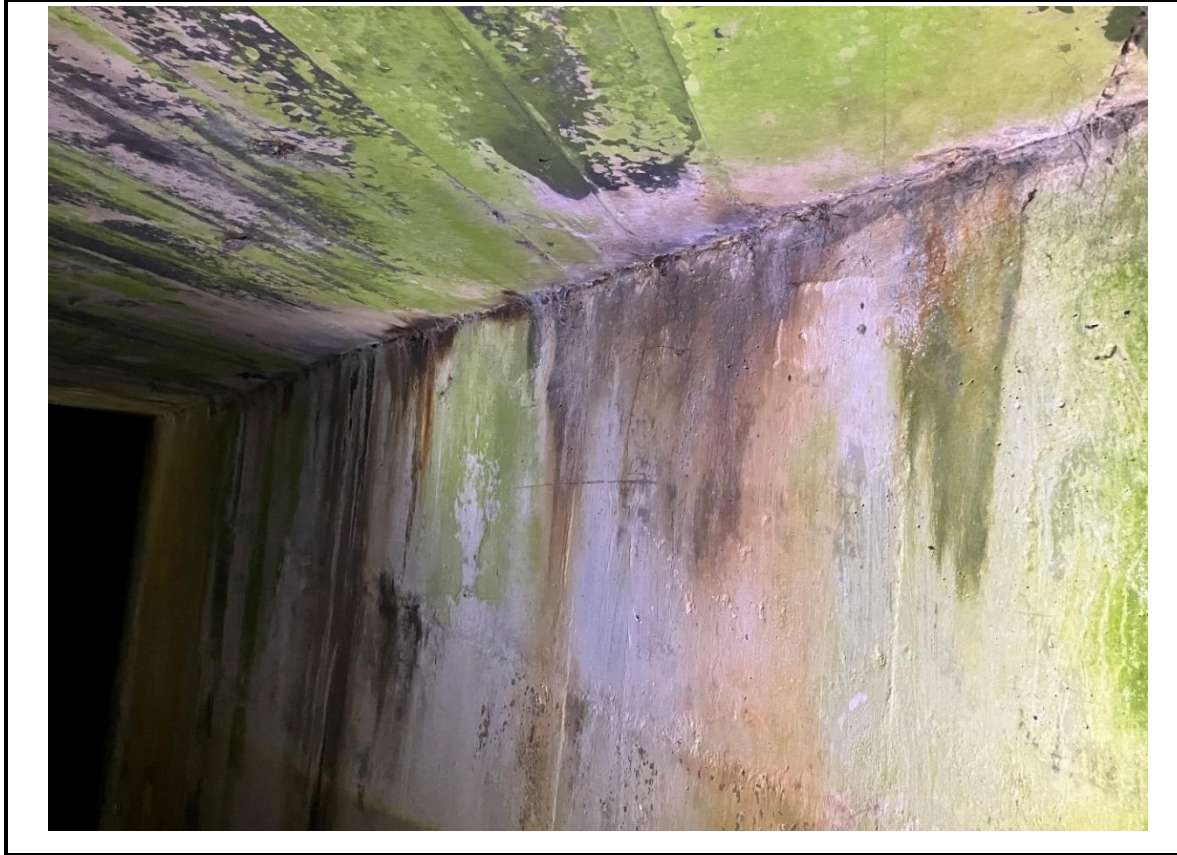
1717_P23_2024 East abutment - Saline leaching and corrosion staining

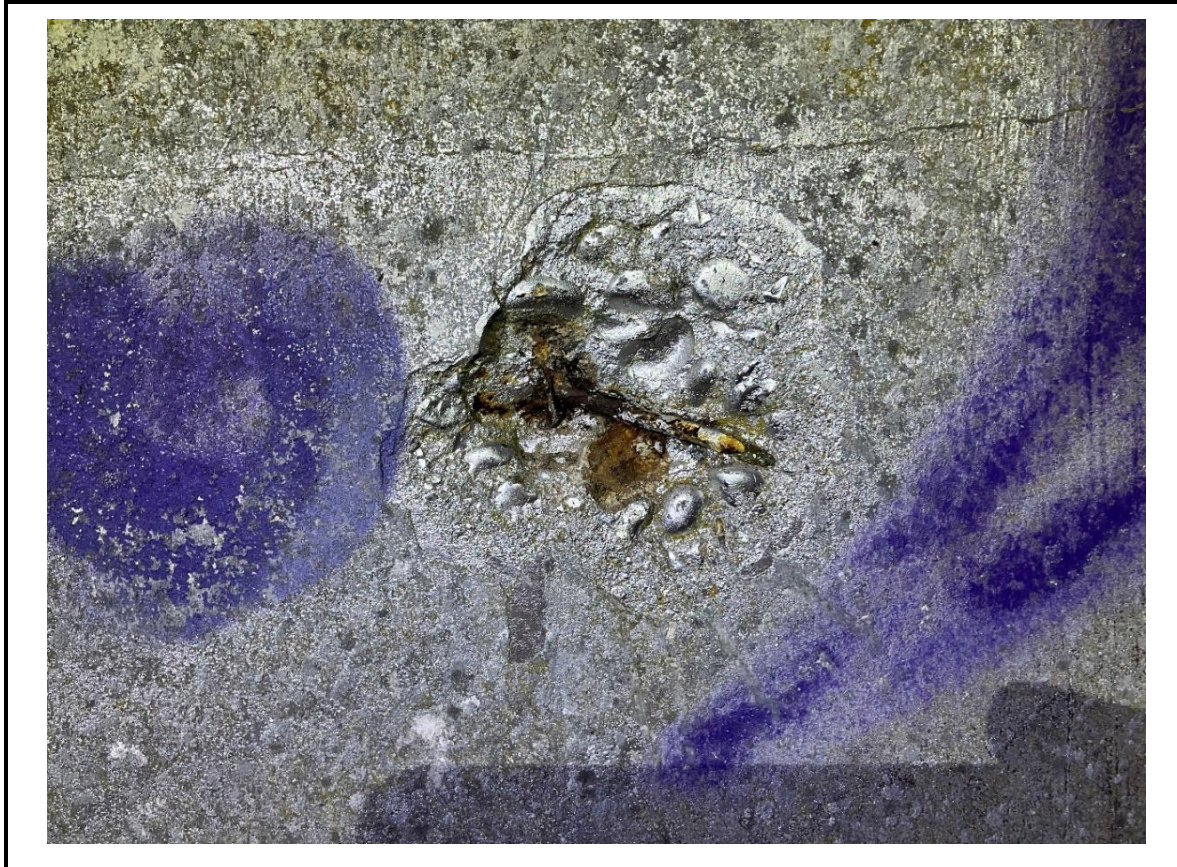
1717_P24_2024 East abutment - Concrete spalling, exposed rebar & non-offensive graffiti

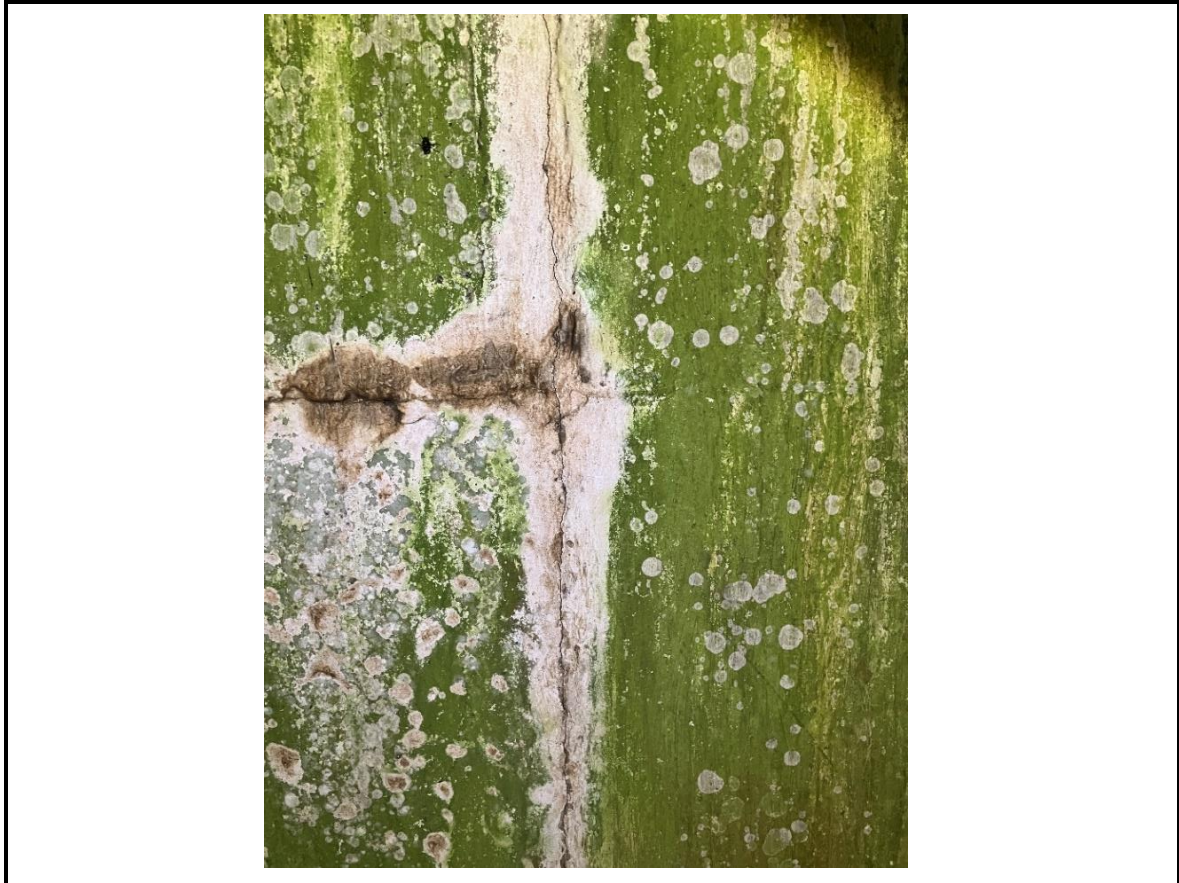
1717_P25_2024 West abutment - Vertical crack (<2mm in width)

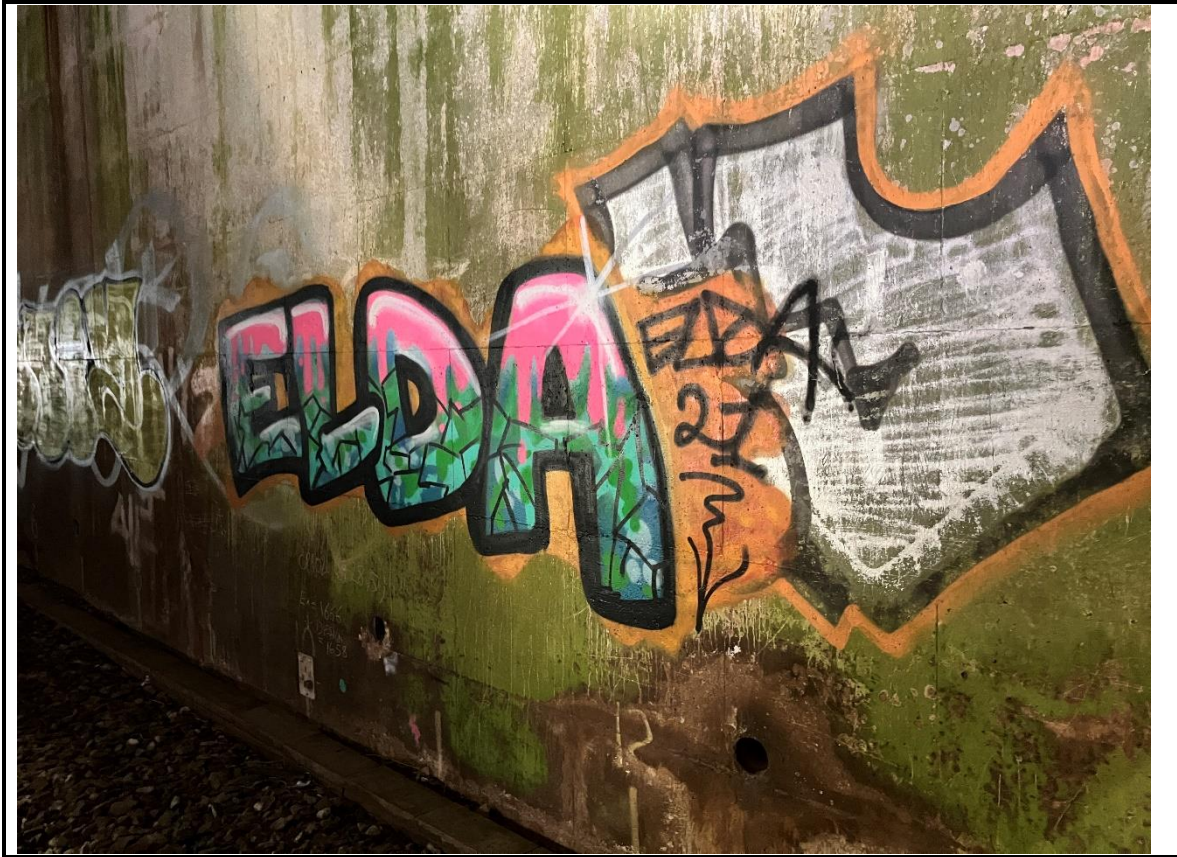
1717_P26_2024 West abutment - Drainage weepholes

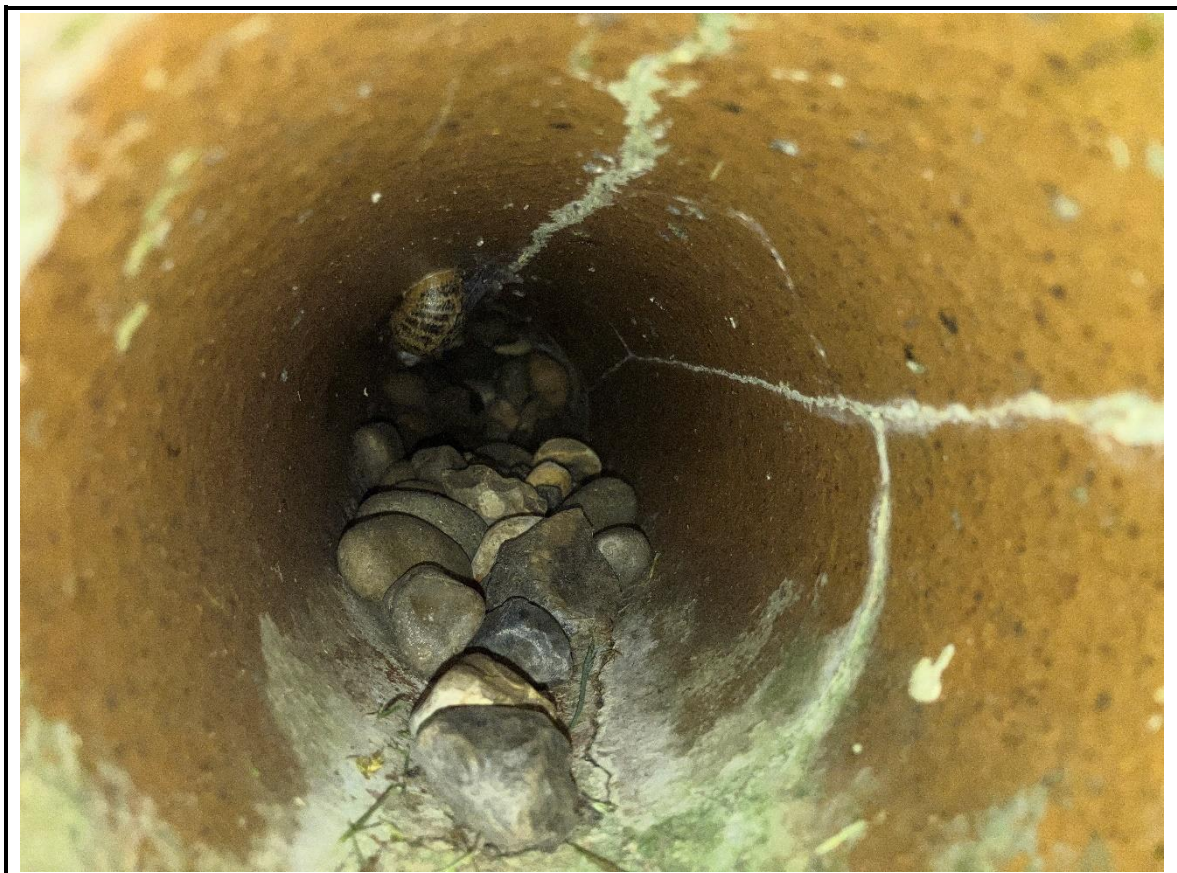
1717_P27_2024 West abutment - Weep hole partially blocked

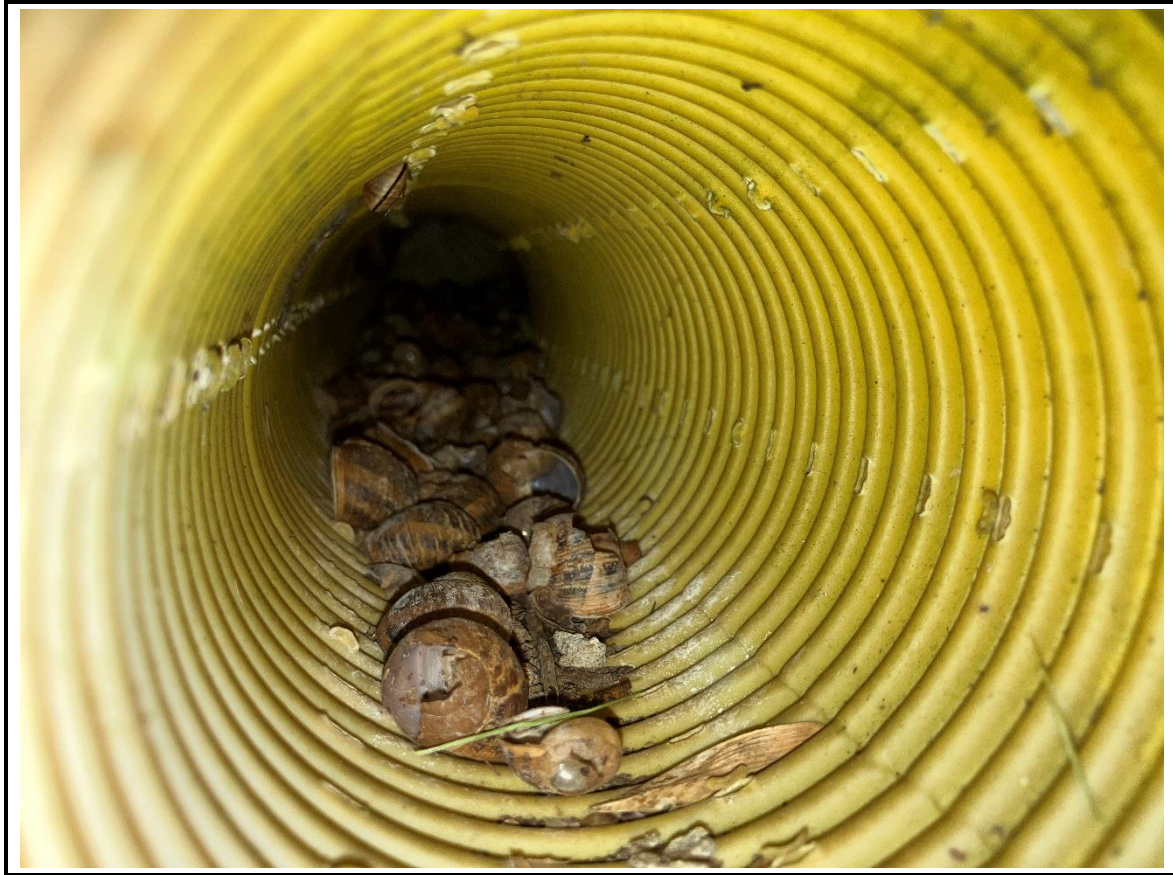
1717_P28_2024 Southeast wingwall - Weephole partially blocked

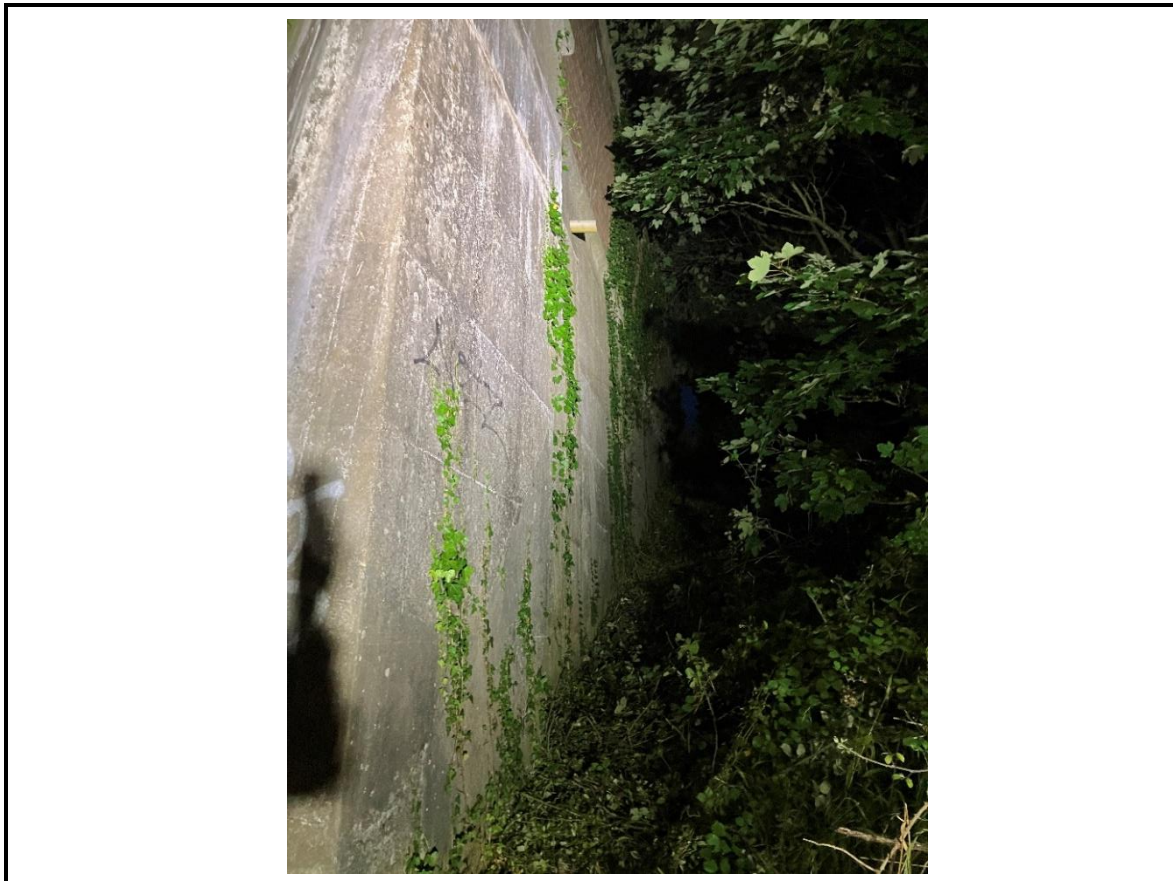
1717_P29_2024 Southeast wingwall - Weephole detail & vegetation growth

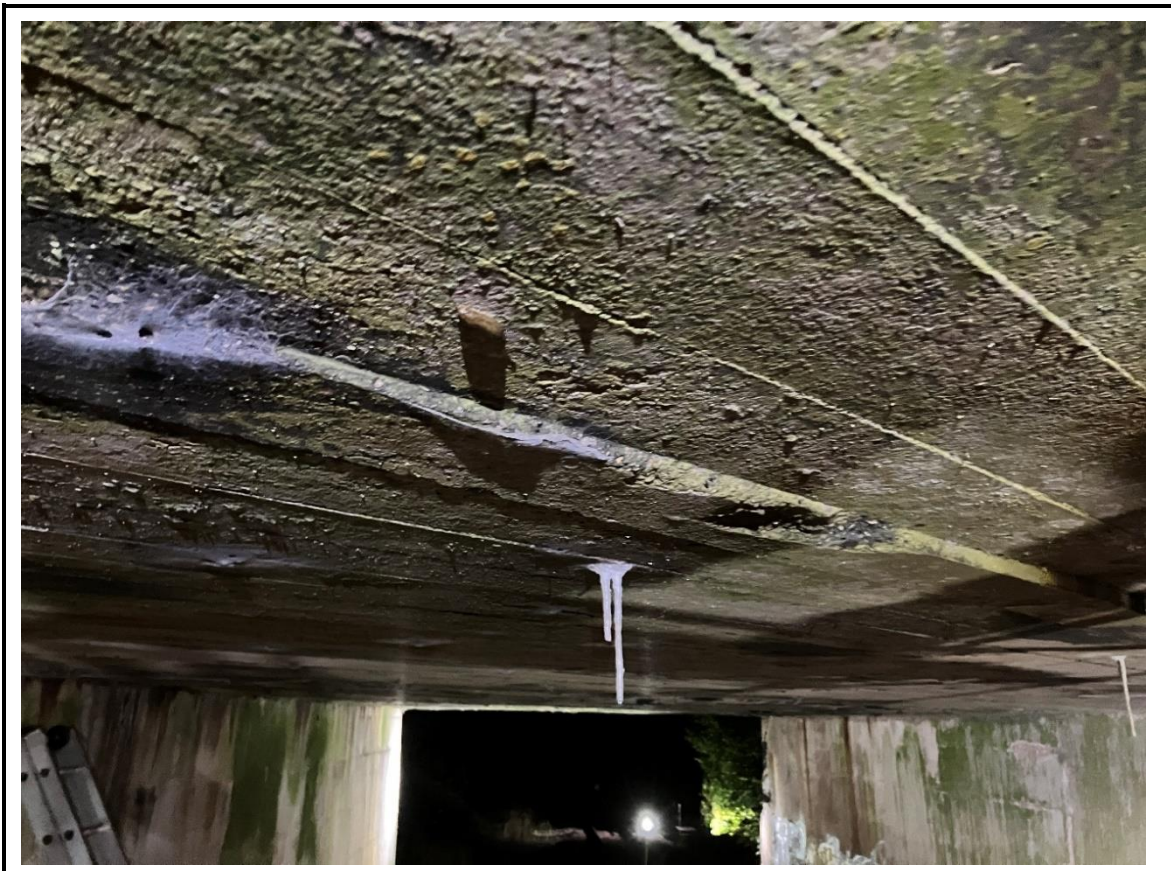
1717_P31_2024 Bridge soffit - Stalactite formation (<150mm)

Re-waterproof bridge deck.

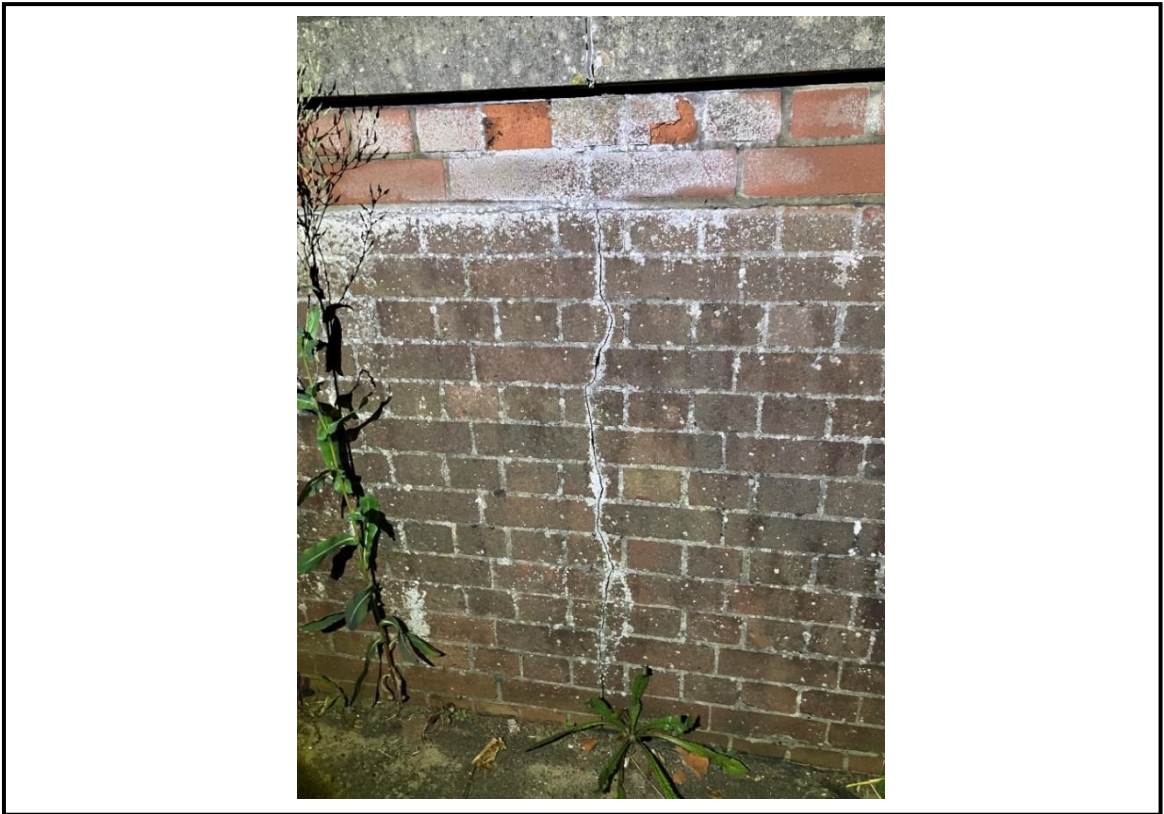
1717_P32_2024 South parapet - Vertical and hairline horizontal cracks (<2mm)

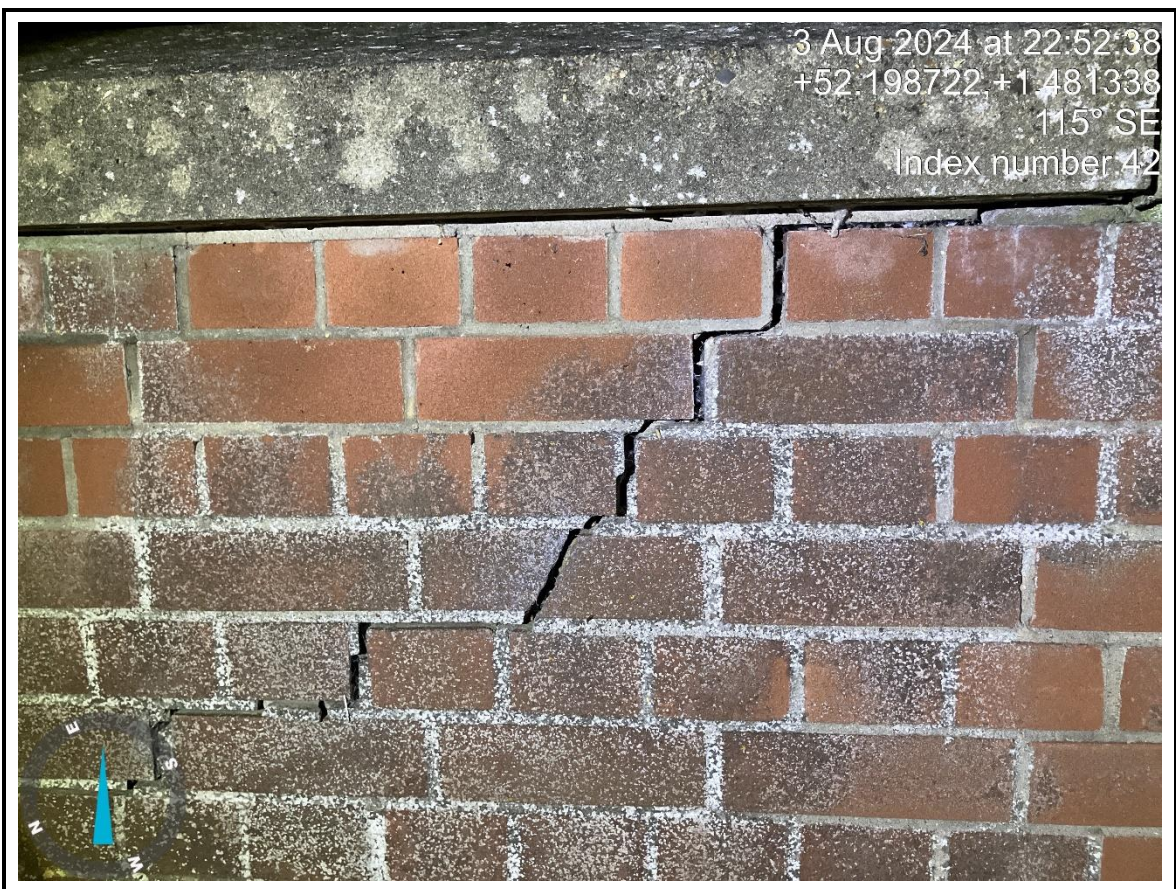
1717_P33_2024 South parapet - Diagonal parapet crack (<10mm)
