Sea Link Grid Reinforcement
Pre-Submission Engagement
Suffolk County Council Response

January 2025

Sea Link Pre-Submission Engagement
Suffolk County Council Response
Appendix C: Benhall Railway Bridge
Principal Inspection Report

**BENHALL RAILWAY BRIDGE
BRIDGE No. 59/42
(BRIDGE CODE 1717)
BENHALL**

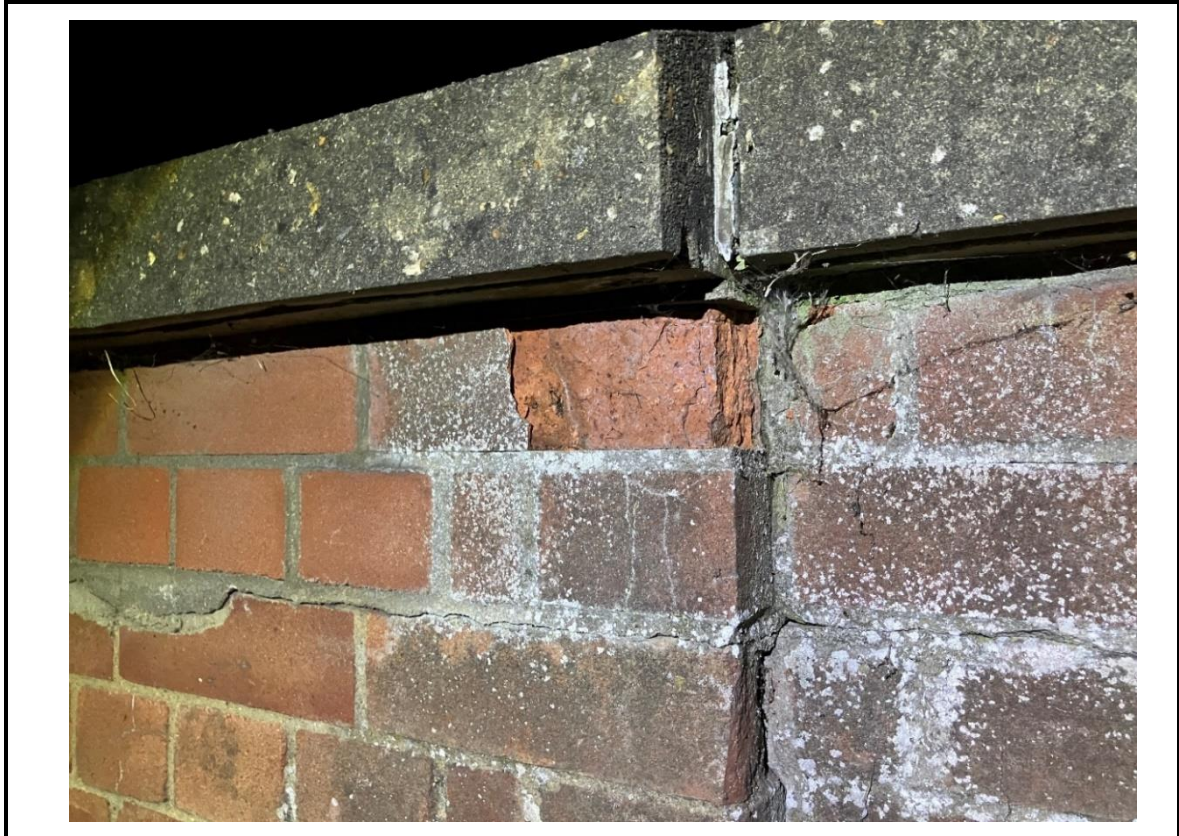
1717_P34_2024 South parapet - Brick spalling (10mm deep) & horizontal hairline crack

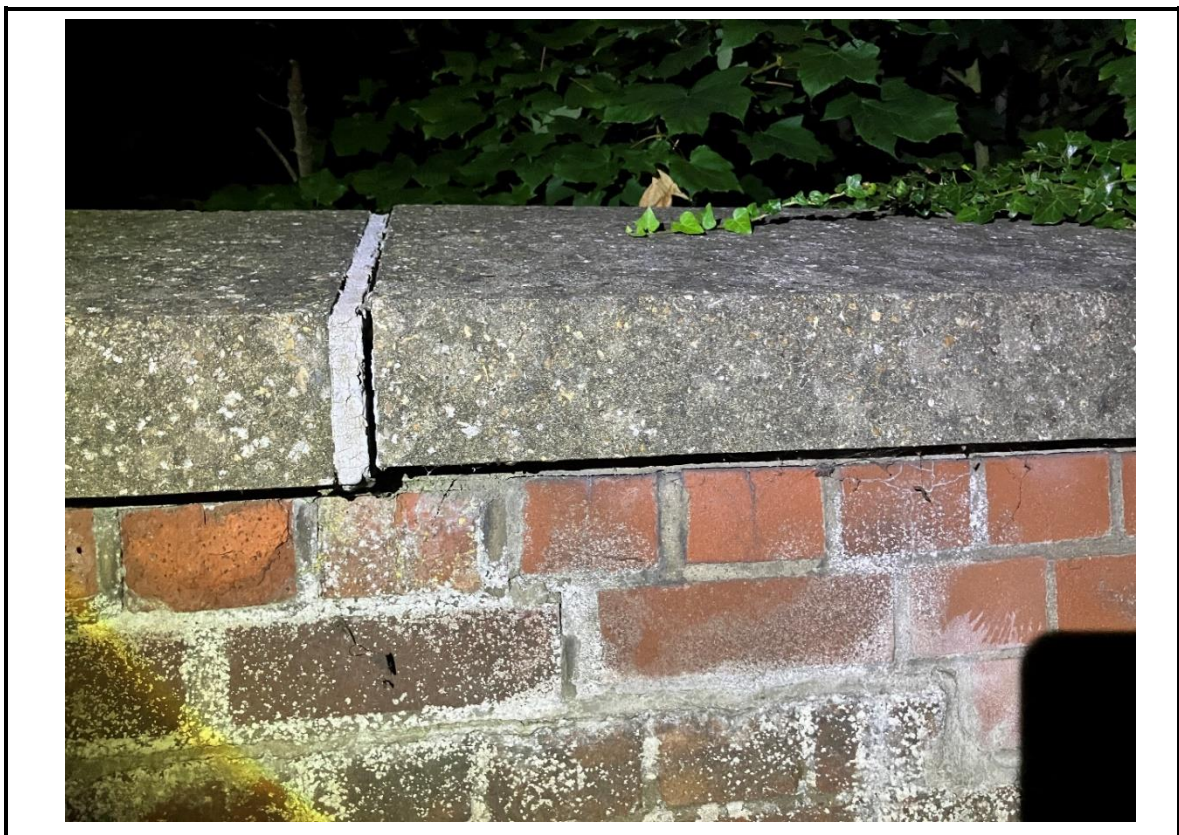
1717_P35_2024 South parapet – Displacement of parapet coping (<15mm) & repaired diagonal crack

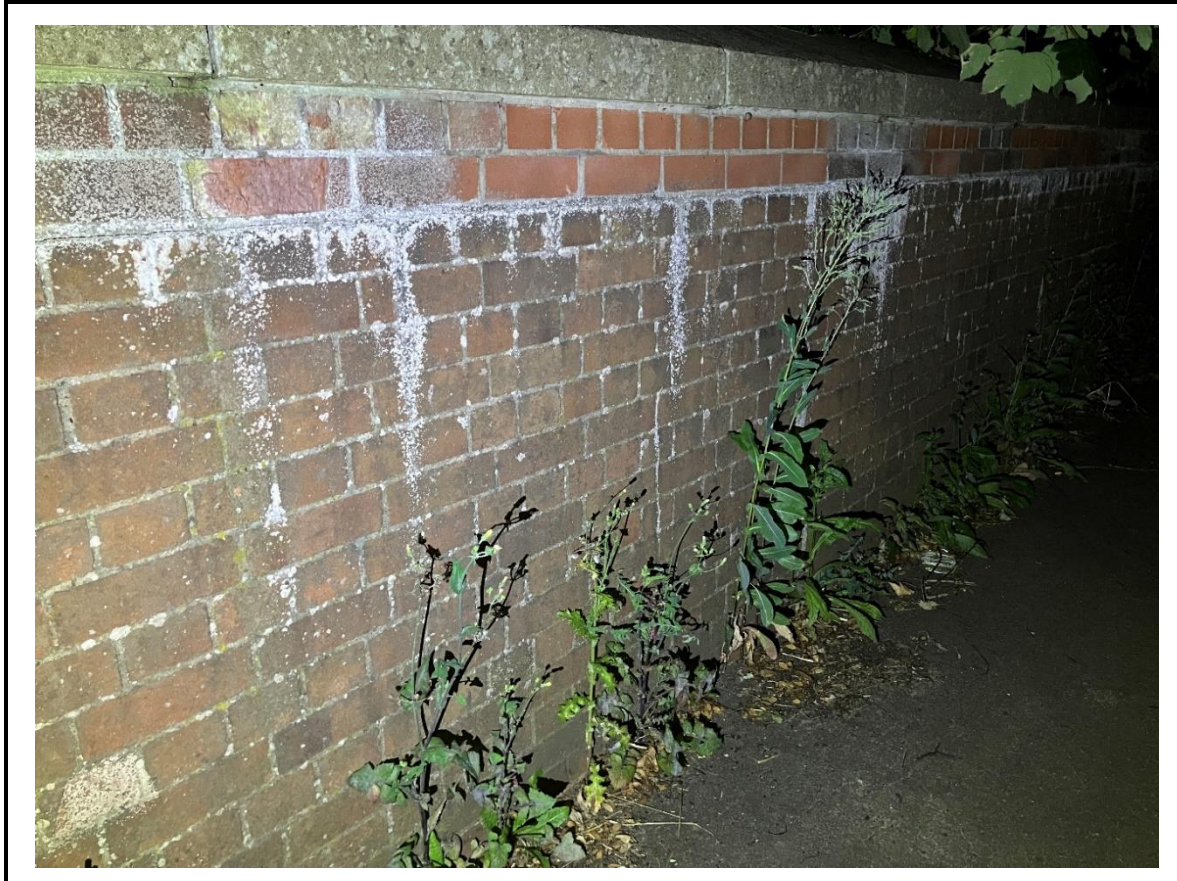
1717_P36_2024 South parapet - Minor vegetation growth & historic leaching

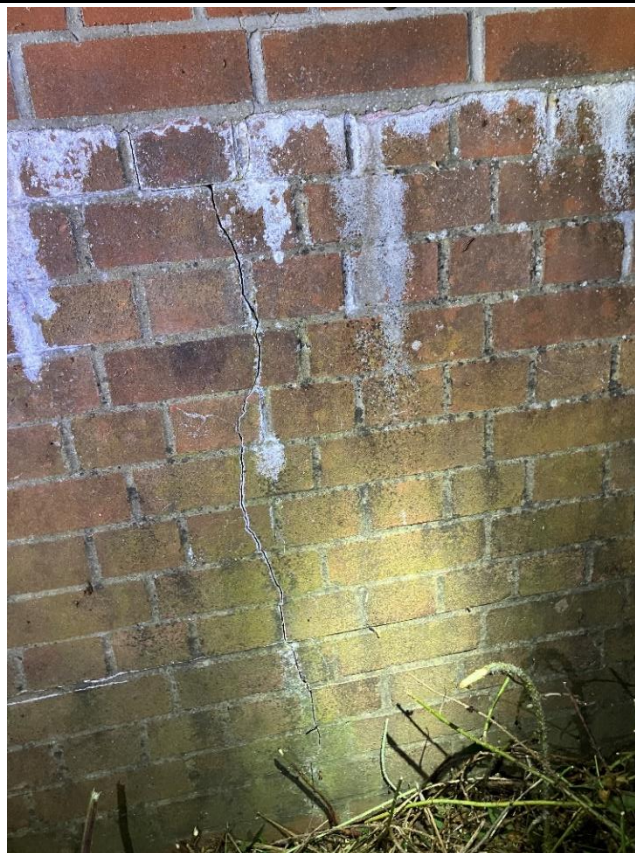
1717_P39_2024 North parapet - Vertical Crack (<1.5mm) & leaching

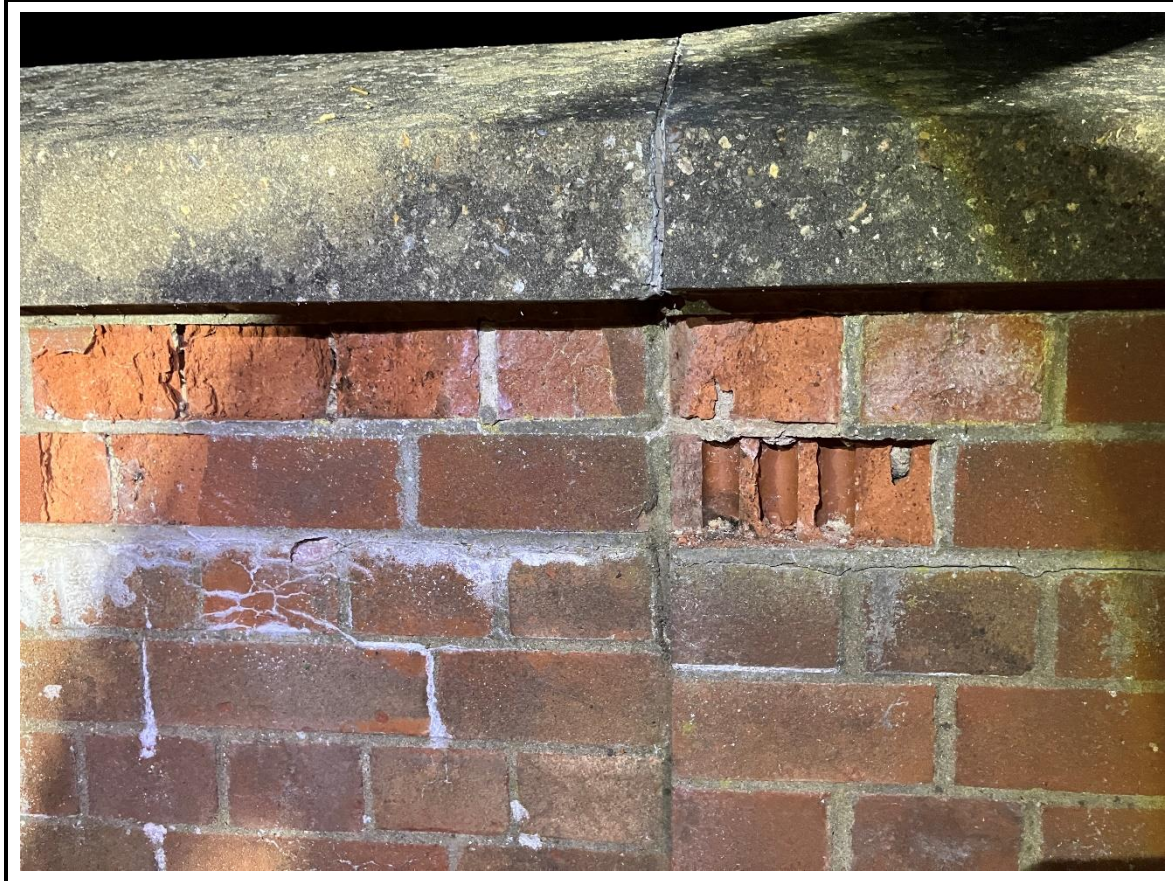
1717_P40_2024 North parapet - Brick spalling & hairline cracks

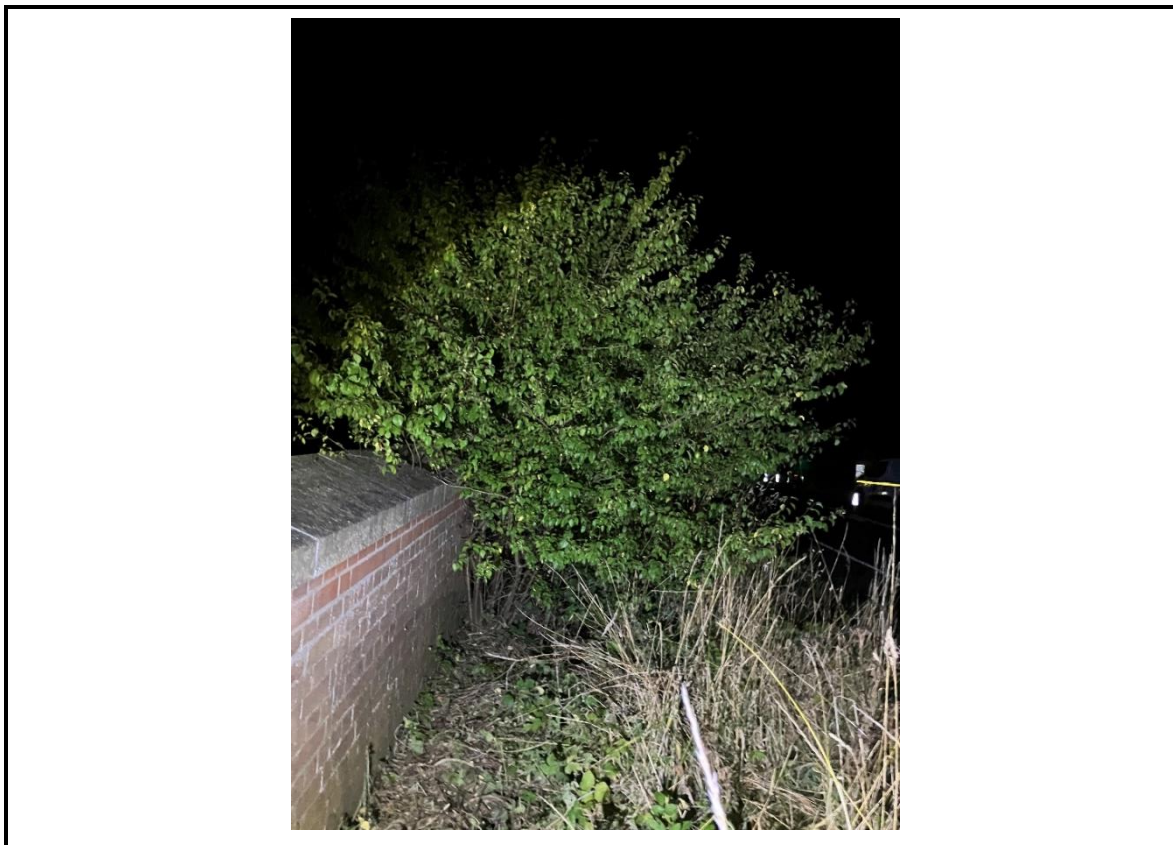
1717_P41_2024 North parapet - Vegetation growth

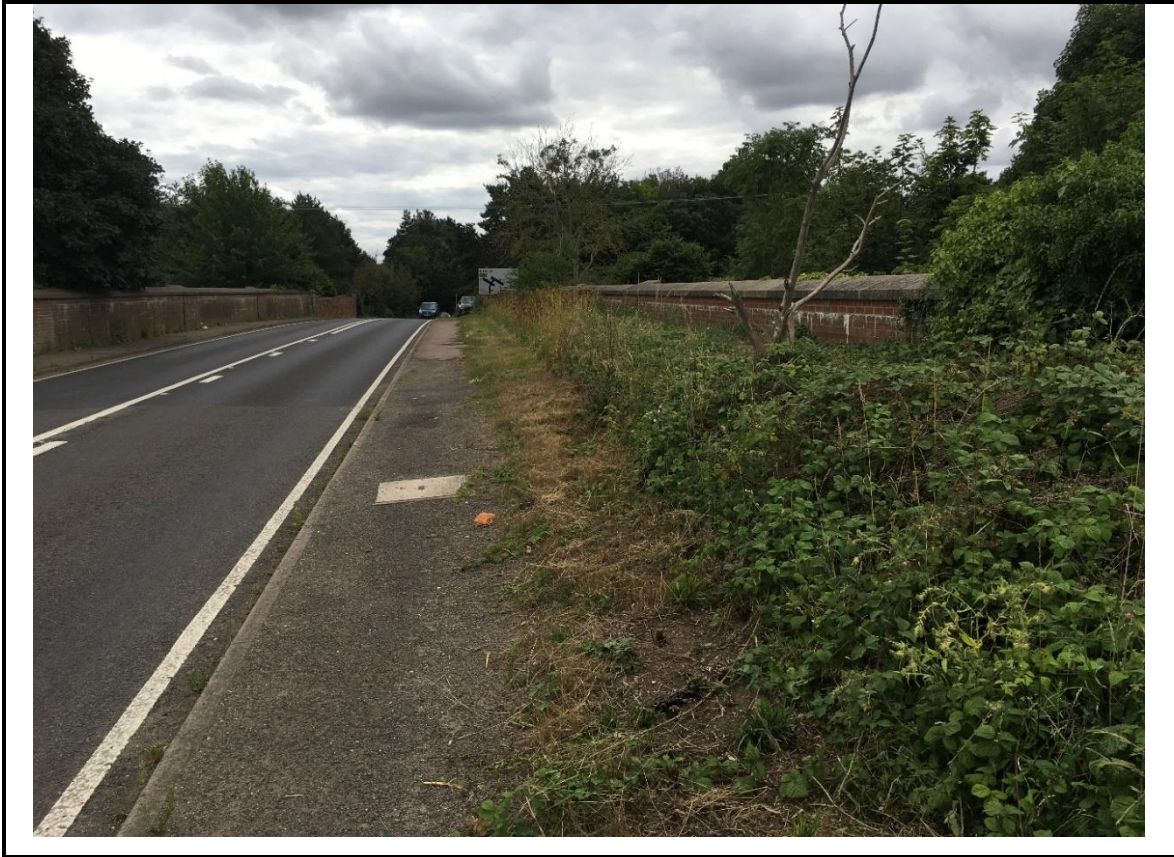
1717_P43_2024 North footway - Footway surfacing and vegetation growth (July 2023)

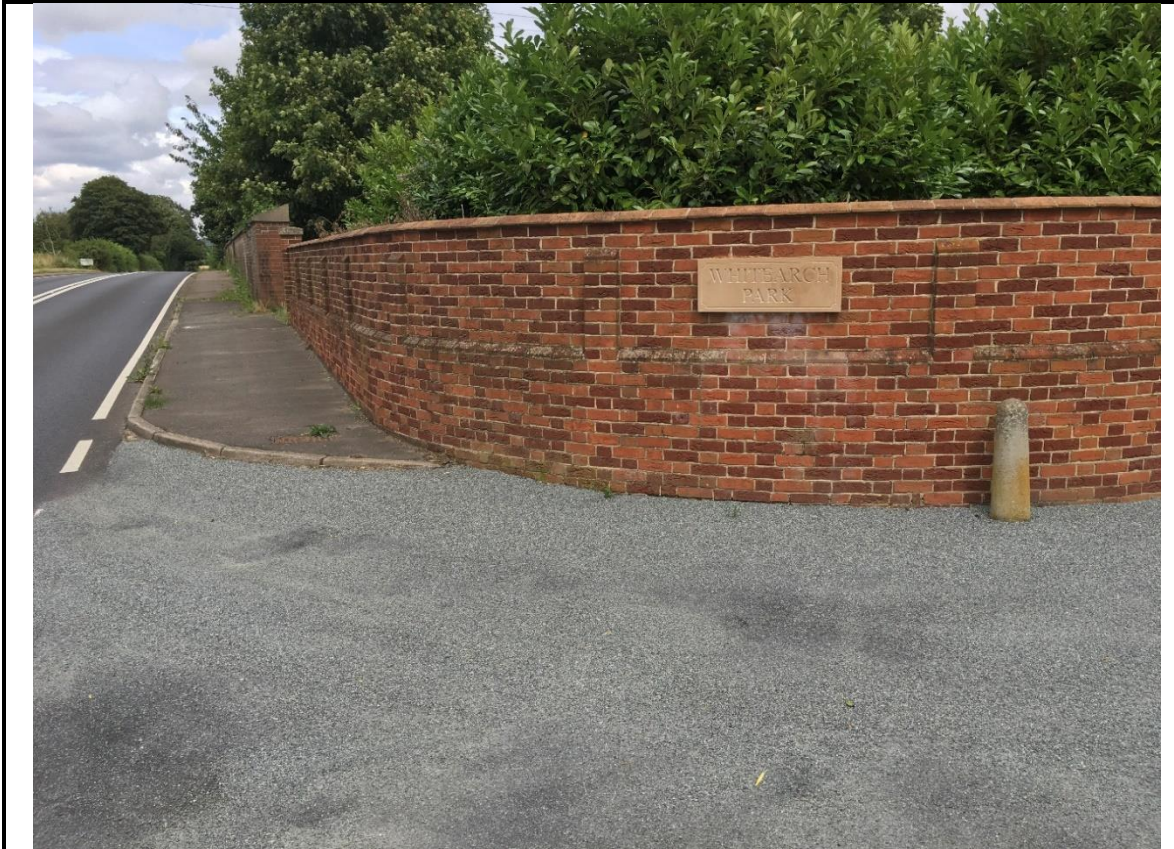
1717_P44_2024 – South footway - Footway surfacing (July 2023)

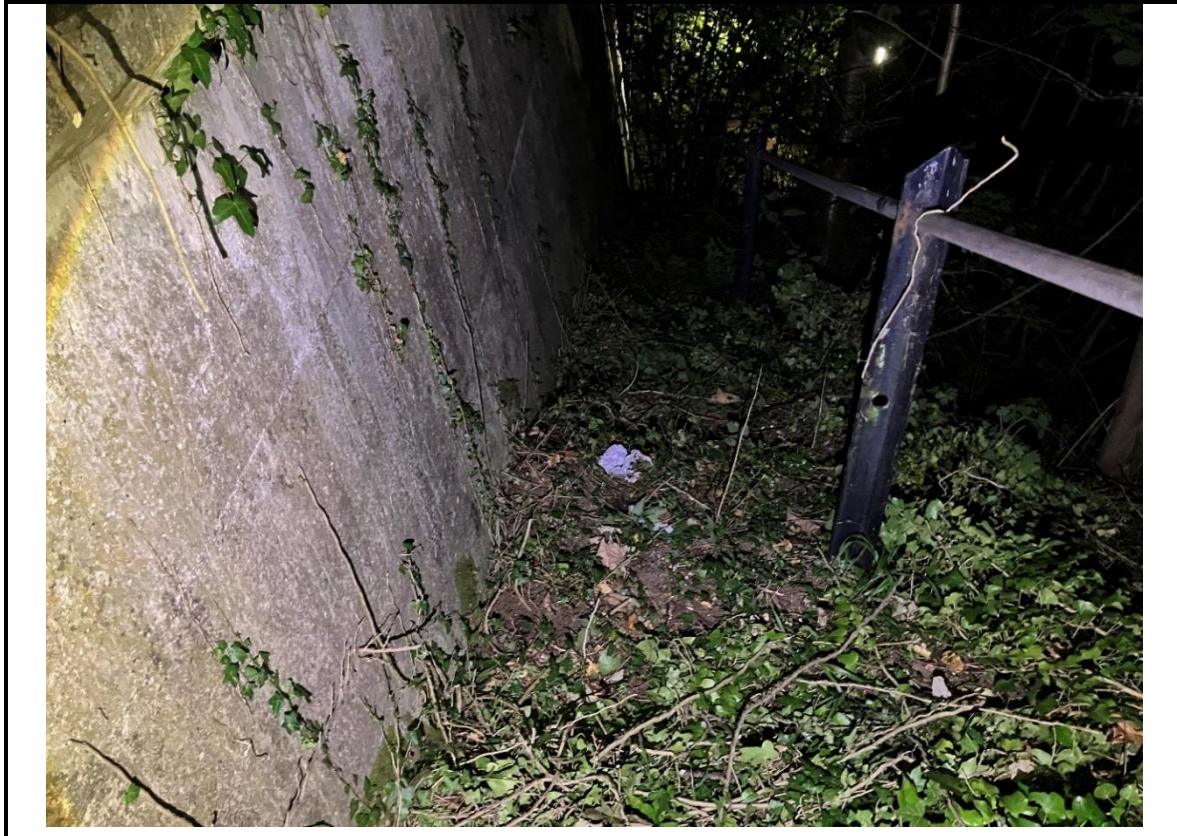
1717_P45_2024 Southwest wingwall - Leaching & vegetation growth

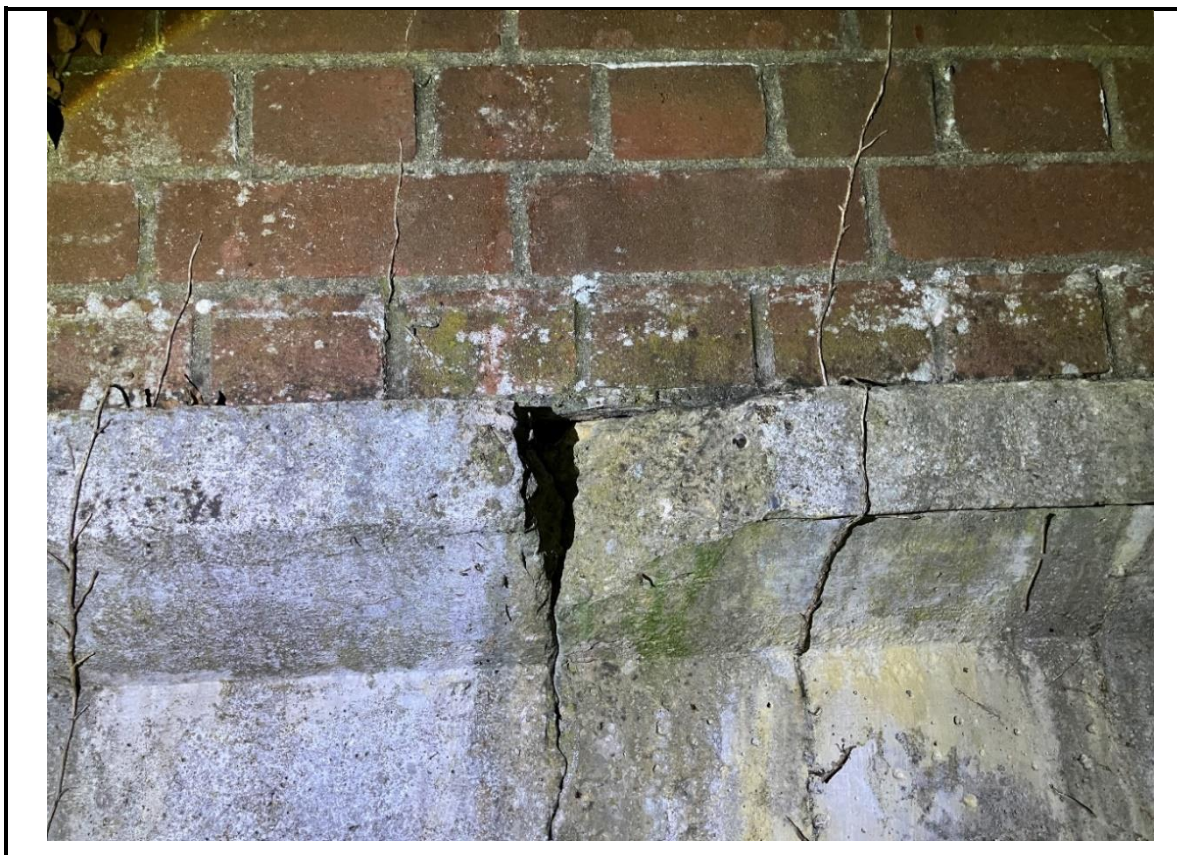
1717_P46_2024 Southwest wingwall - Concrete spalling & Vertical crack

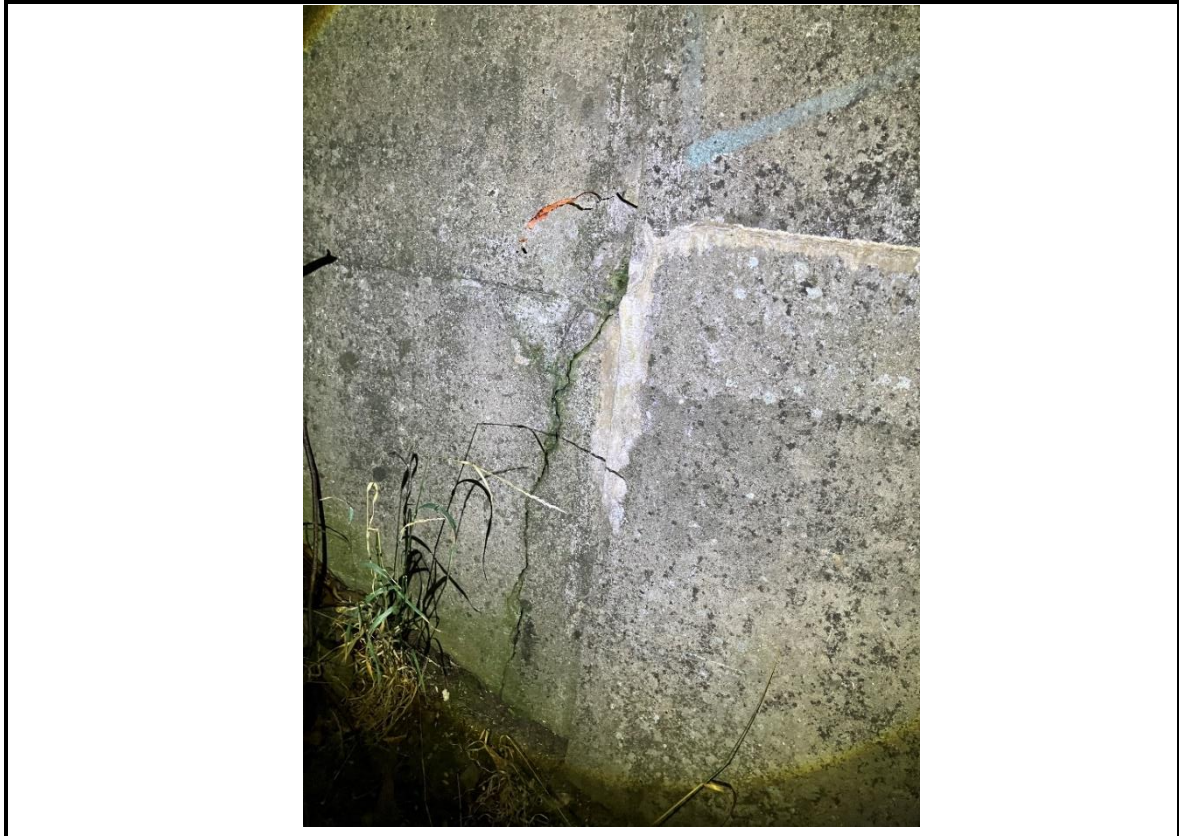
1717_P47_2024 Southwest wingwall/abutment - Concrete spalling & diagonal crack

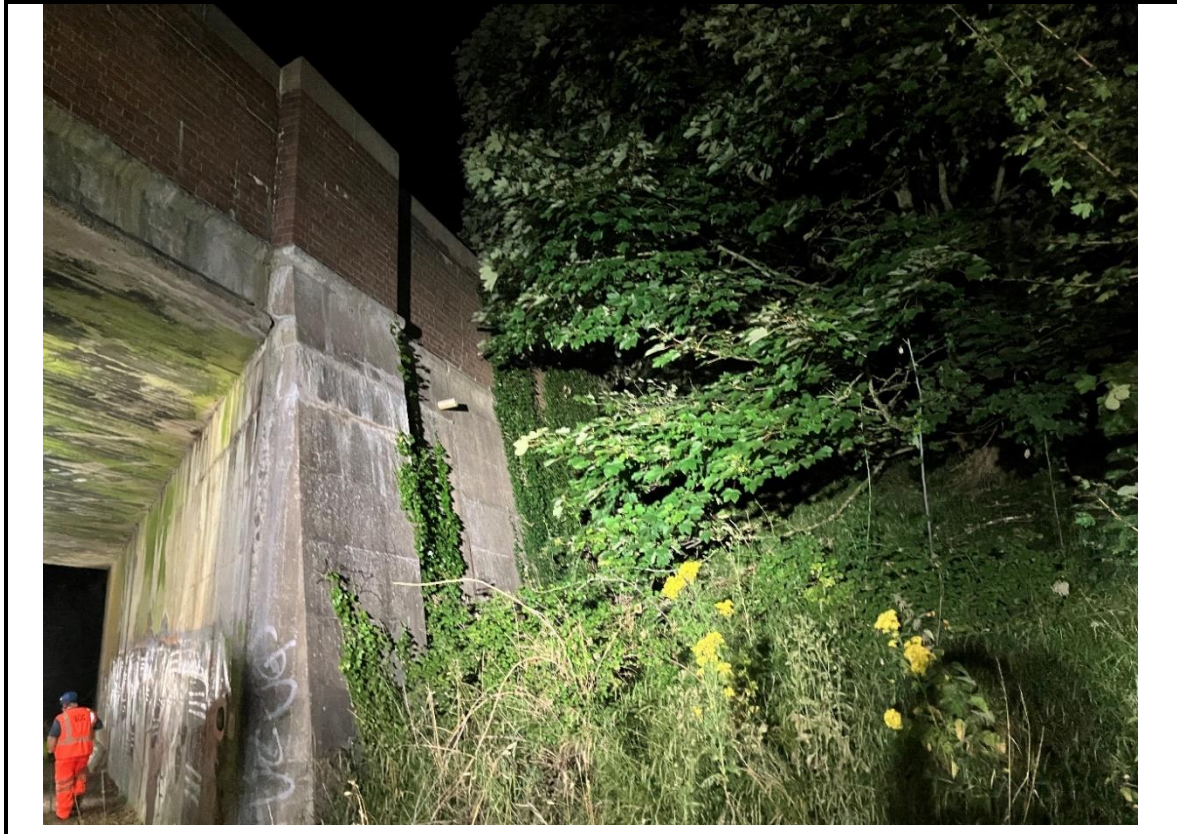
1717_P49_2024 Southeast wingwall – Saline leaching & vegetation growth

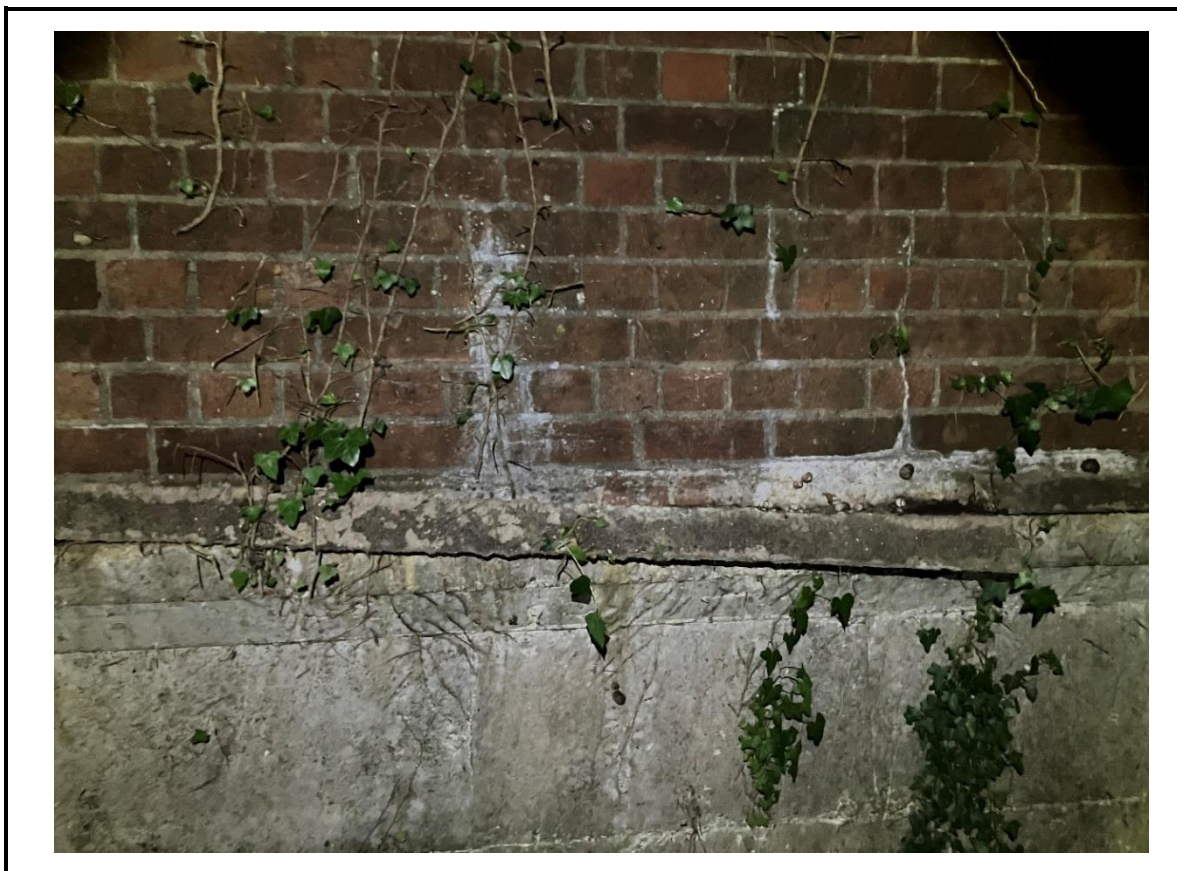
1717_P50_2024 Southeast wingwall - Mortar fillet peeling off

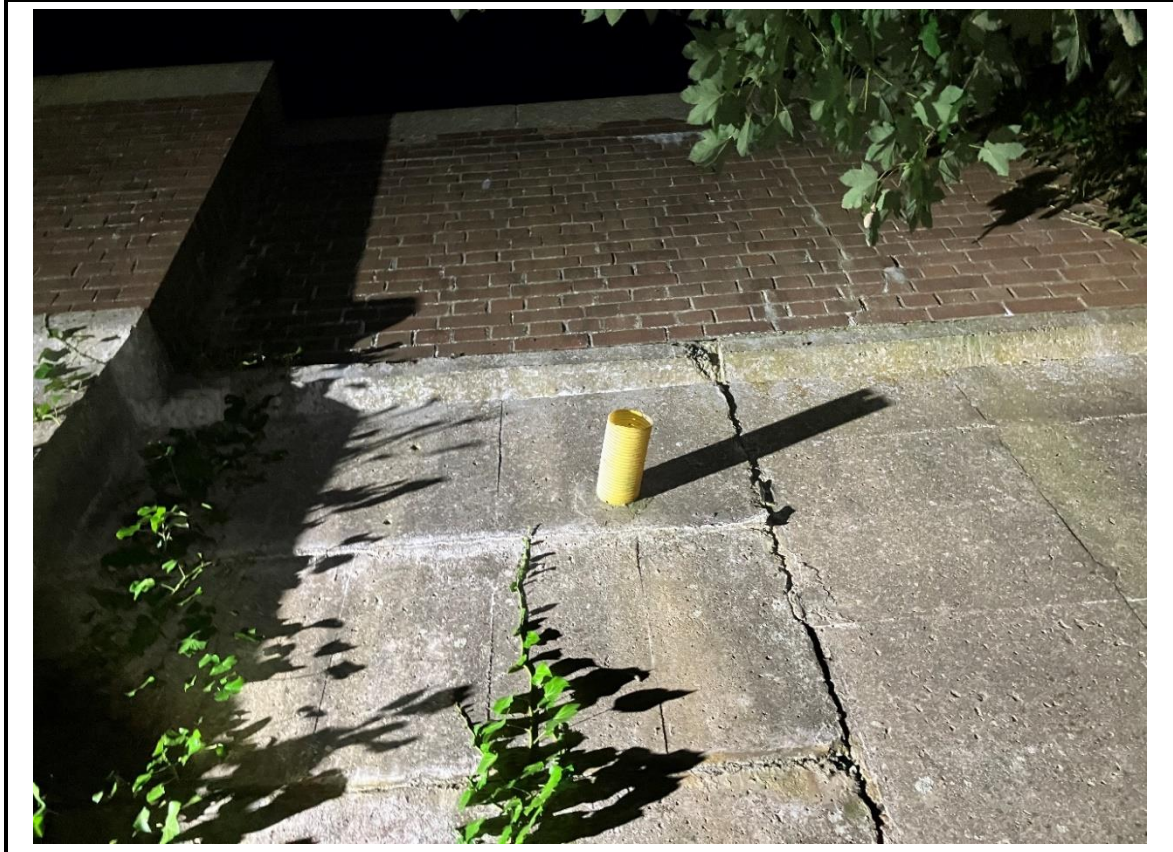
1717_P51_2024 Southeast wingwall - Vertical cracking (<3.5mm) & minor spalling

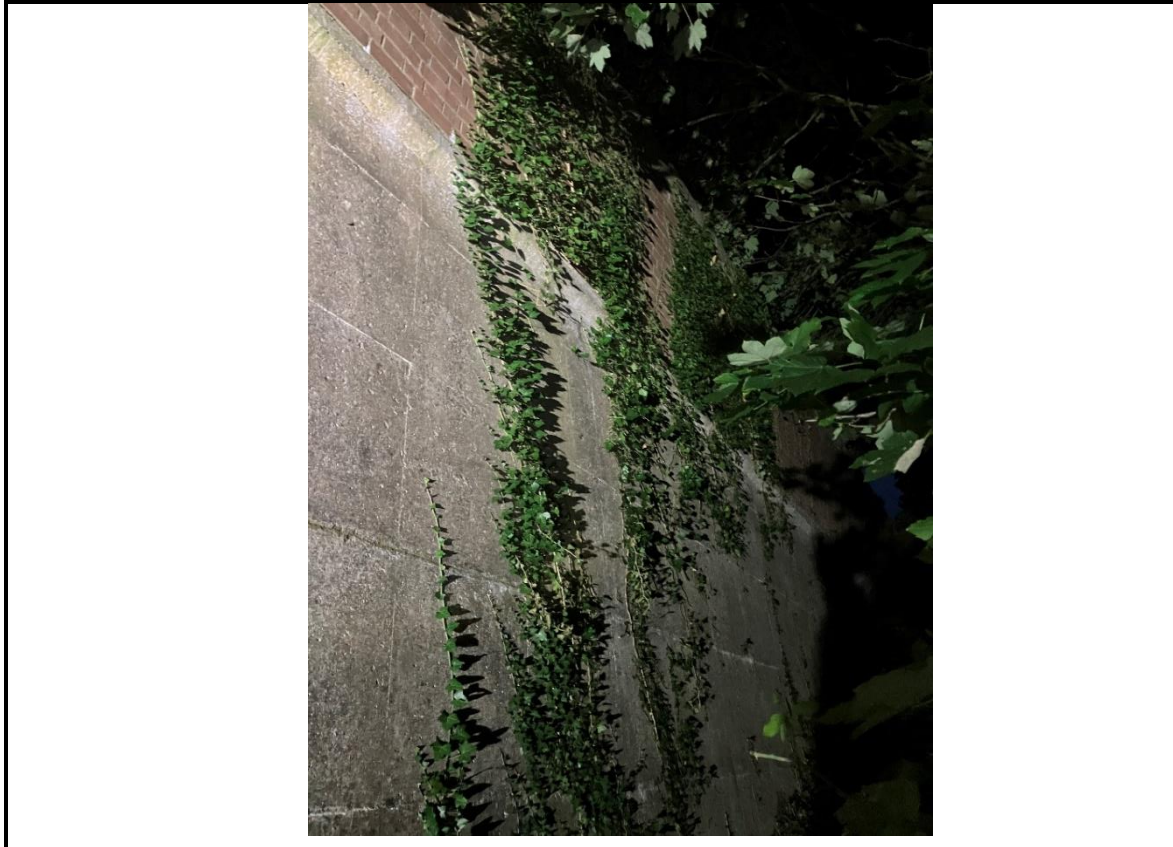
1717_P52_2024 Southeast wingwall - Vegetation growth

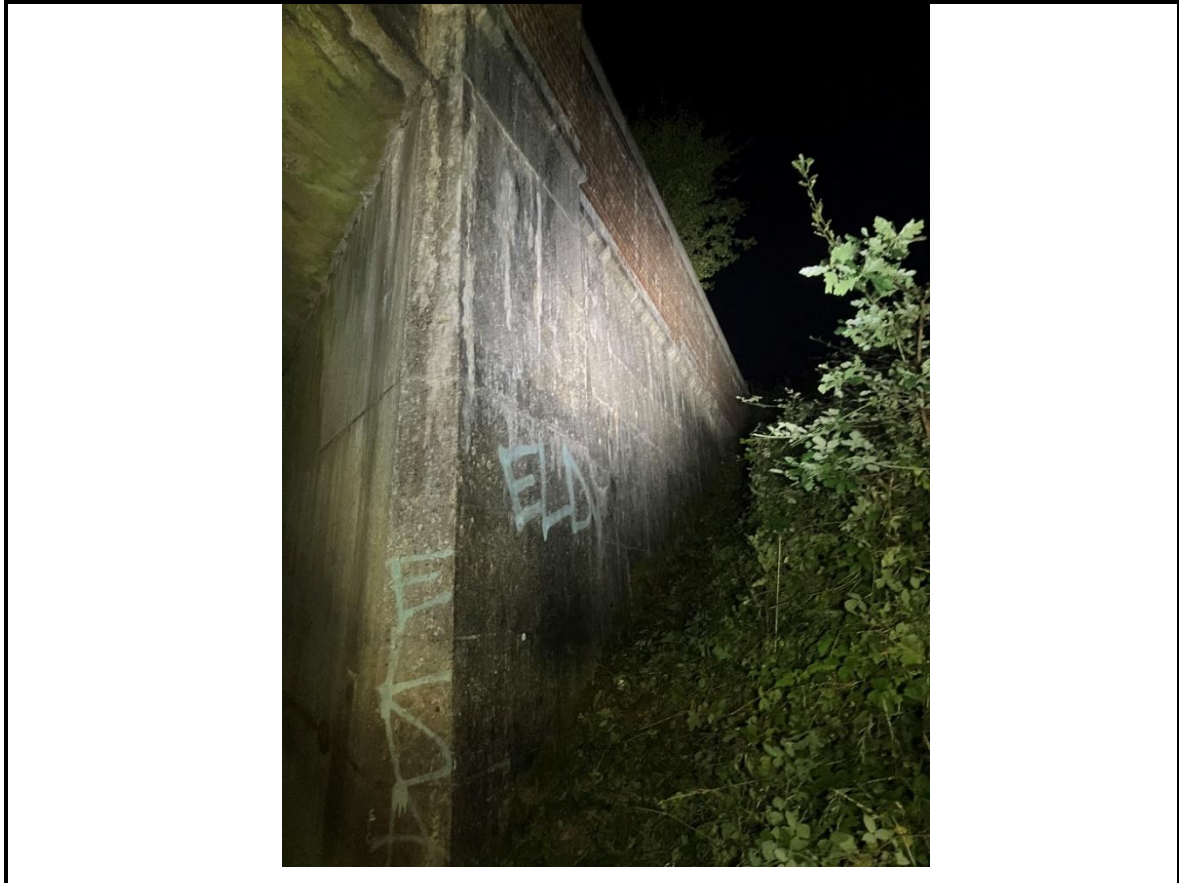
1717_P53_2024 Northwest wingwall – Saline leaching

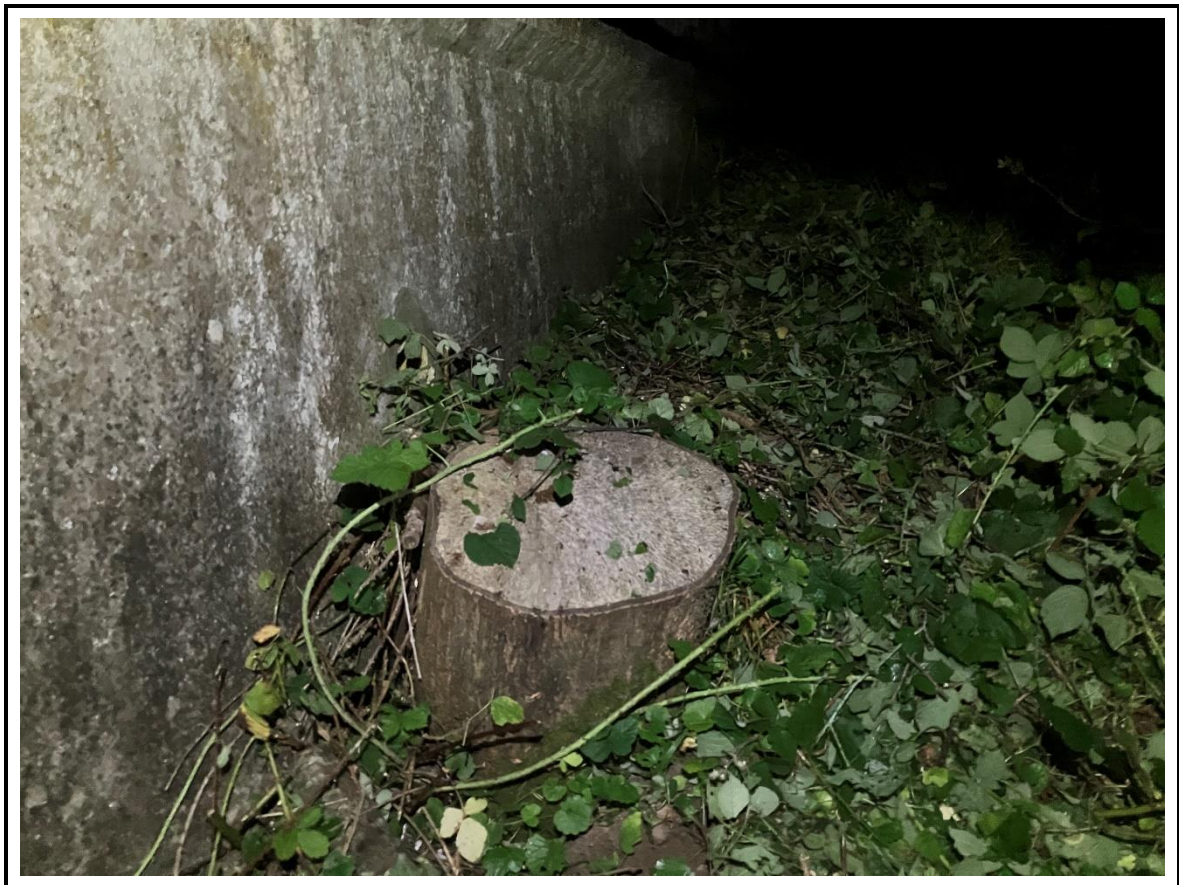
1717_P56_2024 Northwest wingwall - Vegetation growth
