Section 19 Flood and Water Management Act 2010
Wetheringsett-cum-Brockford Flood Investigation – Storm
Babet 2023

Name	Date
Report Author	John Jousiffe	
Responsible Officer:	John Jousiffe	
Checked by:	Ellie Beecroft	17/09/2024
RMA Review:		08/10/2024
Approved by:	Matt Hullis	08/11/2024
Date Published		11/11/2024
Date Report Closed

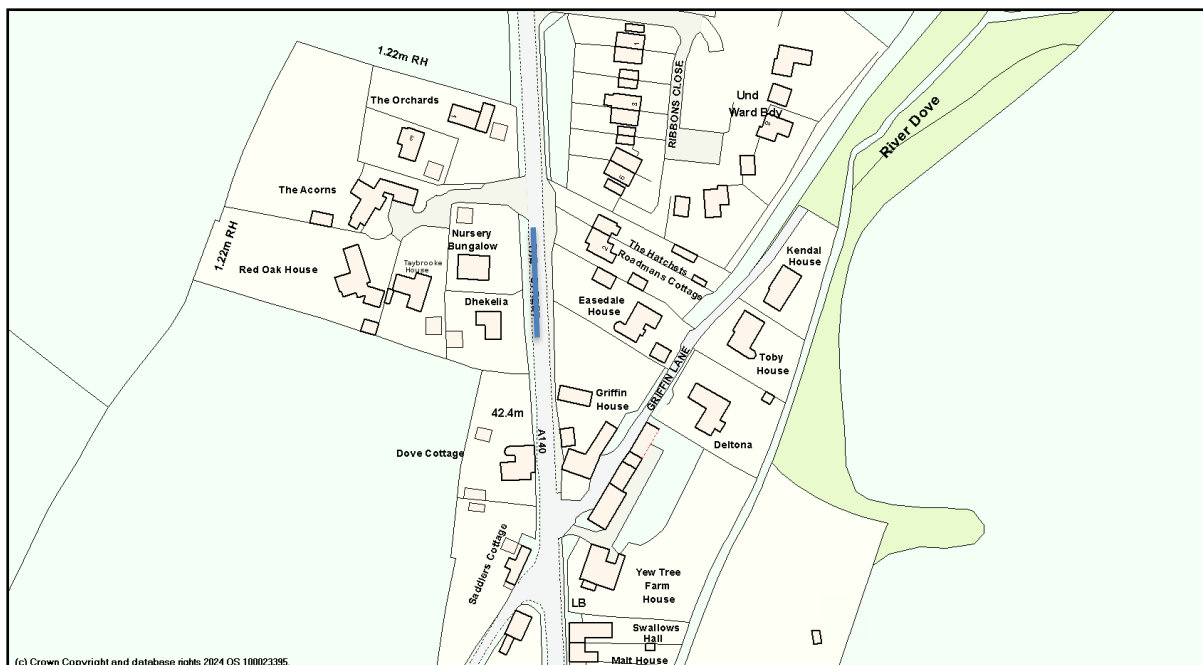
Figure 13 - Small section of watercourse on A140

There is a short section of open watercourse to the north of the main affected area, which borders the A140 to the west (see figure 13). This section of watercourse was reported to have been quickly overwhelmed and caused water to spill onto the highway where it flowed south towards the river. Following a site investigation, this section of watercourse appears to be piped to the north, but no continuation to the south was visible upon inspection. It is presumed that once the capacity was reached, the water

had no continuation route and consequently overflowed onto the highway before continuing down the road.

This watercourse appears to be a Suffolk County Council Highways asset, And following consultation with the Highways Authority, maintenance of the feature is planned to take place. There are several outfall pipes situated in the western bank of the watercourse, likely to be servicing the housing to the west by means of a surface water or sewage discharge points. Modern development standards are required to attenuate water on site and only discharge it at rates the same or lower than predevelopment and as such, it is unlikely that the new development on the western side of the highway was a significant contributing factor. Most Highways drainage assets in the area were shown to be working on the last inspection (July 2022), except one non-operational gully, which should be draining into this watercourse. It is unlikely however that this individual gully would have had any significant impact on the flooding event due to the rainfall experienced. The highway authority has maintenance planned for this short section of watercourse, but timescales are not confirmed.

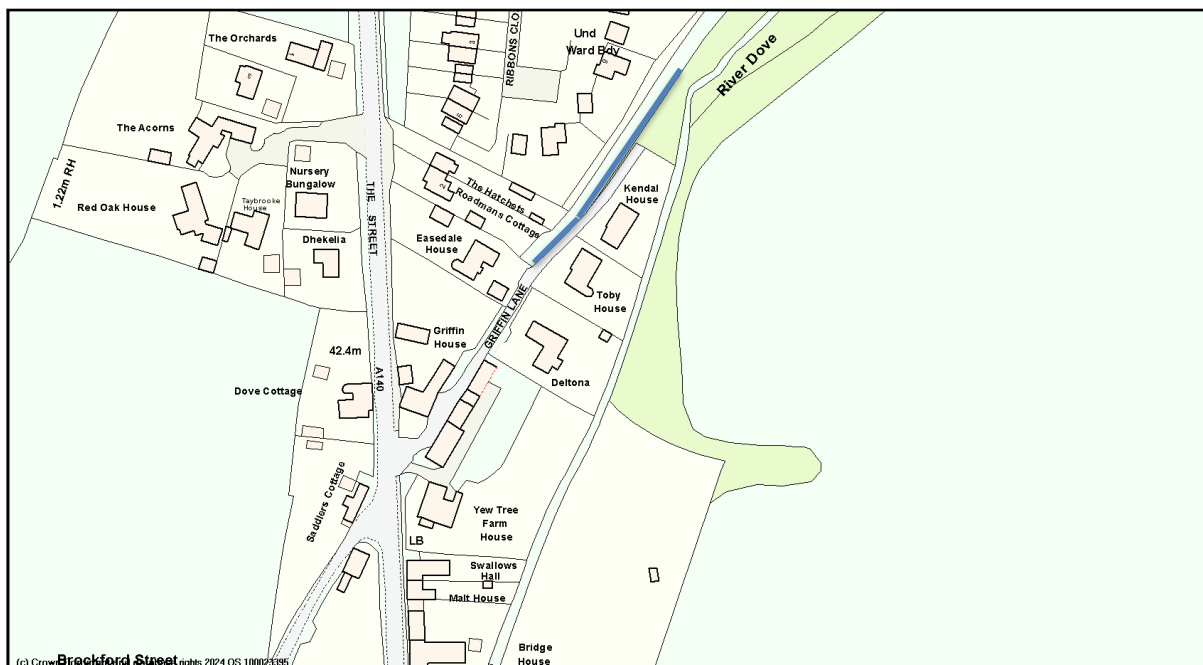
Figure 14 - Griffin Lane watercourse

Properties on Griffin Lane were reported to have been affected by the over topped river Dove, and another smaller watercourse running parallel. The river is located east of the properties and the watercourse is located west of the properties with Griffin Lane situated between the two features. Floodwater came from both sides, from the Dove

River to the east, and from the ordinary watercourse and A140 to the west, it travelled across griffin lane and into properties. The main flow of the water was heading southeast in order to rejoin the river.

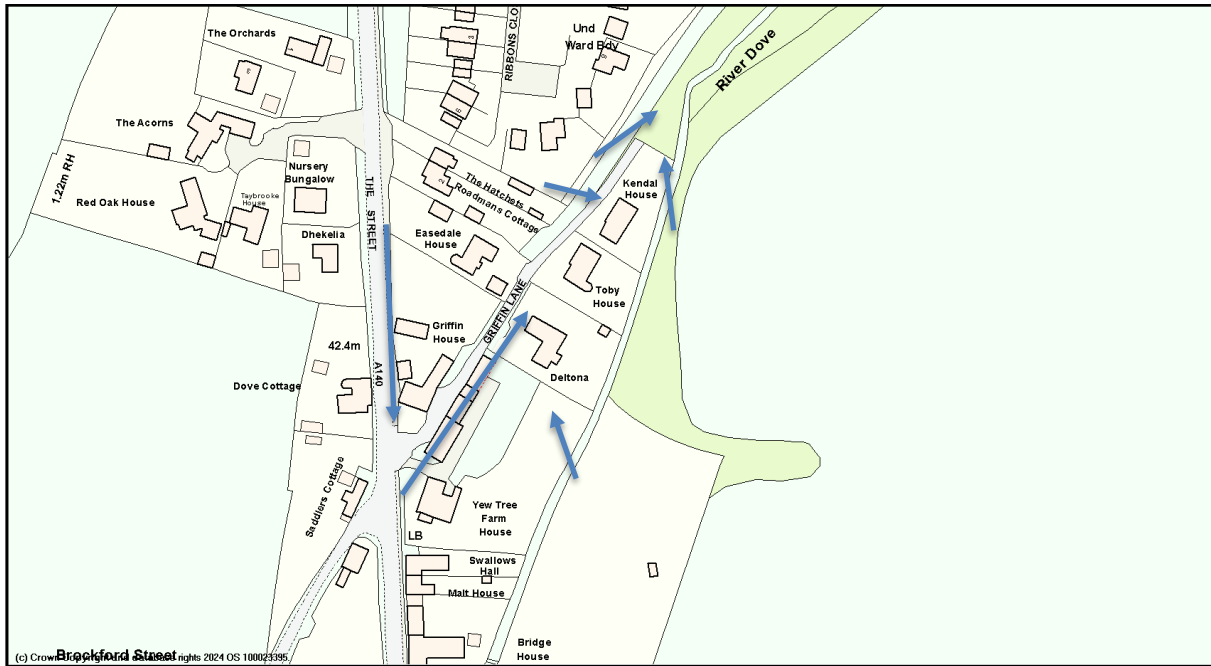
Figure 15 - Waterflow paths in north Brockford Street

Reports taken from community feedback is that there have been some tree felling activities further to the north which may have left debris in the Dove River, possibly causing an impedance to the flow of water. It is possible that this blockage caused the water to back up faster than is natural and as such, cause the river to overtop it banks earlier, although given the scale of the event, it is likely that the river would have overtopped anyway, although the impacts may have been less severe. Following consultation with the Environment Agency, they were made aware of the felling activity in June 2023 and larger branches were found to have been left in the river, however due to the location of the activity (distance from properties, gradient of the channel and capacity of the surrounding floodplain), it was evaluated as not to contribute to increased flood risk to Brockford Street and no further action was taken.

Clearance of debris from a watercourse or river is an activity that the riparian owner can undertake and the LLFA would encourage issues such as this to be reported to the relevant landowner who can then remove obvious debris and blockages as part of their riparian maintenance duties.

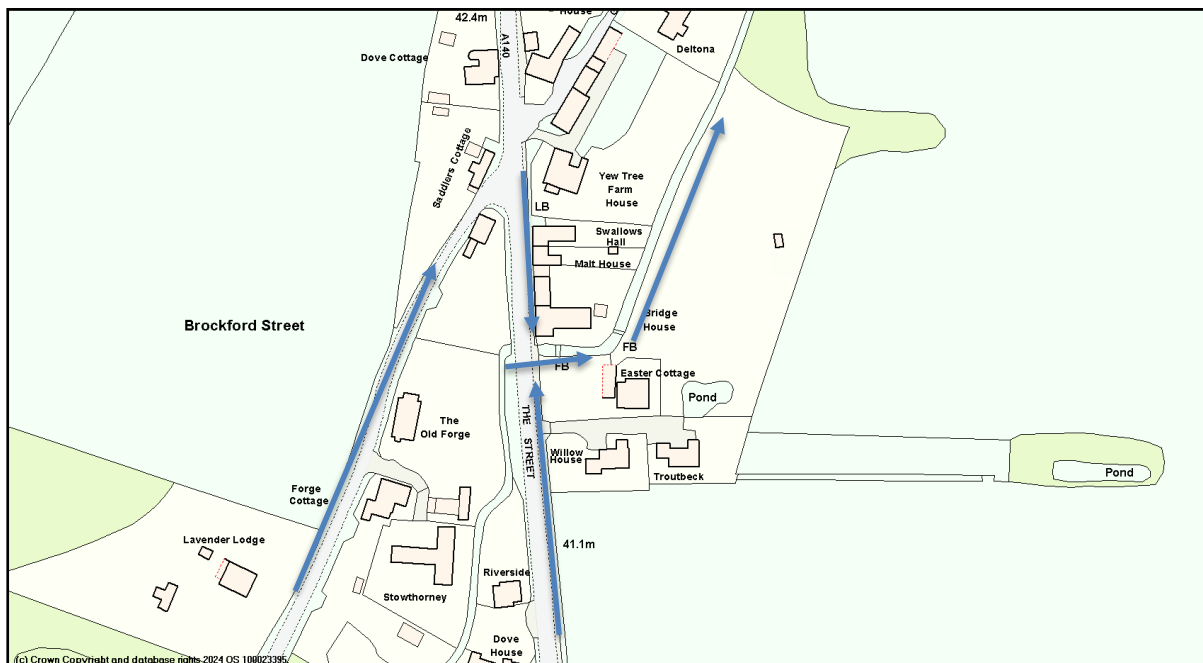
Figure 16 - Waterflow paths in south Brockford Street

Immediately south of the junction with Griffin Lane, there is a small bridge which allows the river Dove to pass underneath the A140. Reports from the community suggest the capacity of the bridge crossing was not of sufficient size to allow the volume of water to pass underneath and during the event, this resulted in a significant portion of the water flowing out of the channel upstream and by the bridge abutments. This water flooded onto the road and surrounding properties on the west side of the A140.

Consultation with the Suffolk Highways have confirmed that the structure is a single span masonry arch structure with a width of 2.7m and is believed to have been constructed circa 1881. Confirmation that the bridge was the main restriction in this area is not possible to quantify and instead is likely to be a combination of factors. Whilst the bridge can cater for the vast majority of flow conditions in the river, there will be instances during extreme events when water flow is greater than capacity, which might lead to a restriction in flow in the river at the bridge. The bridge is one of the lower lying points in this area and is therefore susceptible to breaches if water volumes and/or blockages impede the flow of water. The bridge is subject to biennial inspections, the last one being undertaken in May 2024, at which there was no blockage.

Further reports have suggested that recent works on the bank close to the bridge need some repair, with rocks from the Gabion Baskets spilling out and further reducing the capacity under and close to the bridge. However, recent inspections by the structures team from the Highway Authority, suggest that the gabions are in good condition and it was noted that some material was laid in the bed of the river as part of these works for scour protection. It is possible that the rocks noted by the residents were part of this scour protection and as such are unlikely to have a significant impact on capacity.

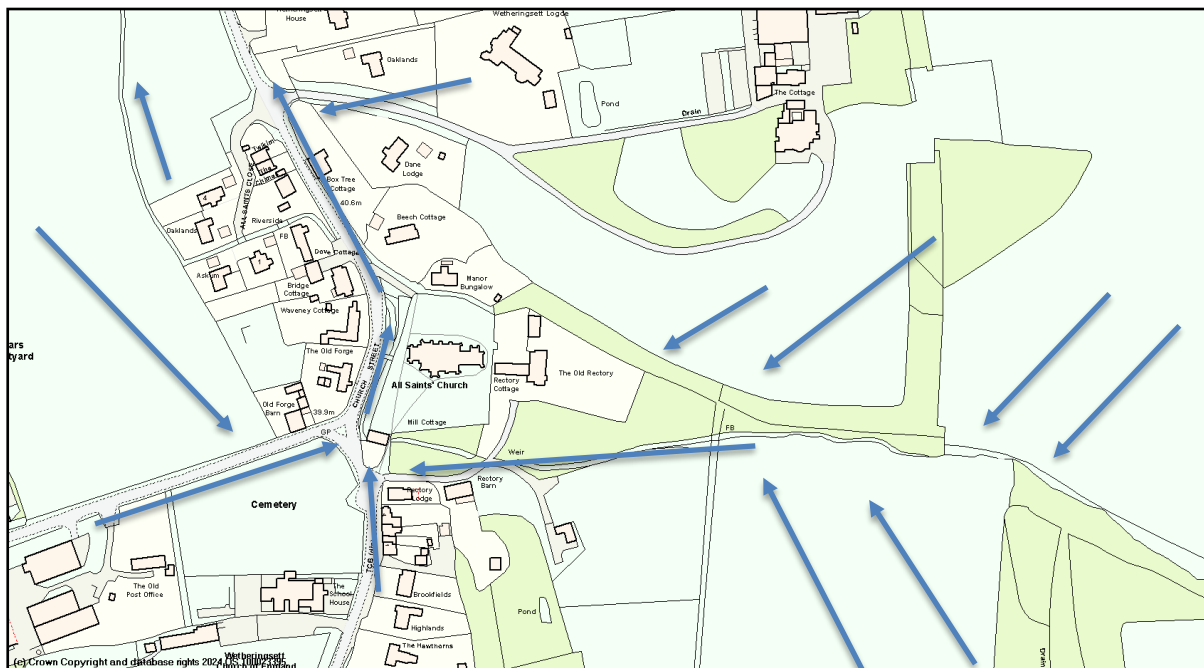
Figure 18 - Flow path map in Wetheringsett

Starting from the eastern edge of the village, there is a very large rural catchment, where significant levels of surface water runoff were observed during the event. Due to saturated ground conditions and generally low permeability of soils, significant surface water runoff travelled towards the watercourse which enters the village from the east. This area was one of the first affected as the watercourse was very quickly overwhelmed, with water levels rising rapidly, exacerbated by a series of constrictions in the network.

The watercourse which travels into the village from the east, is of sufficient size and can accommodate substantial flood flows. However, as it enters the residential areas in Wetheringsett, its capacity is reduced, with shallower banks and a number of constrictions, including a weir, two small brick arch bridges, a culvert passing under the old mill, followed by an engineered turn through nearly 90°, turning the watercourse north where it meets the highway. The sharp changes in direction of the channel and small capacity structures were observed to have exacerbated localised flooding.

Reports from the community suggest that the watercourse in this area overtopped early on during the event. At the points where the waterflow met a restriction, the water was observed to force its way around or over the top of the constrictions, adding to flood water on the highway and in surrounding properties. Additionally, reports from the north of the village suggest some sections of the watercourse as it leaves the village, require some maintenance to ensure a suitable flow. It is possible that unmaintained watercourses may have reduced capacity within the channel, impeding the flow of water through the village during the event.

The central part of the village has a junction, serving 3 routes from the south, west and north. The southern and western access roads have a significant gradient which caused surface water to travel across the highway at high speed. Reports from the event described a torrent of water coming down both sections of the highway with the extents of the flooding reaching several meters up the road from the watercourse in both directions. There is a watercourse on the eastern side of the highway on the

southern road (Hockey Hill) which manages the water flows until it reaches the culvert at the entrance to the primary school where, once capacity is reached, it overtops into the highway. To the north, the road has a small increase in height before flattening out, so while little water was being added to the flood from this direction, the small rise in the highway was causing the water to attenuate in the low spot in the centre of the village.

- Increase maintenance of the watercourse throughout the village to ensure a good flow is always possible.
- Look into possible natural flood management features to the east of the catchment to capture water upstream and reduce the intensity of the water getting to the village.
- Carry out repairs to highways drainage infrastructure to allow for water movement to nearby watercourses unimpeded.
- Ensure the completion of highway drainage asset cyclic maintenance.
- Community to consider uptake of Suffolk Highways Community Self-Help Scheme to deploy flood warning signs.

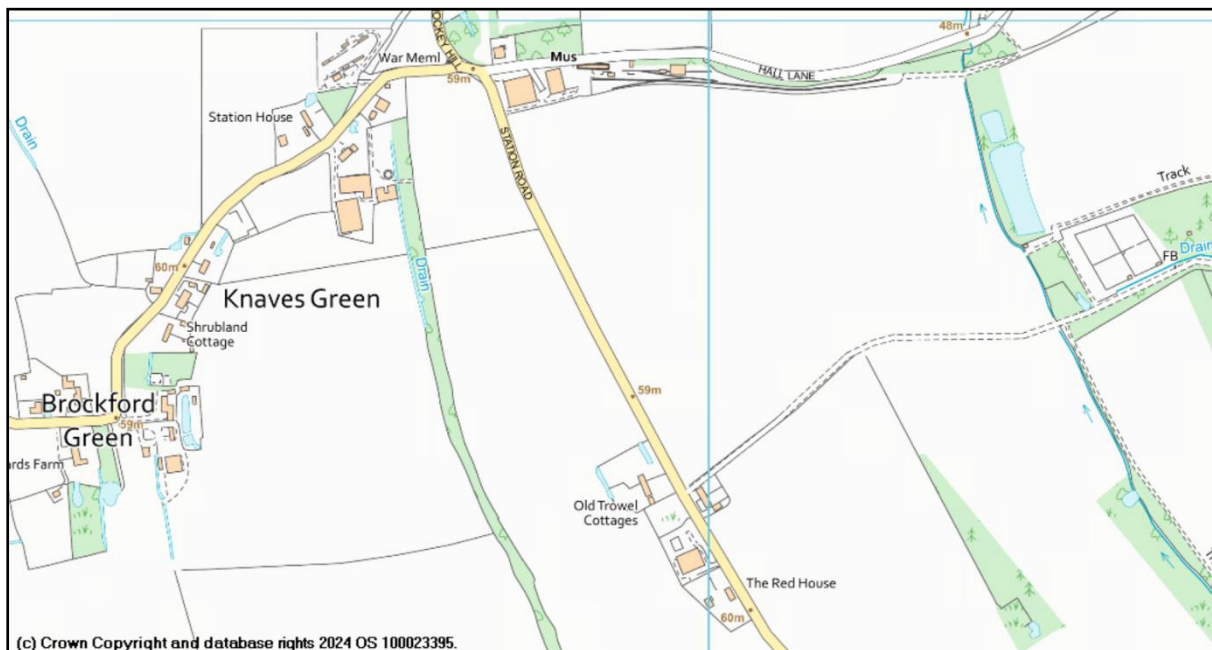
Figure 19 - Map of station road

The flooding at Station Road was different to the other locations, instead being an isolated incident in which surface runoff came from the surrounding fields, and flooded a single property located in a dip in the road. The event caused the shared septic tank to flood and overflow into the garden. Reports suggest the watercourses in the nearby fields may not have been maintained possibly exacerbating the event.

Reports from the community suggest maintenance of these watercourses has since been undertaken and the flooding issue has not reoccurred.

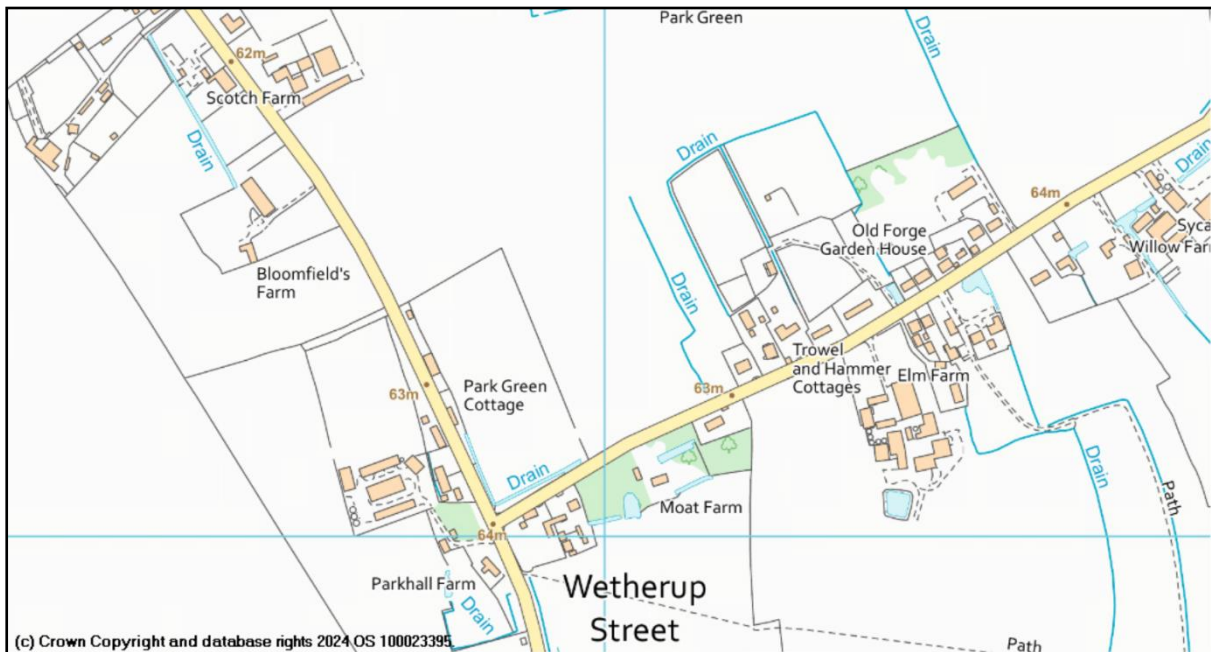
Figure 20 - Map of Park Green and Wetherup Street

Reports from the community in Park Green suggested high levels of surface water overwhelmed the drainage systems and surface water ingress into homes was a combination of runoff from both the highway and surrounding fields as saturated ground could not cope with the volume of rainfall.

Reports from Wetherup Street suggested similar issues with the addition of watercourses and ponds also overflowing. The area contains no mains drainage and agricultural land around the affected properties was already saturated, resulting in watercourses flooding and the village pond, located to the west of the affected properties, being unable to cope with the volume of water. Due to the prolonged precipitation event, flood water began to pool in the isolated dips and flood water ingress was through the floorboards of the affected properties.

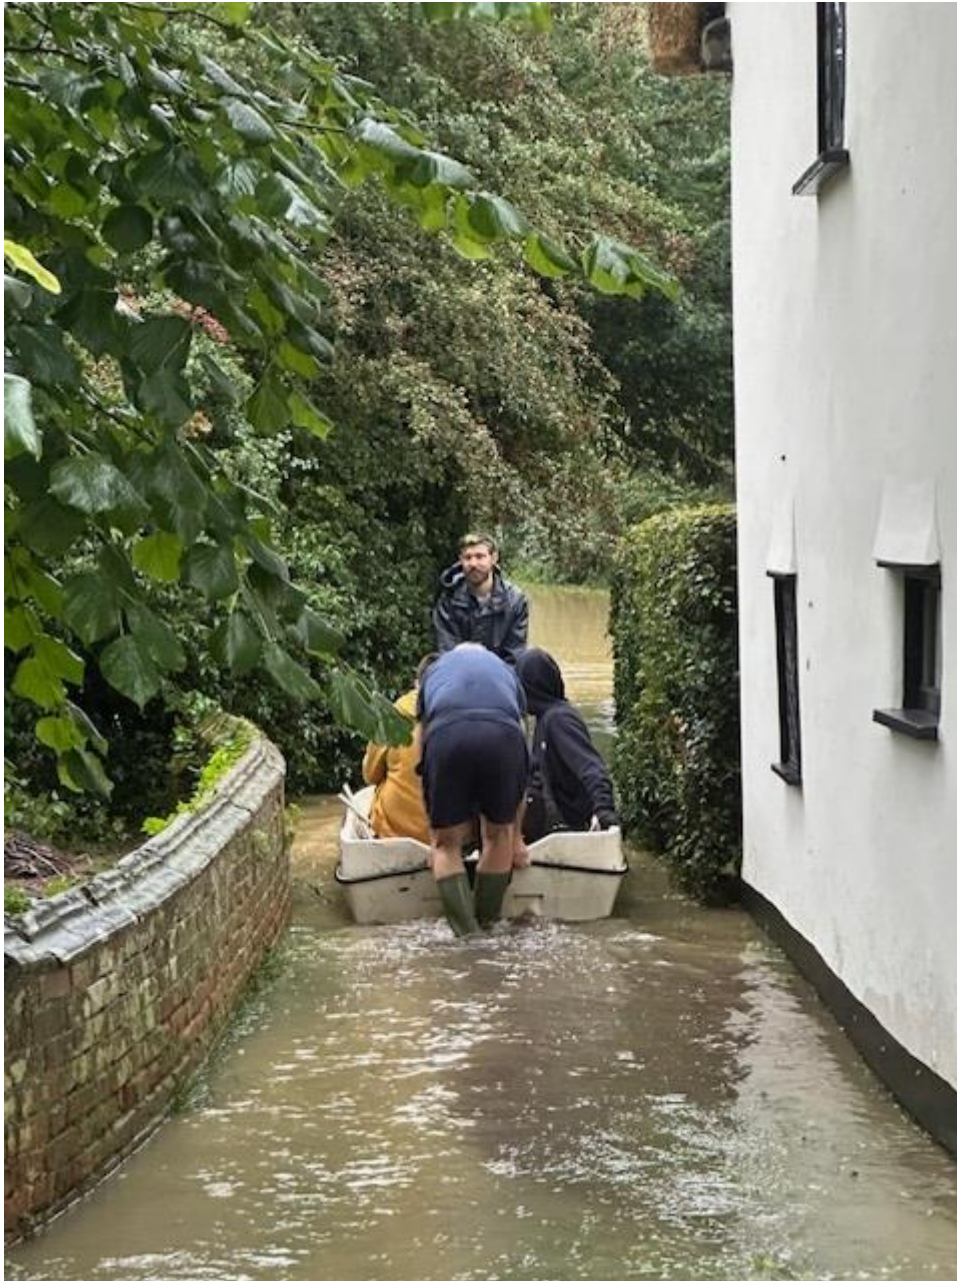
Flooding close to the church in Wetheringsett

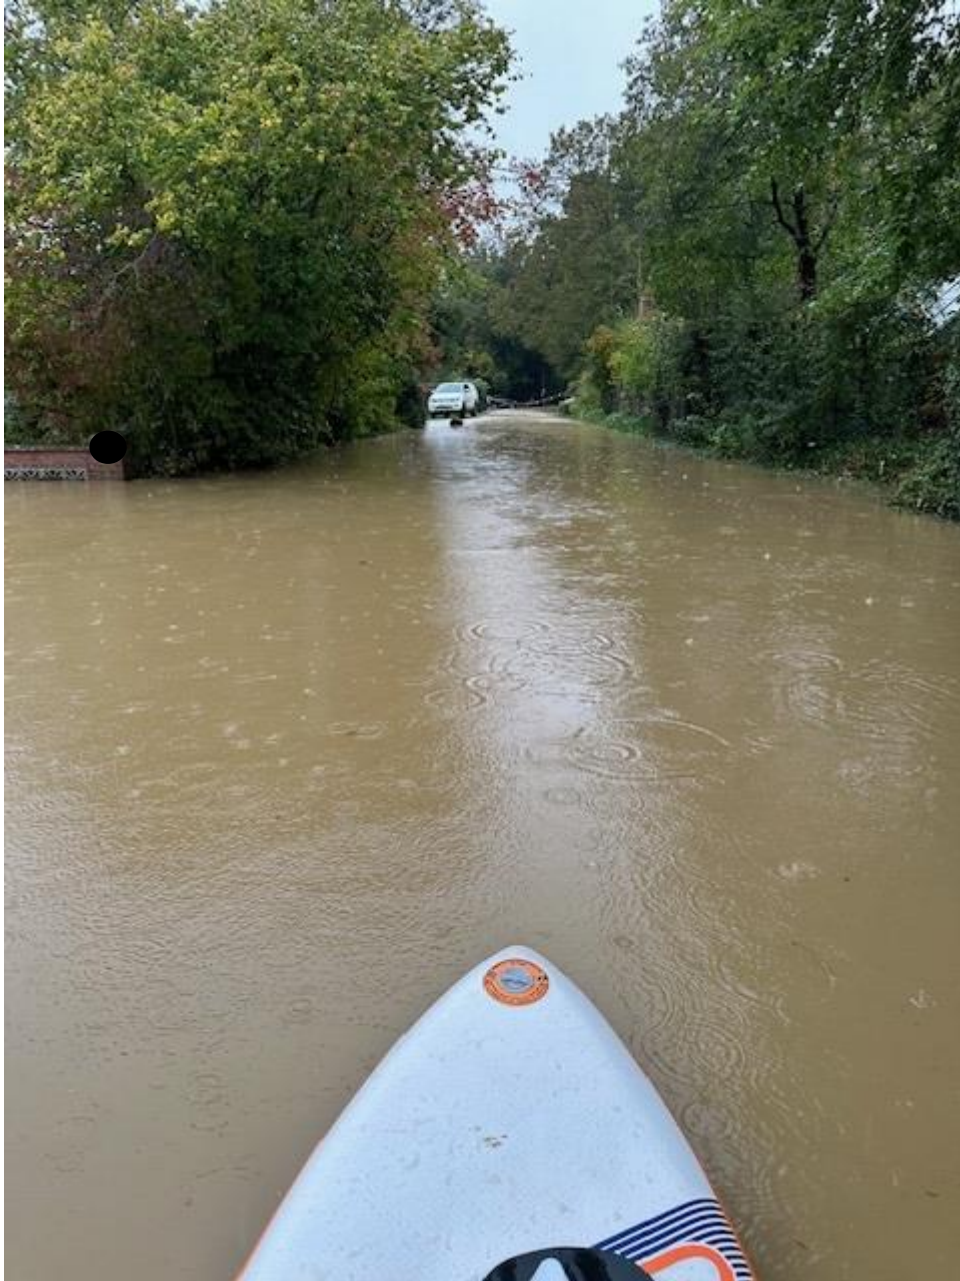
View of Church Street during the event

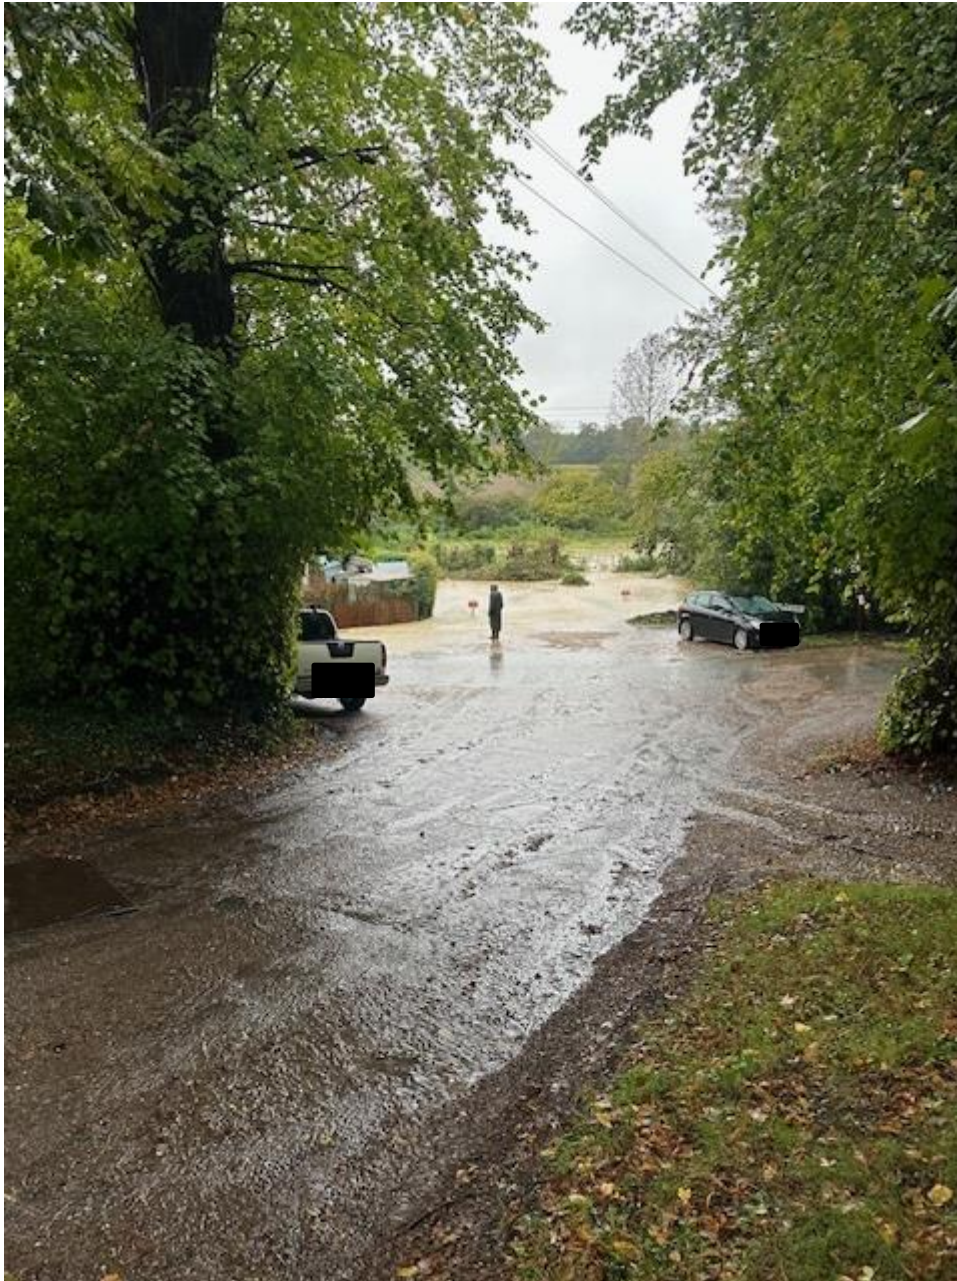
View down Manor Drive during the event
