## Executive Summary

## Justification for Investigation

# Understanding the flood context

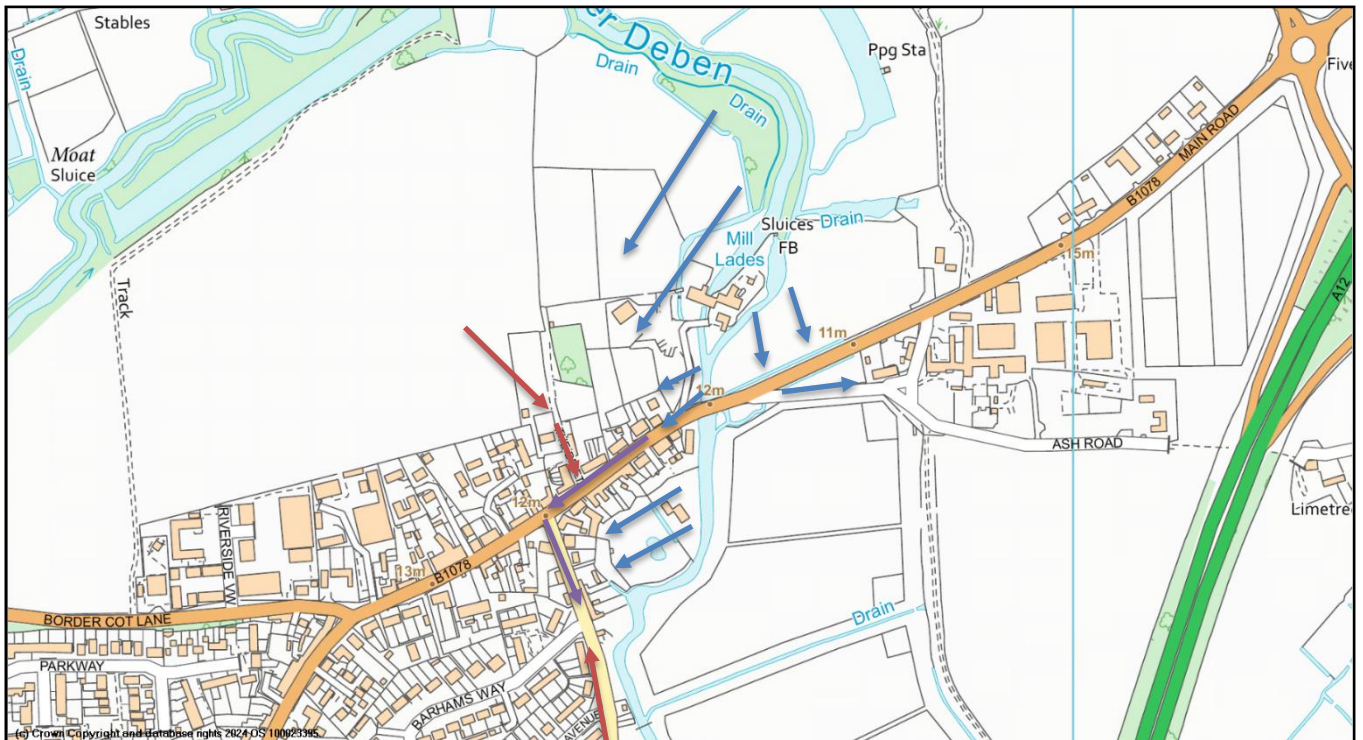
Figure 7 - Event flow paths (north)

The map below shows the main flow routes of the flood water in this area. It is important to note that following a site visit from the EA after the event, a significant build-up of silt in the main channel of the river has been identified adjacent to the B1078 road bridge over the River Deben. Investigations between Suffolk Highways

Flood water from the overtopped river channel.
-

Flood water from the surrounding field runoff. (flow path to the south of the map was originating from the fields to the south).
-

Combined flood water.

- Flood water from the Deben overtopping, flowed down High Street, Spring Lane and across Rackham's and Deben Mills estates. Some flows were not in line with currently predicted flood risk.
- Highway drainage gullies became overwhelmed due to significant rainfall and water from overtopped river.
- Anglian Water assets were overwhelmed due to significant water volumes entering the system predominantly from the overtopped river Deben.
- Significant silt build up in the river Deben to the north and south of the main road bridge may have reduced capacity in the channel.
- Surface water flow paths from the north and south exacerbated the severity of the event.
- Possible attenuation opportunity on the fields to the south.

- EA and SCC to investigate possibility of removing silt build up near main road bridge
- Investigate the possibility of Natural Flood Management (NFM) in the fields to the north-west and south-west to try and prevent these secondary flow paths from having such an impact.
- Anglian water to investigate the capacity of the pumping station in the area to ensure it is of adequate size.
- SCC highways to investigate the possibility of increasing the capacity of the drainage network in the area

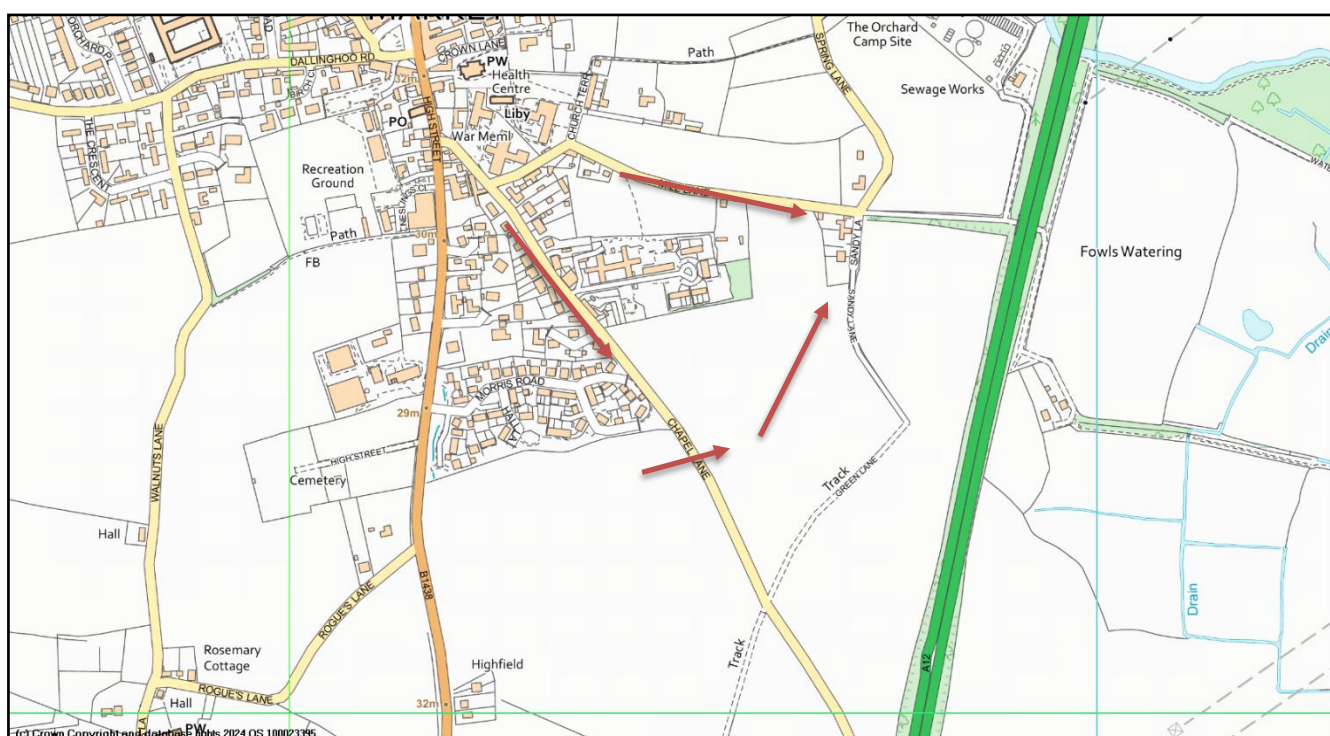
Figure 8 - Event flow paths (east)

- Mill Lane is a high risk area for surface water flooding and the sheer volume of water from rainfall is likely to be the main cause of the flooding in this area.
- Possible ordinary watercourse maintenance in the area will allow a better flow path for the water to escape.
- Possible natural flood management opportunity which may reduce flood risk in this area.

- Ensure correct maintenance of the watercourses in the area are regularly carried out and any issues/obvious blockages are highlighted to the relevant RMA/landowner/Parish as soon as possible.
- Investigate the possibility of NFM in field to the south of the area affected.

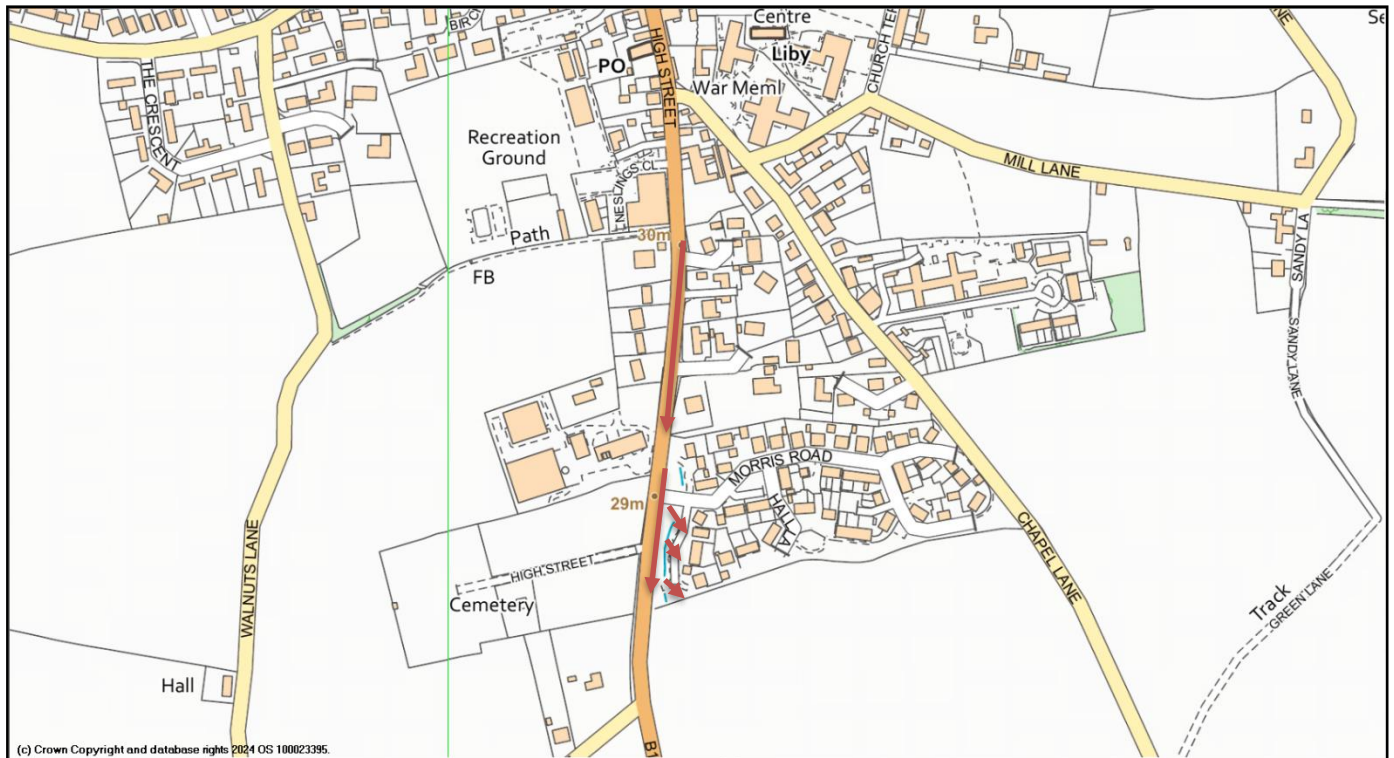
Figure 9 - Event flow paths (south)

- Significant rainfall resulted in high levels of surface water runoff, possibly exacerbated by a lack of effectively working highways drainage assets and poorly maintained watercourse preventing onward flow.

- SCC Highways to investigate area where significant number of drain gullies are blocked and try to get these working effectively again.
- As a result of the new development under construction to the south, a new footway is being put in place which due to the raised curb may channel the water into the new sites SuDS features which could make an improvement in future events.

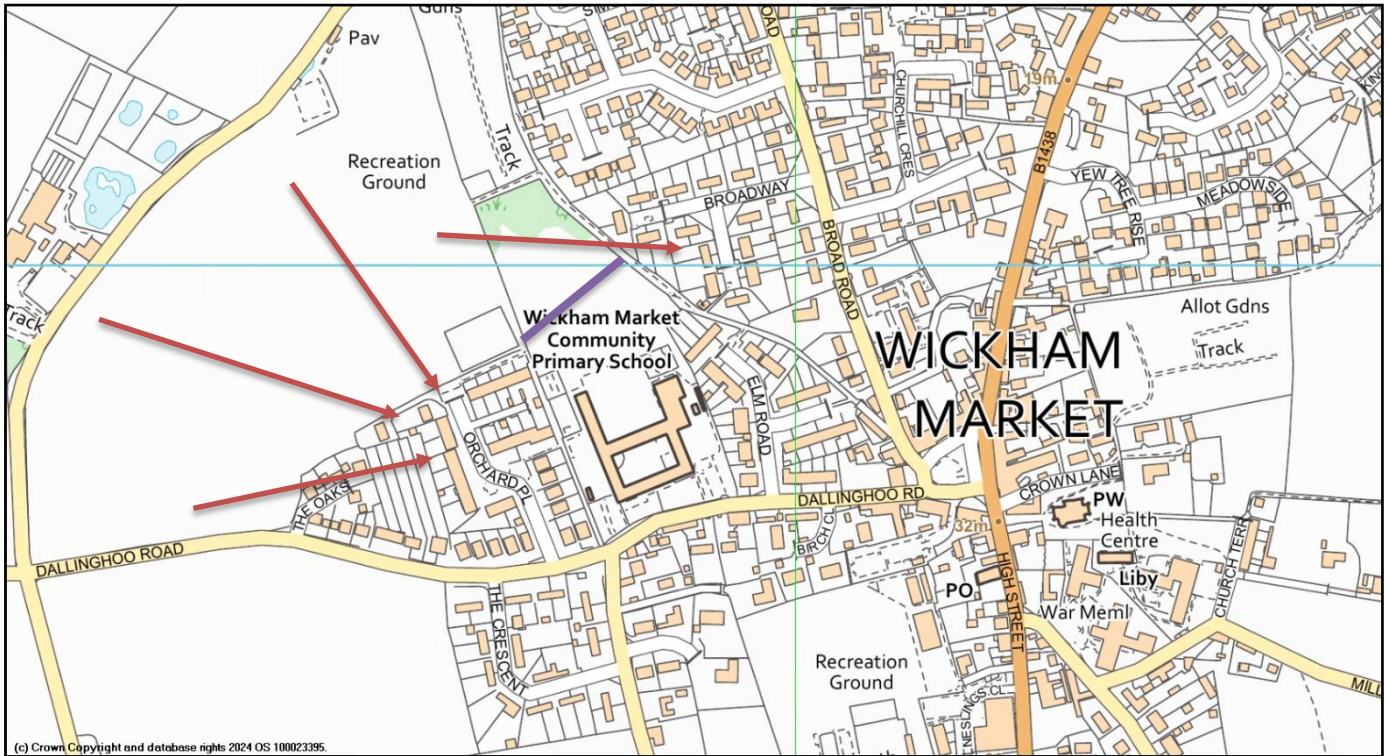
Figure 10 - Event flow paths (west)

Indicates rough alignment of unknown piped section

- Significant rainfall resulted in large volumes of surface water runoff from the fields to the west.
- Highway infrastructure became overwhelmed causing the flood water to flow to the lowest points and pool.
- Lack of maintenance and possible issues with underground pipework to the north of Orchard Place may have impeded the flow of water away from the area.
- Highways gullies were inspected and found to be working correctly in February of 2023, but reactive work took place on the day of the event in specific areas.

- SCC/Landowner/Parish to investigate ownership of the pipe work north of Orchard Place and confirm maintenance is carried out, to ensure its flow is maintained. CCTV of pipe may be required to ensure pipe is still in working order and to try and discover possible cause of water bubbling up.
- SCC highways to ensure regular maintenance is carried out in line with gully cleansing regime.
- Primary school to ensure gullies in the playground are regularly cleaned and maintained. CCTV inspection may be required to confirm pipes are still in working order.

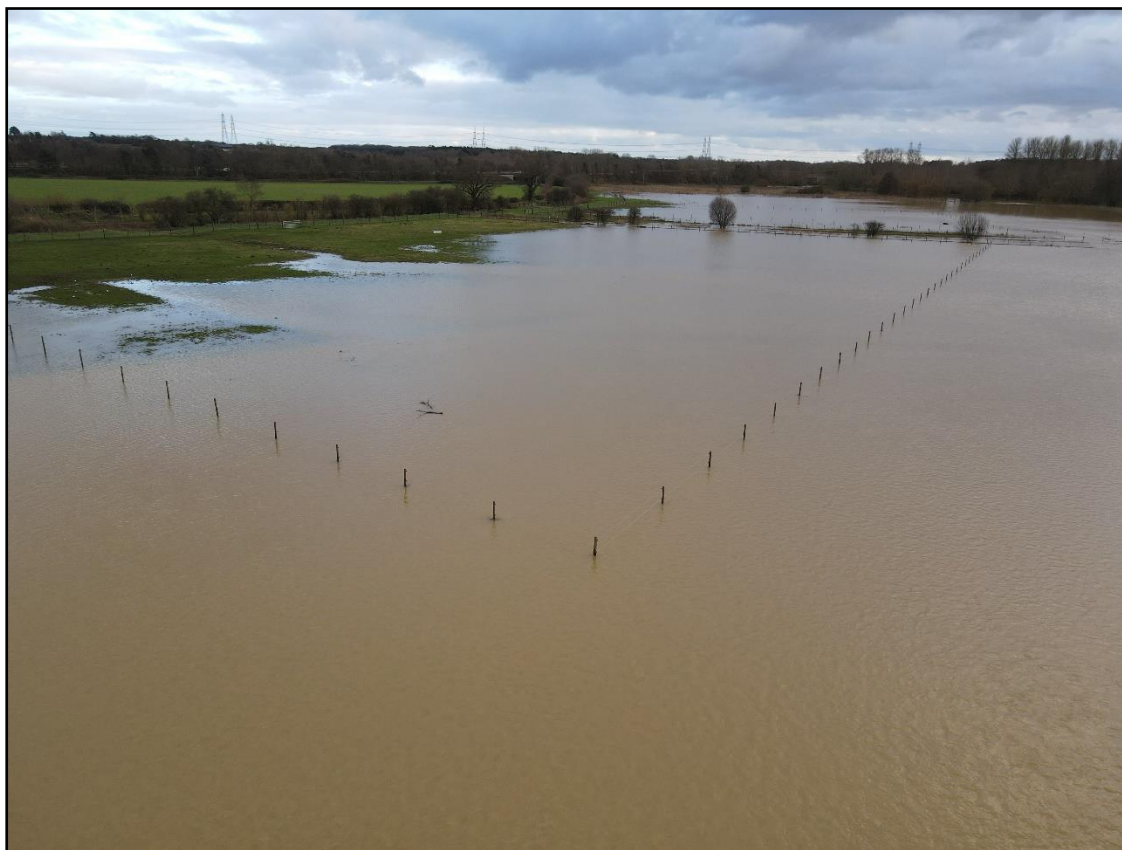
*Image 1 - Flooding to pastureland in north Wickham Market*

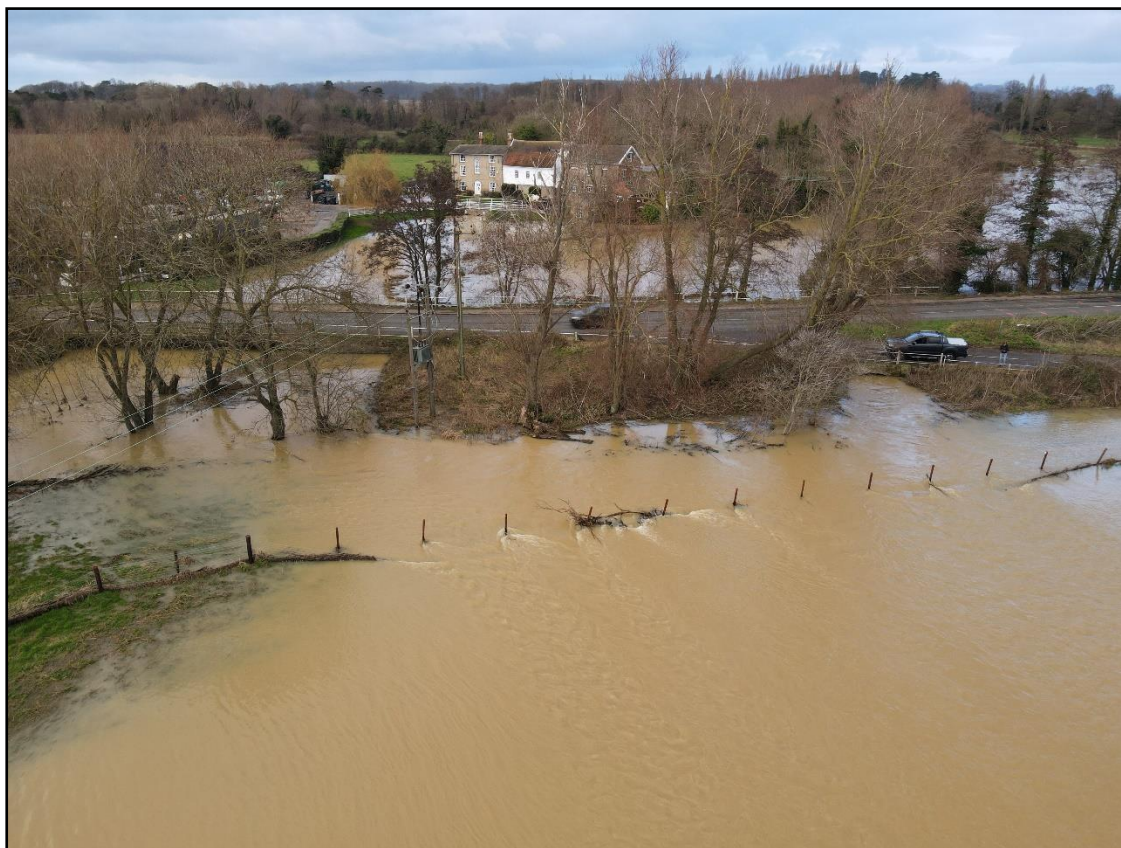
*Image 2 - Wickham Market bridge*

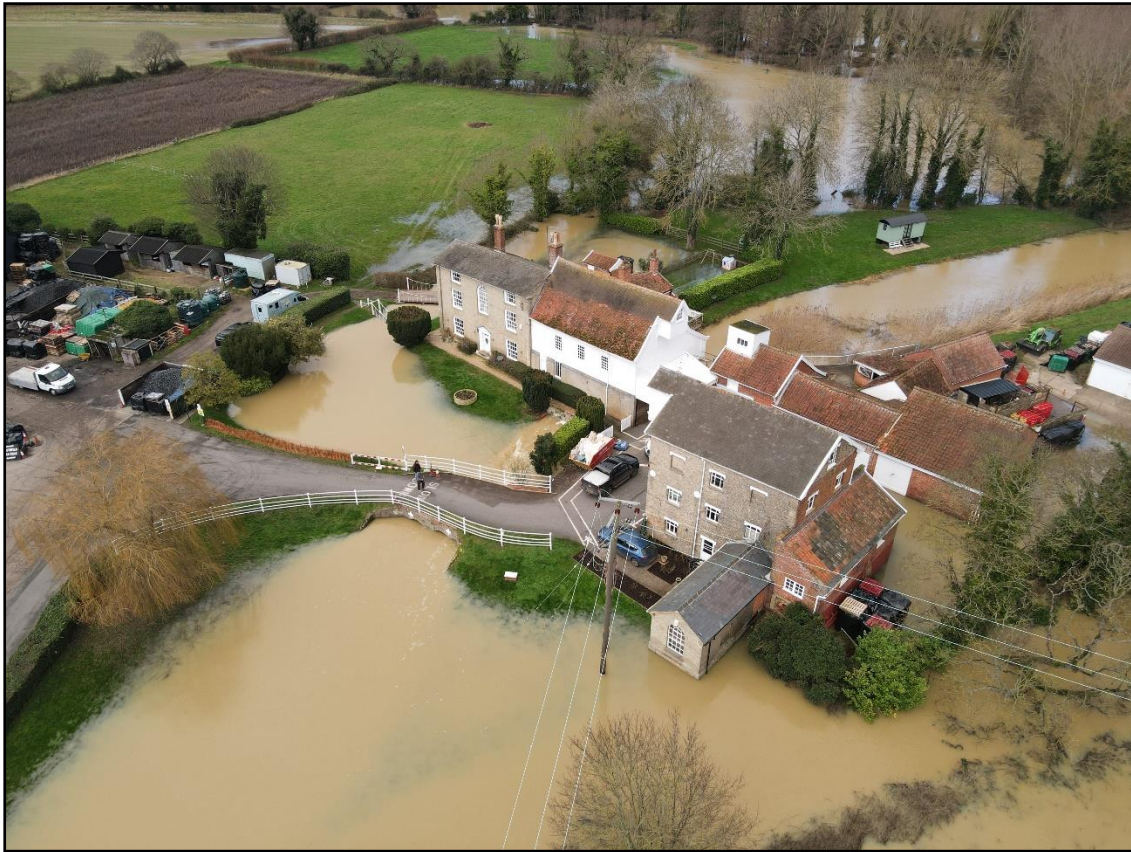
*Image 3 - Deben Mills*

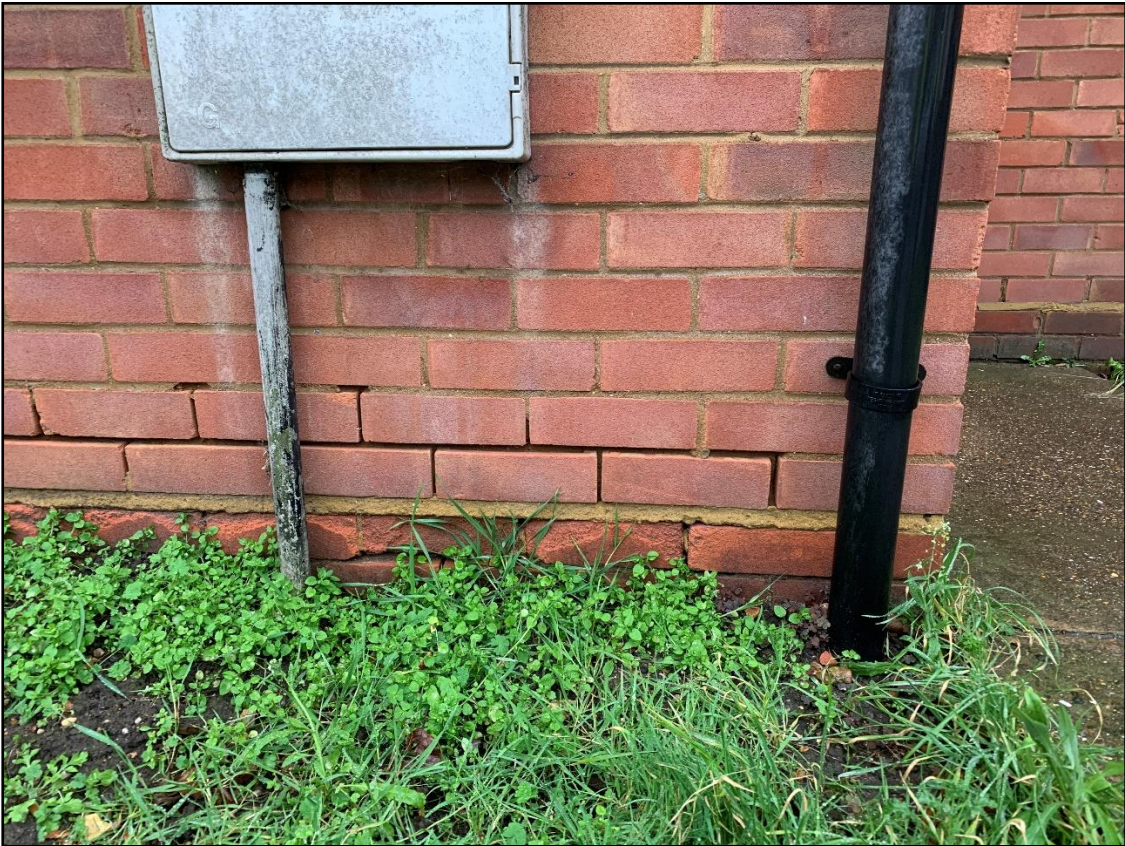
*Image 4 – High water level marks post event showing erosion to brickwork*

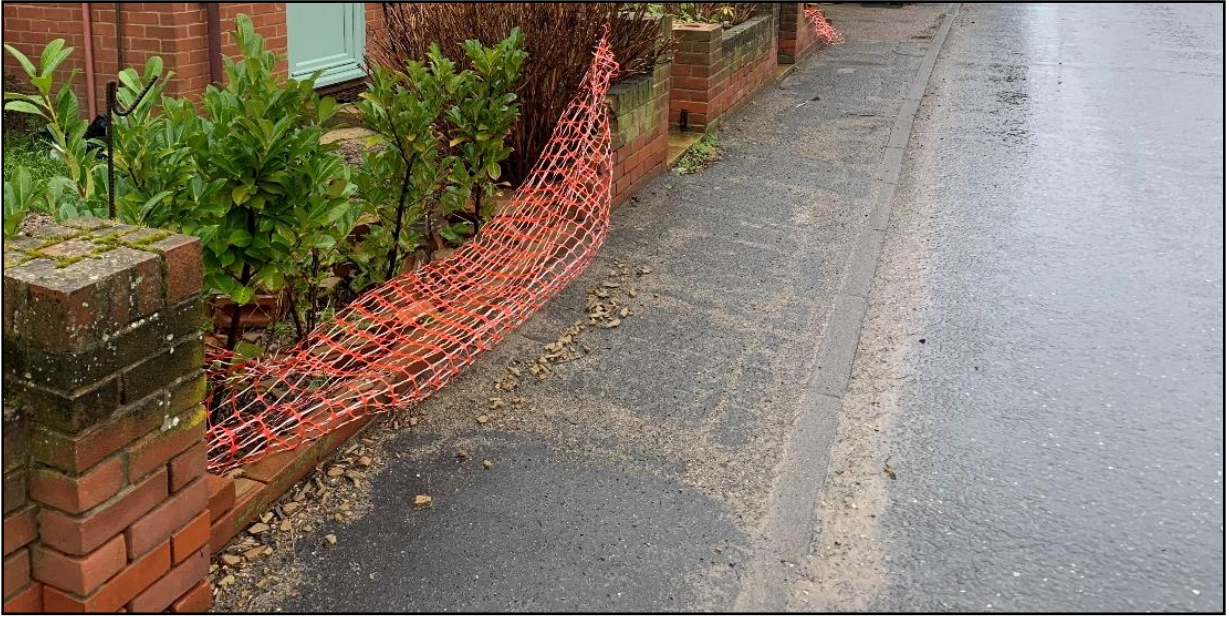
*Image 5 - Post event damage*

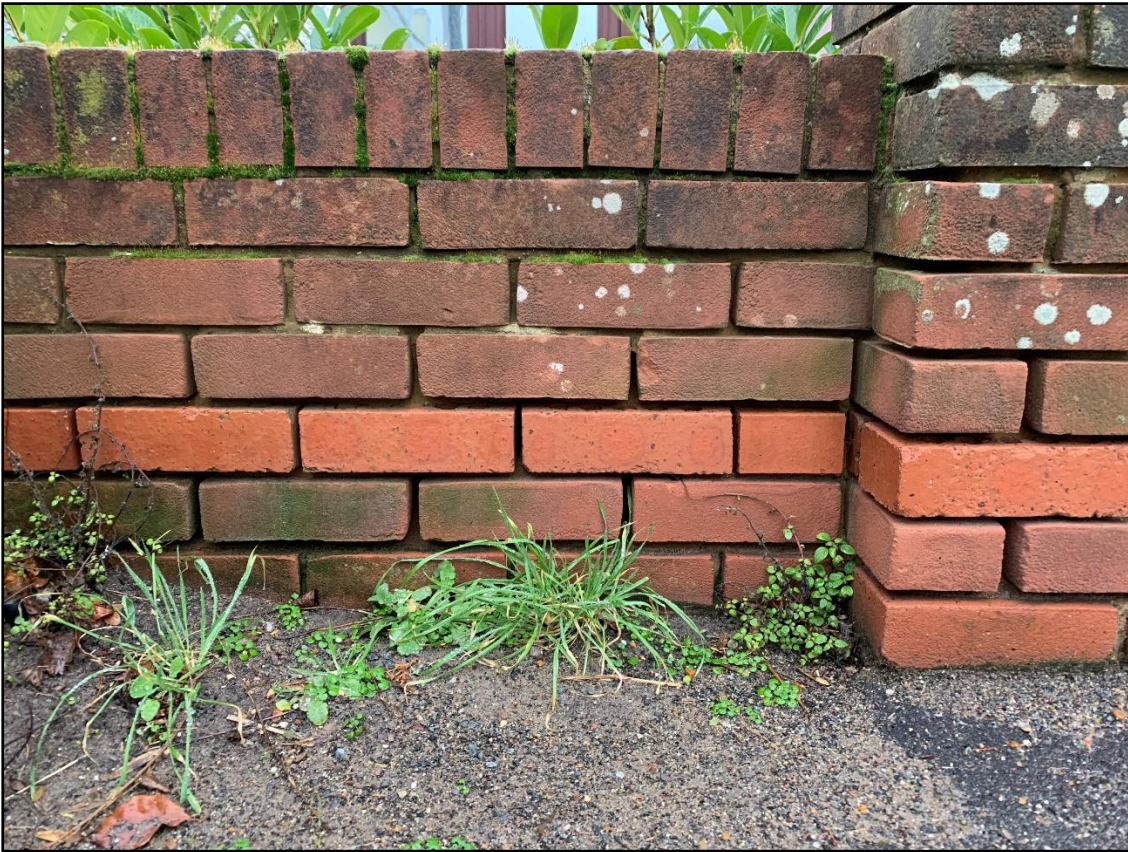
*Image 6 - Post event damage*

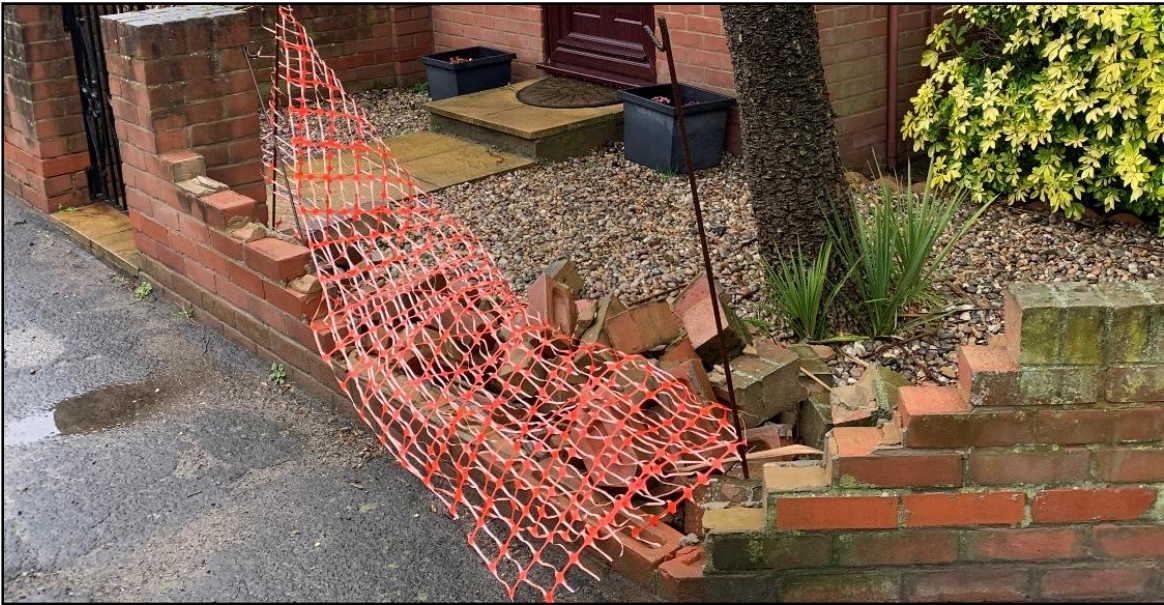
*Image 7 - Post event damage*
