## Section 19 Flood and Water Management Act 2010

### Report Title: The Heath, Bucklesham

CRNos 415332, 415335, 415791, and 468101.

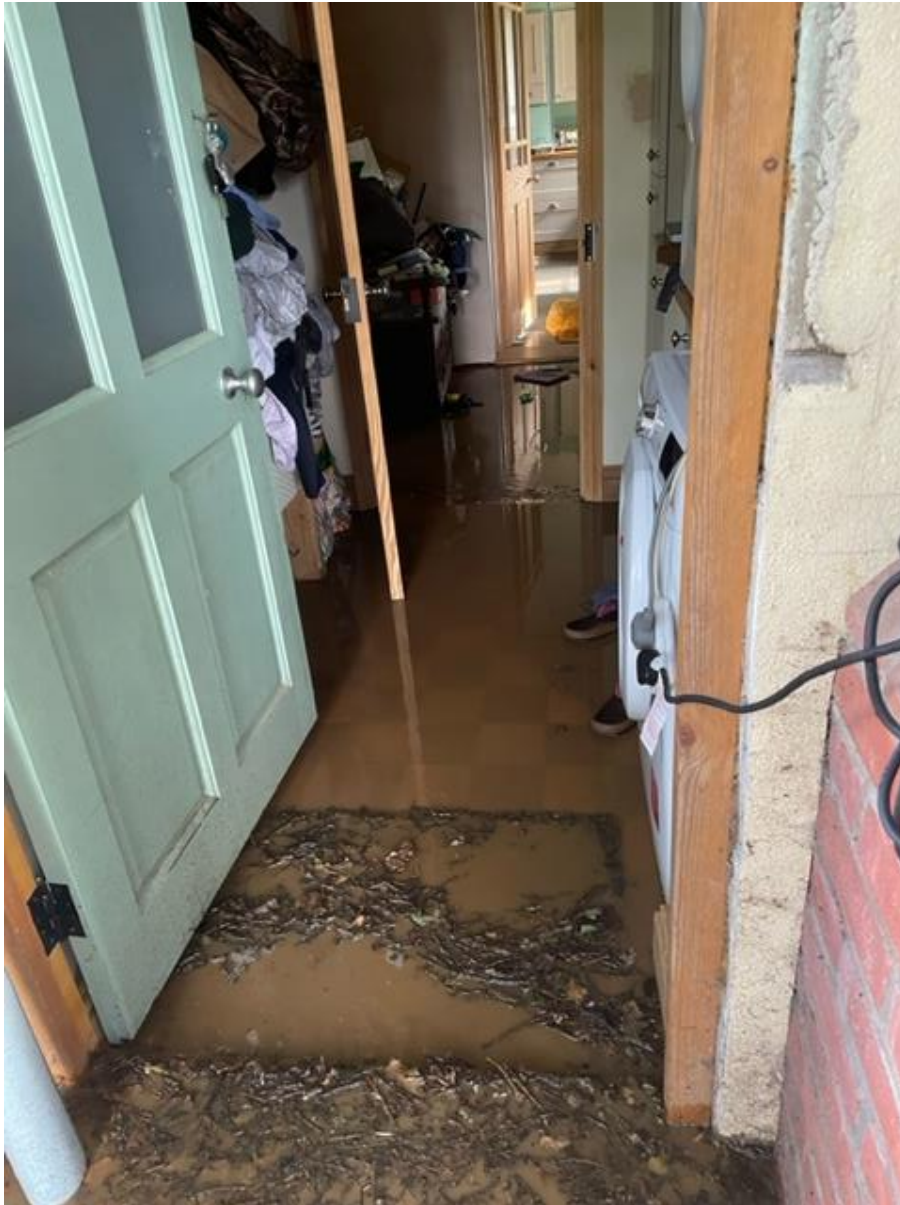
**Photo 1 – Internal flooding photograph provided by resident in August 2023.**

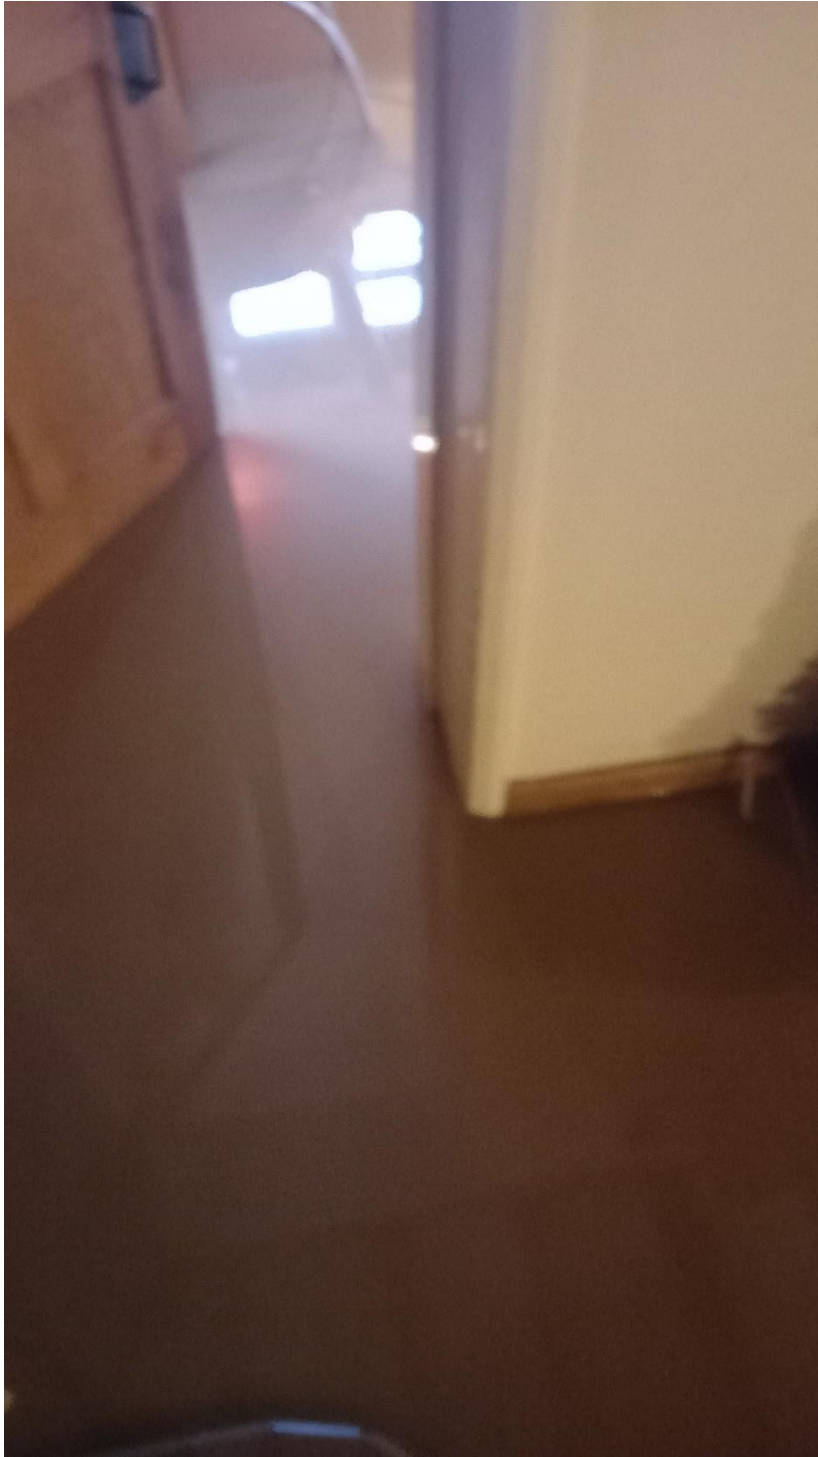
**Photo 2 – Internal flooding photograph provided by resident in August 2023.**

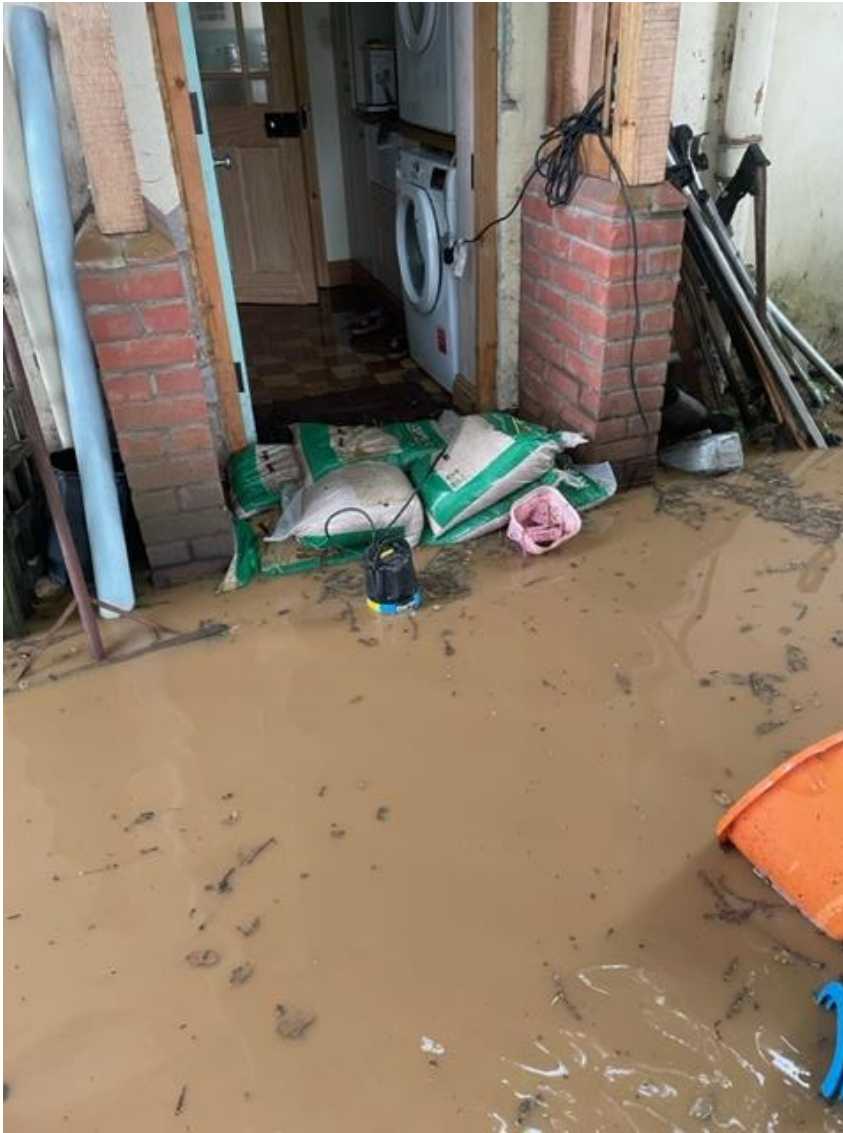
**Photo 3 – Internal flooding photograph provided by resident in August 2023.**

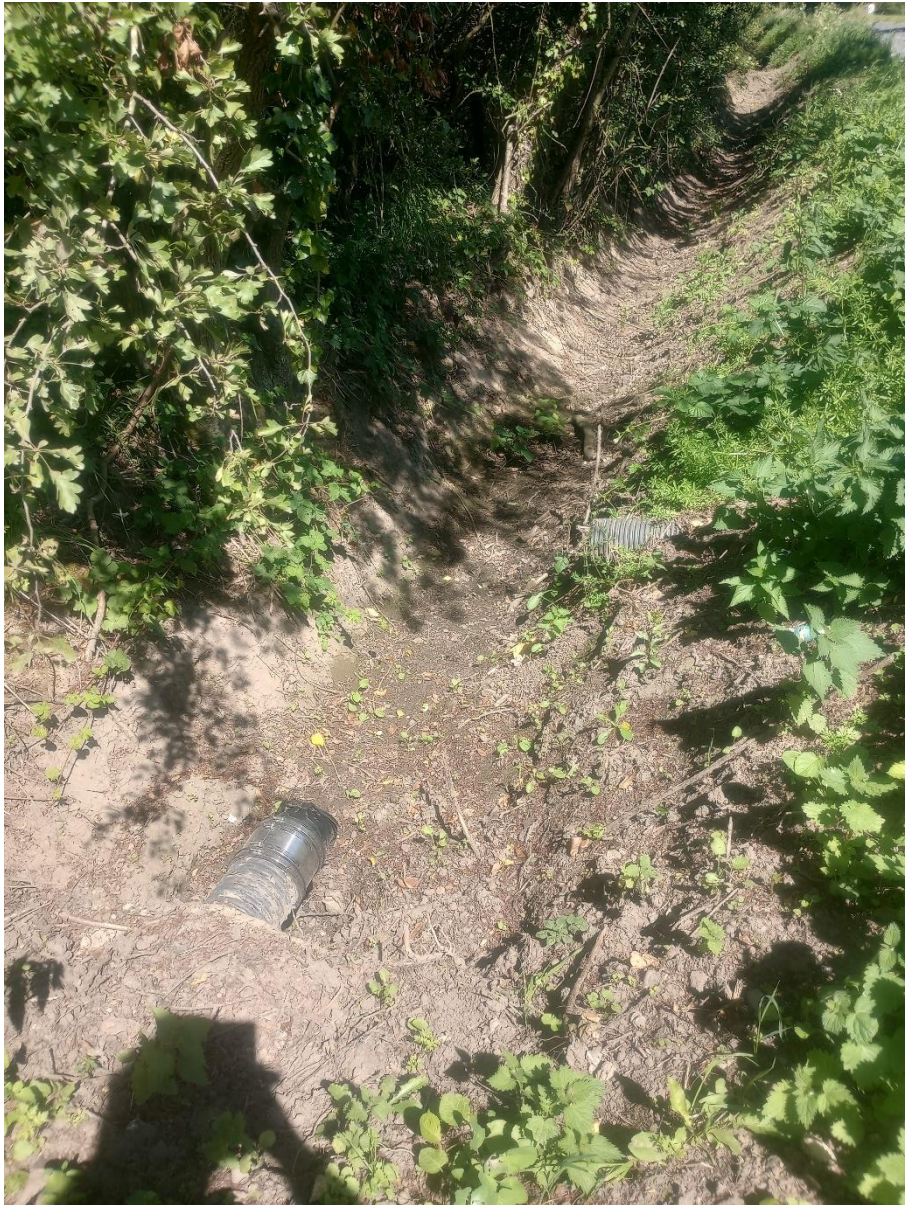
The initial source of flooding was an overtopping ditch line adjacent to the affected properties. This ditch line has since been confirmed to be a highways asset; therefore, it is the Highways Drainage Asset Team's responsibility for maintenance and remediation.

**Photo 4 – Highways Ditch line**

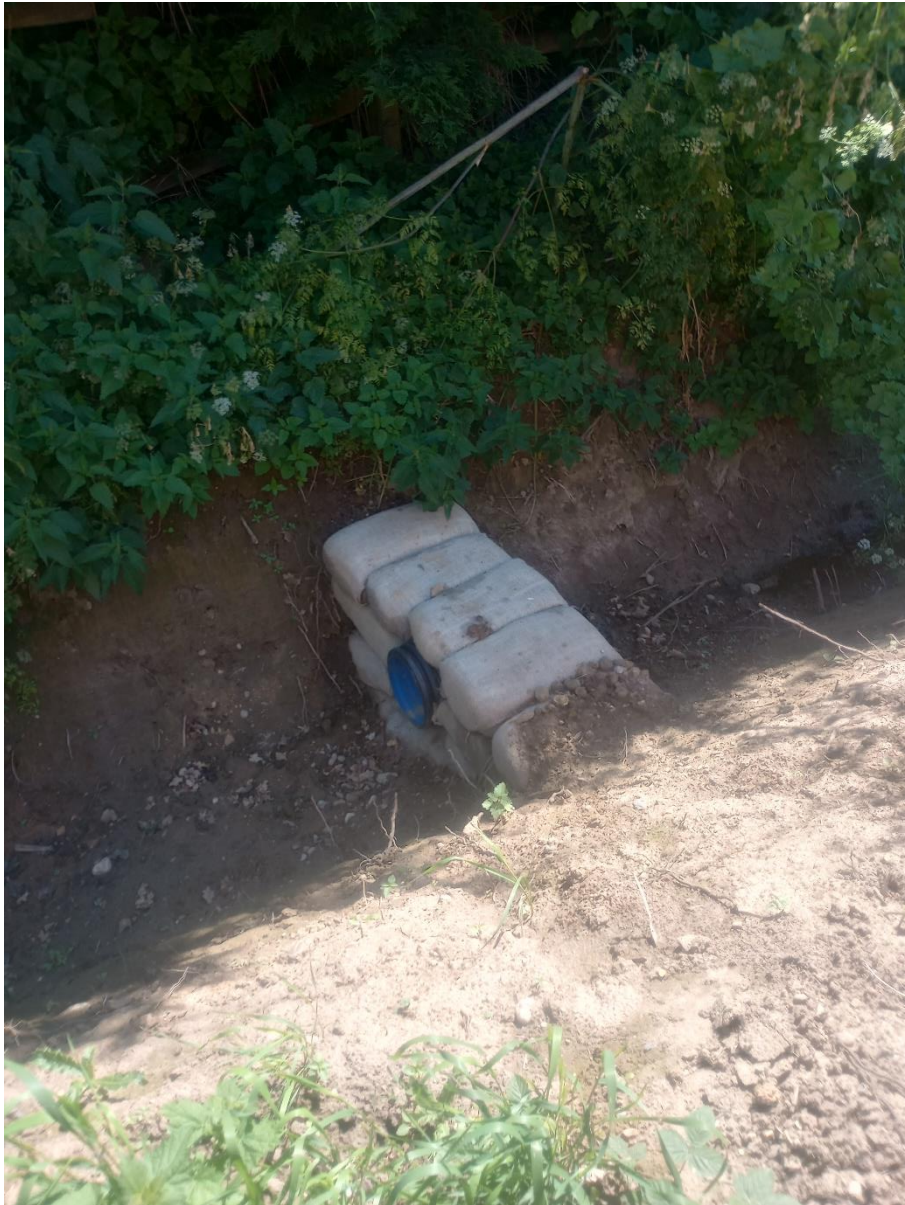
**Photo 5 – Installed hessian sandbag headwall in highways ditch line.**

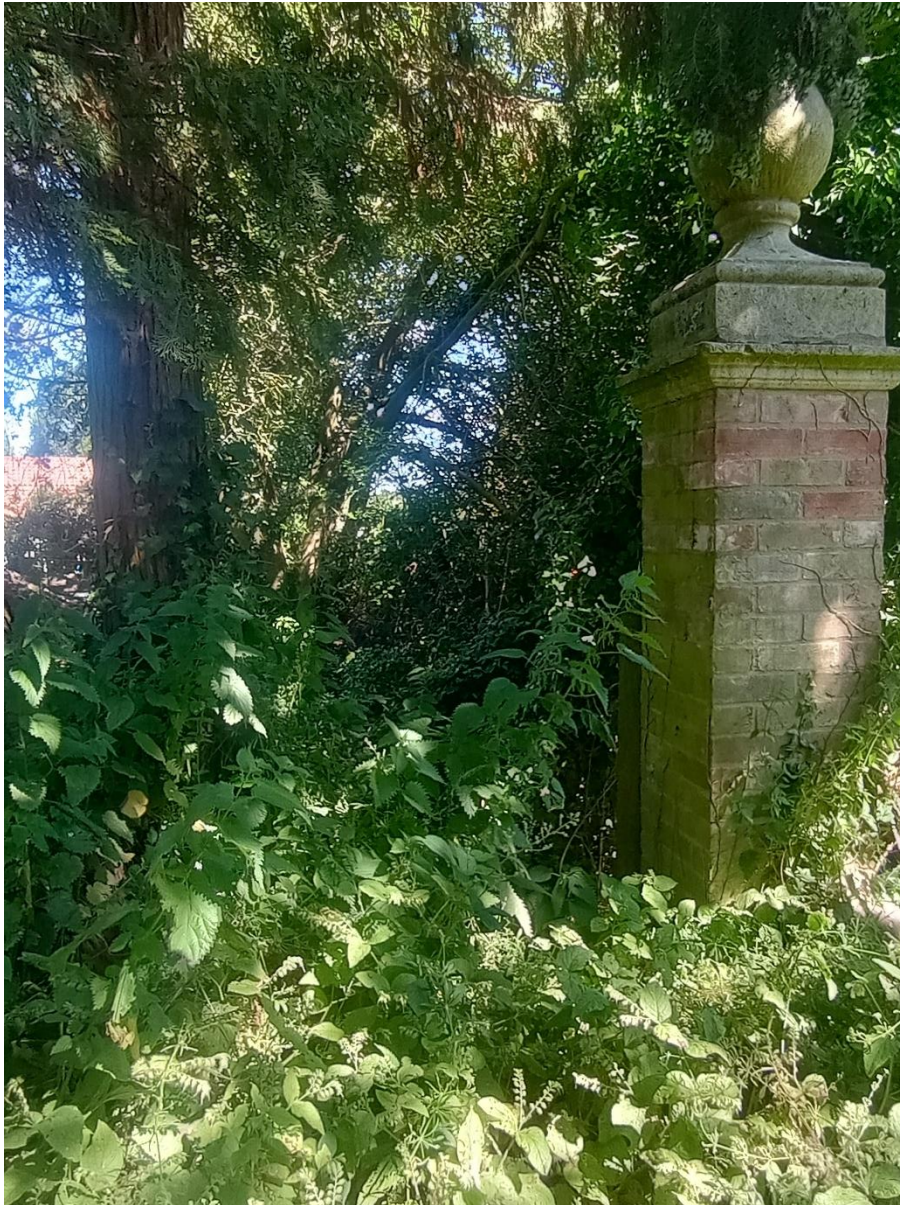
**Photo 6 – Access to private ditch line.**

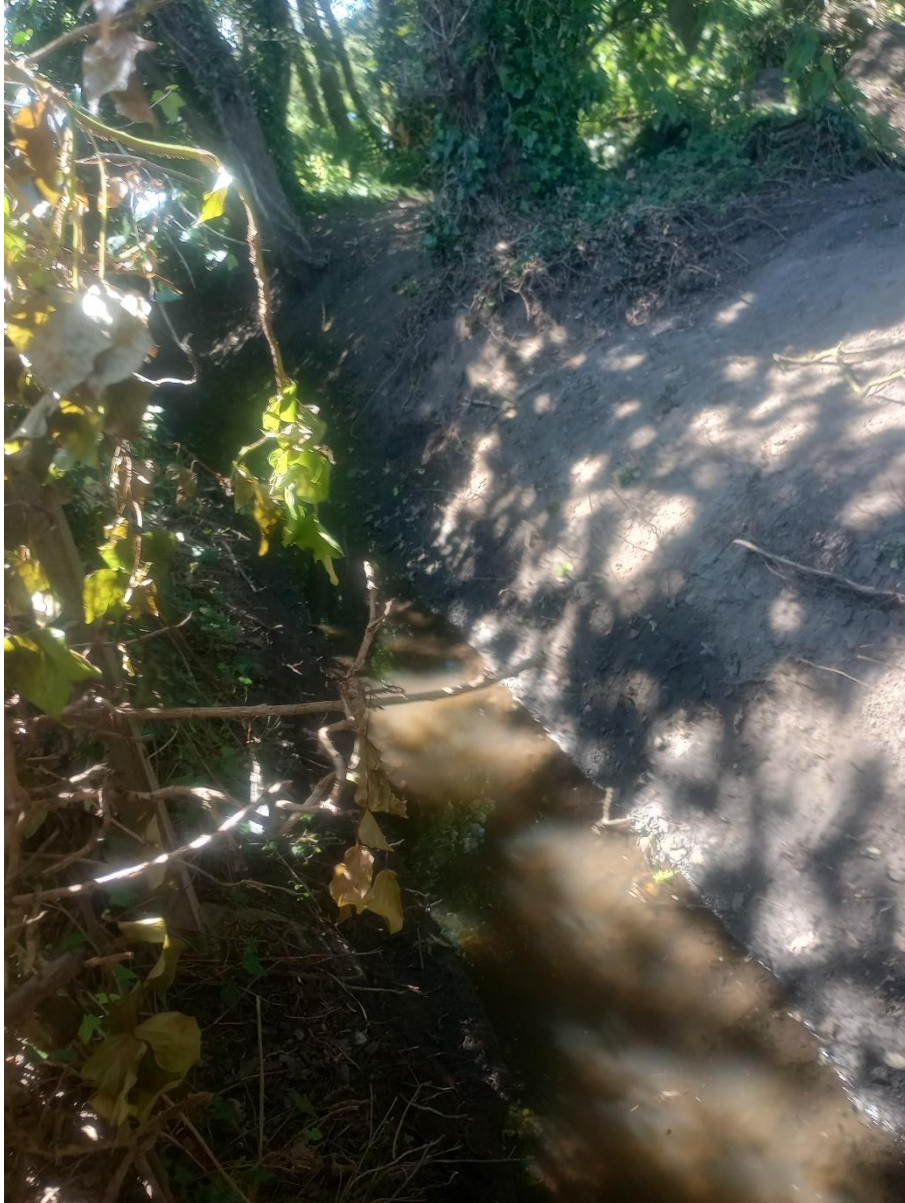
The private ditch line stops approximately 30m in where it connects to an ancient brick structure – possible culvert under private land. The Highways ditch and private ditch line do not seem to have any connectivity.

**Photo 7 – Private ditch line.**

There has also been some enforcement work raised on 26/04/2024 for a different ditch line south of the affected properties. The maintenance of this section of ditch is the responsibility of the adjacent landowner, not the local highway authority. The extent of works was deepening 85m of ditch to a new depth of 1.5m to improve the capacity of the ditch line. Evidence on site on 17/06/2024 suggests this is partially complete.
