## Section 19 Flood and Water Management Act 2010

### Dennington Flood Investigation

### Storm Babet 2023

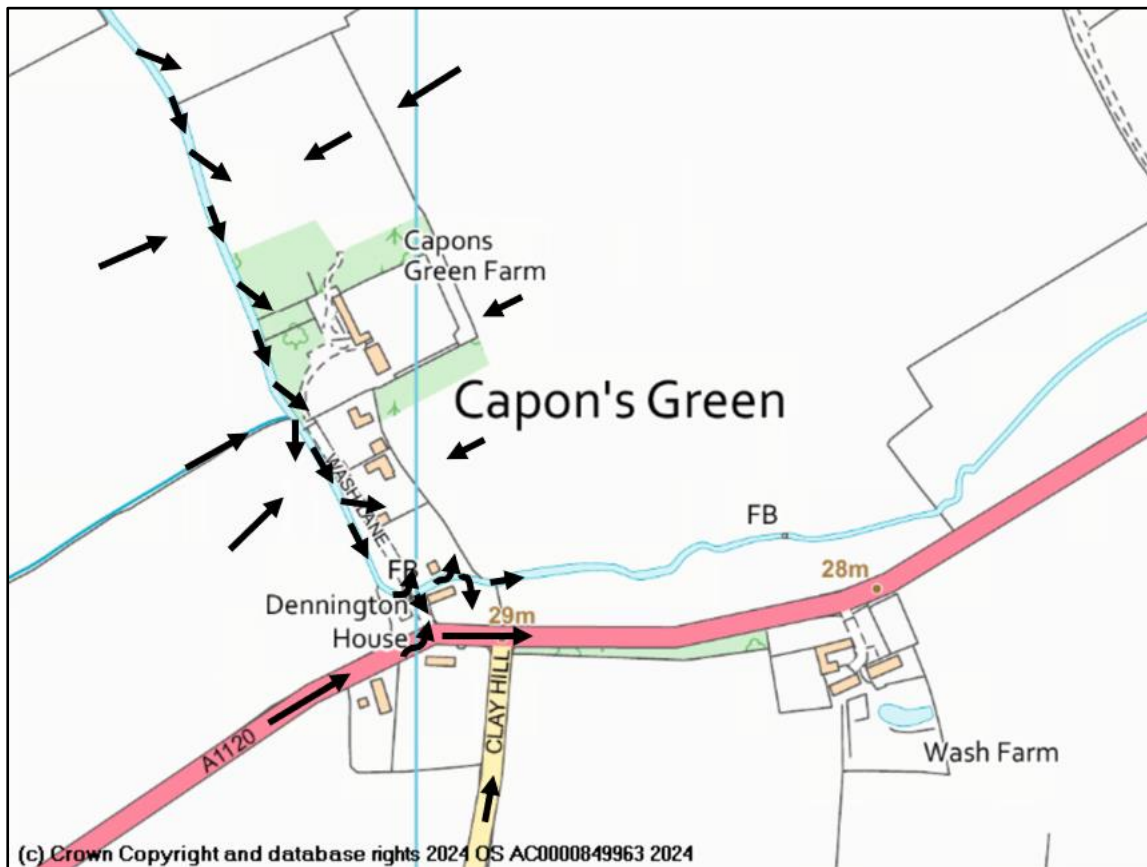
Figure 13 Approximate flood water flow paths at Capon's Green

During Storm Babet, the River Alde, which runs through Capons Green, was reported as overtopping, contributing to floodwater in and adjacent to Wash Lane. In addition to this, customer reports also describe surface flood water flowing from fields and highway drainage being overwhelmed. Surface water flowed east down the A1120 towards the junction with Wash Lane. Some of this surface water then flowed down Wash Lane, further adding to flood water. Highway gullies on the north side of the A1120 west of and adjacent to Wash Lane were reported to be non-operational. Flooding of property on Wash Lane reached internal levels of approximately 45cm.

- The River Alde overtopped its banks, contributing to floodwater in Wash Lane.
- Surface water flowed from the fields west, east and north of Wash Lane, contributing to the River Alde flow adjacent to Wash Lane.
- Highway drainage on the A1120 was overwhelmed.

- Residents to install Property Flood Resilience (PFR) via grant funded scheme.
- Suffolk Highways to investigate the functioning of gullies on the north side of the A1120, west of Wash Lane.
- Explore potential natural flood management measures (eg. leaky dams, attenuation ponds and flood plain reconnection) to “slow the flow” and attenuate water north and west of Capon’s Green in the upper catchment of the River Alde and on the surface water flow paths.

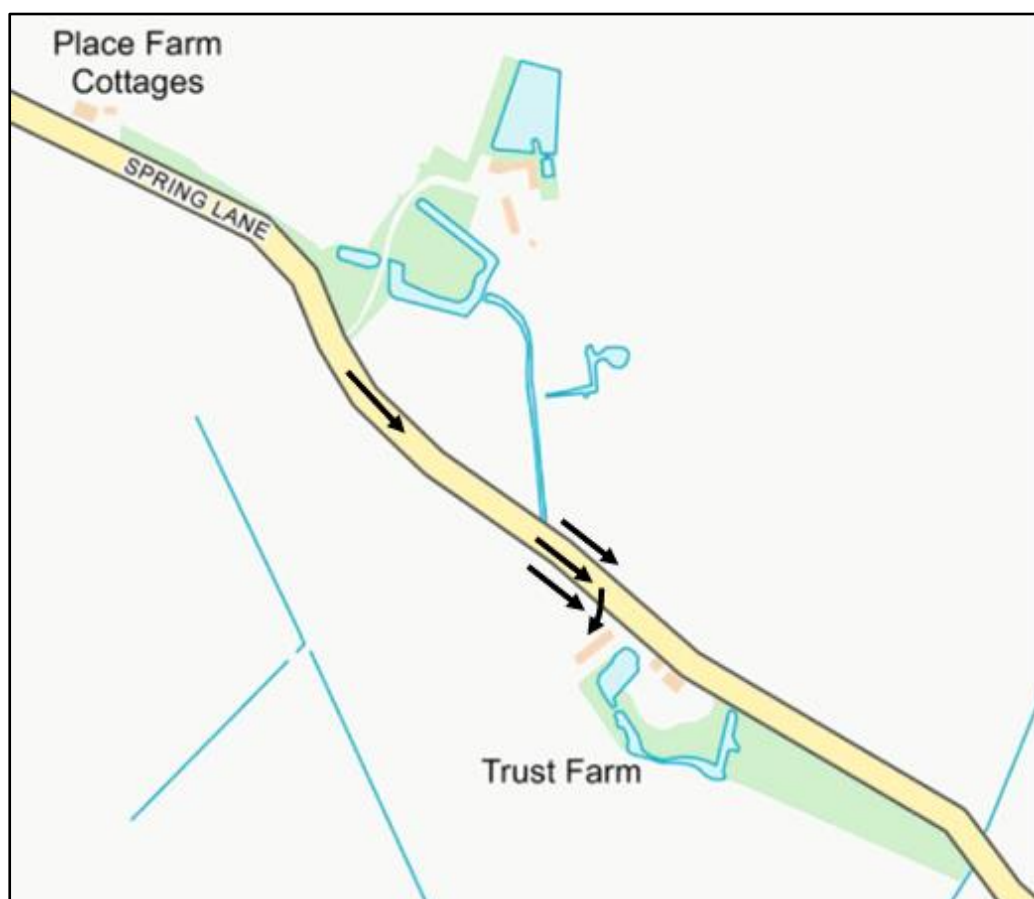
**Figure 16 Approximate flood water flow paths in Spring Lane**

Affected property in Spring Lane is adjacent to a localised area of high surface water flood risk. Reports describe floodwater not being able to drain into ditches from the

highway due to blocked grips on both sides of Spring Lane. Driveways which were at a lower level than the highway facilitated surface water runoff from the highway. In extreme rainfall conditions, drainage capacity in the field ditch above affected property on the south side of Spring Lane is restricted due to the only outlet from the ditch appearing to be a small drainage pipe through the adjacent field. The length and capacity of this pipe is unknown.

- Blocked grips on Spring Lane restricted highway drainage.
- Drainage capacity from the ditch on the west side of Spring Lane is restricted due to the size of the piped ditch outlet.

- Suffolk Highways to undertake the re-cutting of grips on Spring Lane.
- Landowner to investigate drainage capacity of pipe on south side of Spring Lane, in particular its size and ability to convey flows.
- Landowners north and south of Spring Lane to carry out watercourse/culvert maintenance to reduce flood risk as necessary in accordance with their riparian responsibilities.

Suffolk Highways to undertake the re-cutting of grips on Spring Lane.	SCC Highways	6 months	Recutting grips on Spring Lane will be investigated.
