Section 19 Flood and Water Management Act 2010

Stowmarket Flood Investigation – Storm Babet 2023

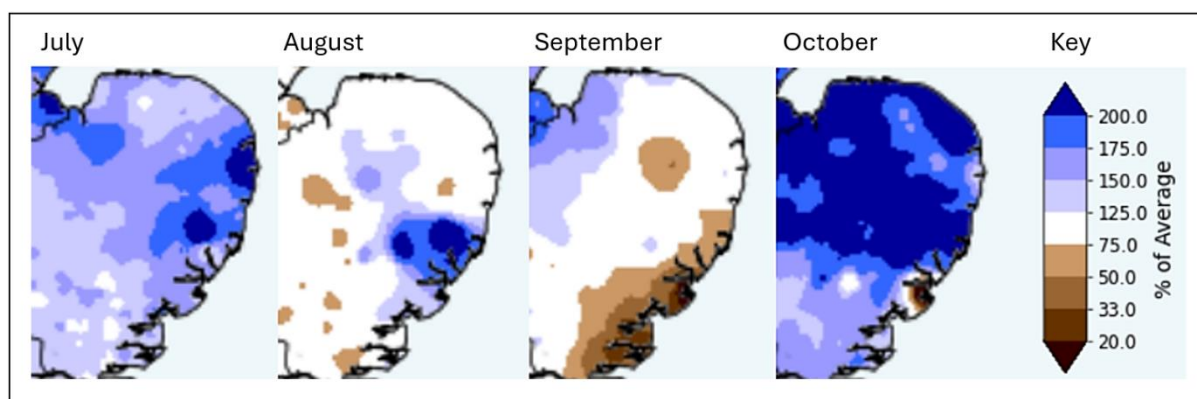
Figure 1. Average monthly rainfall (July – October 2023) as a percentage of the historic average monthly rainfall

The following maps illustrate the extent to which the rainfall in the months preceding Storm Babet exceeded the average monthly rainfall for July to October in recent years in Suffolk.

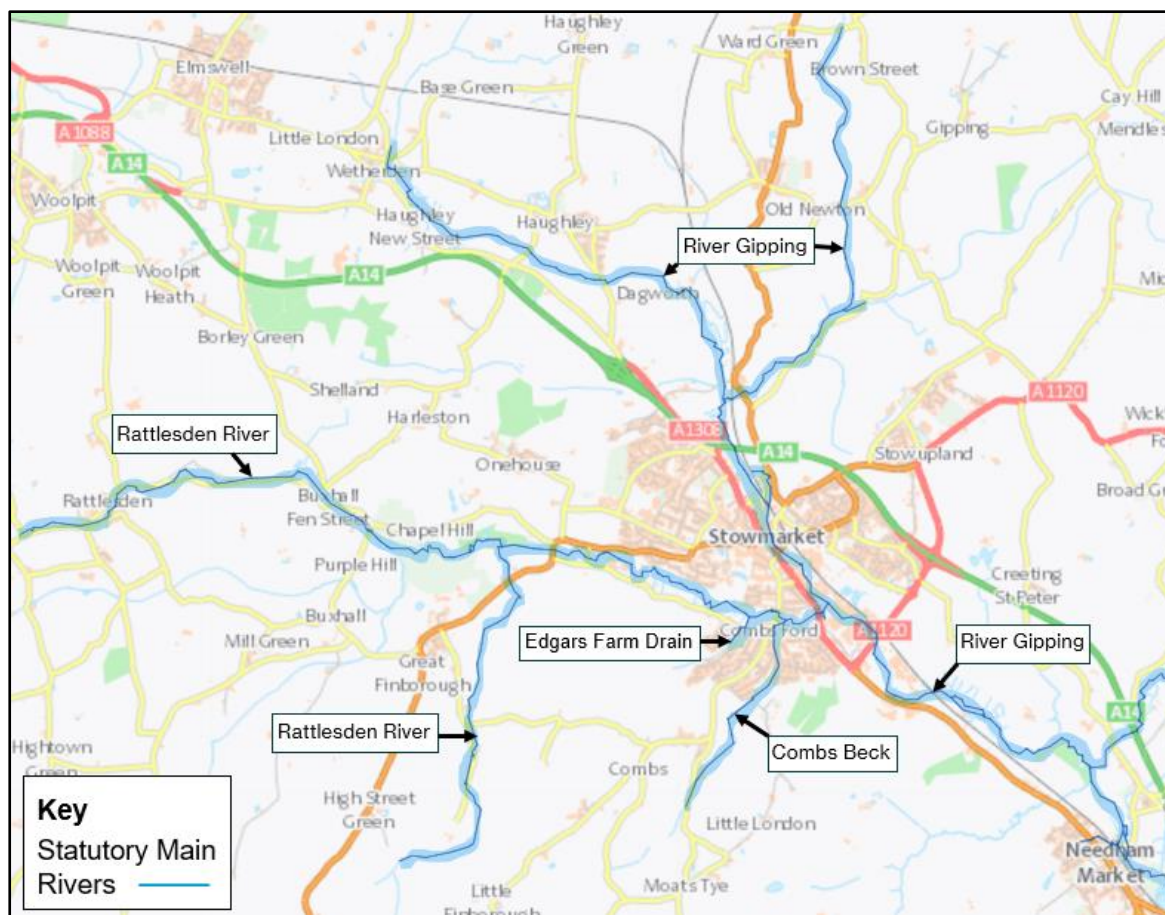
Figure 3. Location of statutory main rivers

Figure 3 shows the statutory main rivers in and around Stowmarket. These include the River Gipping (flowing from the north) and the Rattlesden River (flowing from the west) which join in Stowmarket. Stowmarket is the confluence for a number of tributaries which also flow into the River Rattlesden from the south. These include Combs Beck and Edgars Farm Drain.

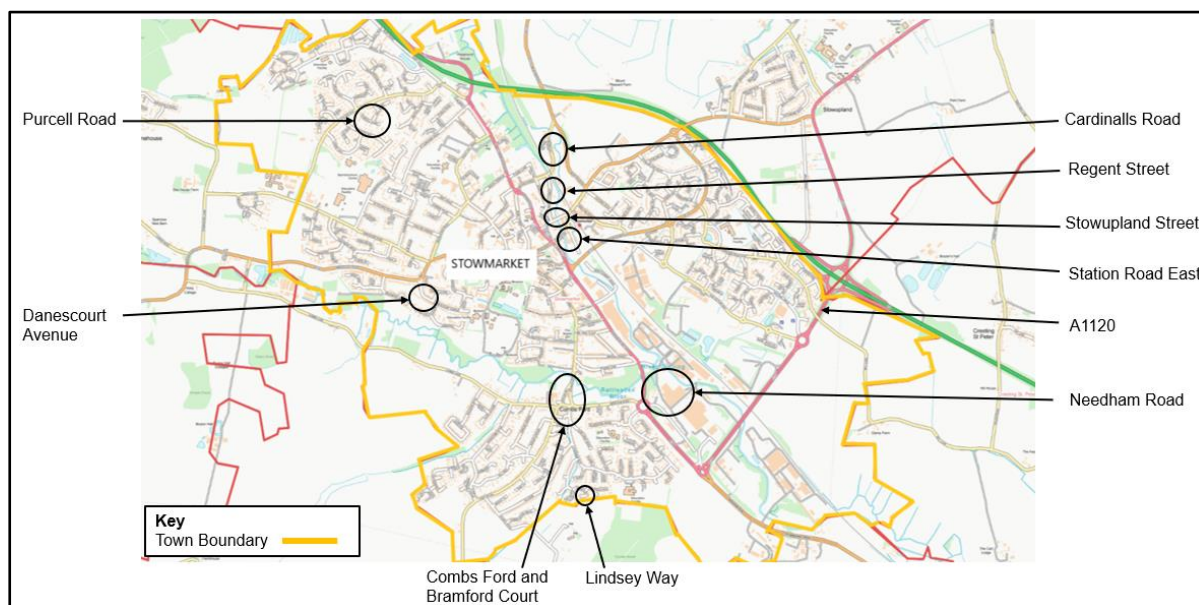
Figure 4. Locations where internal flooding of property was reported or major infrastructure was affected by flooding (A1120)

Property was reported as flooding internally in ten locations across the town and for the purposes of this investigation they will be described by road name, except for Combs Ford, which refers to the area:

1. Cardinalls Road
2. Regent Street
3. Stowupland Street
4. Station Road East
5. Purcell Road
6. Needham Road
7. Combs Ford
8. Bramford Court
9. Lindsey Way
10. Danescourt Avenue

The A1120 near the A14 junction was also partially closed by flooding.

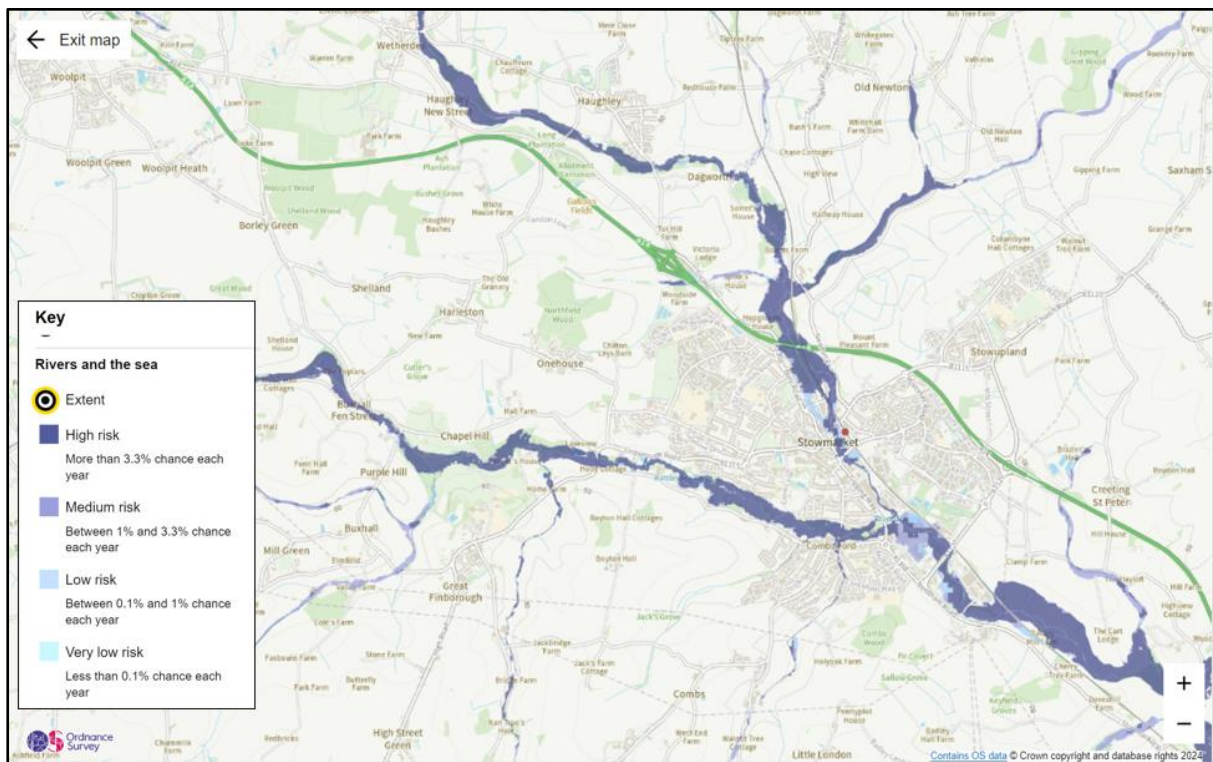
Figure 5. Predicted flood risk from river water (fluvial)

Fluvial flood risk in Stowmarket is associated primarily with the River Gipping, Rattlesden River and Combs Beck (Figure 5). This corresponds with affected property in Cardinals Road, Regent Street, Stowupland Street, Station Road East, Combs Ford, Bramford Court and Needham Road where flooding was attributed by residents to be partly or entirely due to fluvial flooding. Affected properties were projected to be in the high fluvial flood risk areas.

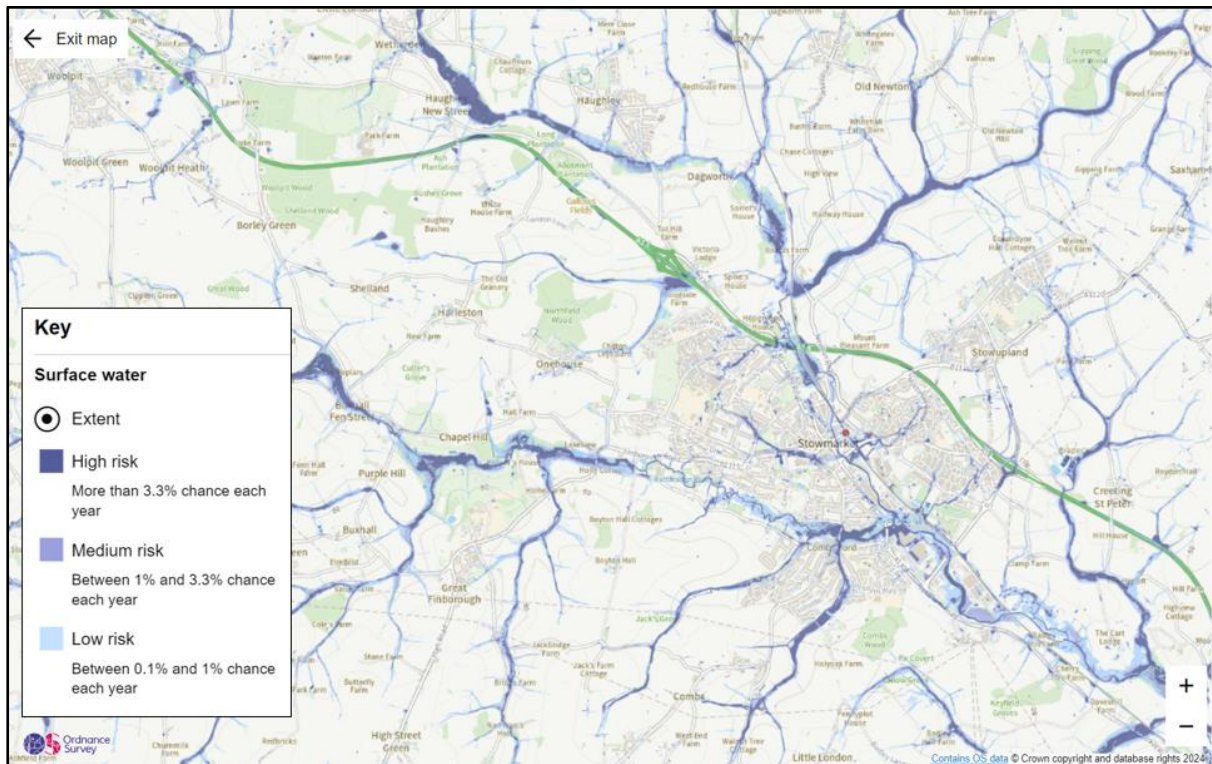
Figure 6. Predicted flood risk from surface water (pluvial)

Stowmarket has significant surface water flow paths, predominantly channelling water from the south to the Rattlesden River and from the west, north and east towards the River Gipping (Figure 6). These flowpaths are associated with areas of surface water flood risk. There are also some isolated areas in the town predicted to be at surface water flood risk which are associated with low-lying locations where floodwater typically collects during a rainfall event.

Affected property in Cardinalls Road, Regent Street, Stowupland Street, Station Road East, Lindsey Way, Combs Ford, Bramford Court, Needham Road and Purcell Road was in areas predicted to be at risk of surface water flooding. The flooded section of the A1120 was also predicted to be at high risk of surface water flooding.

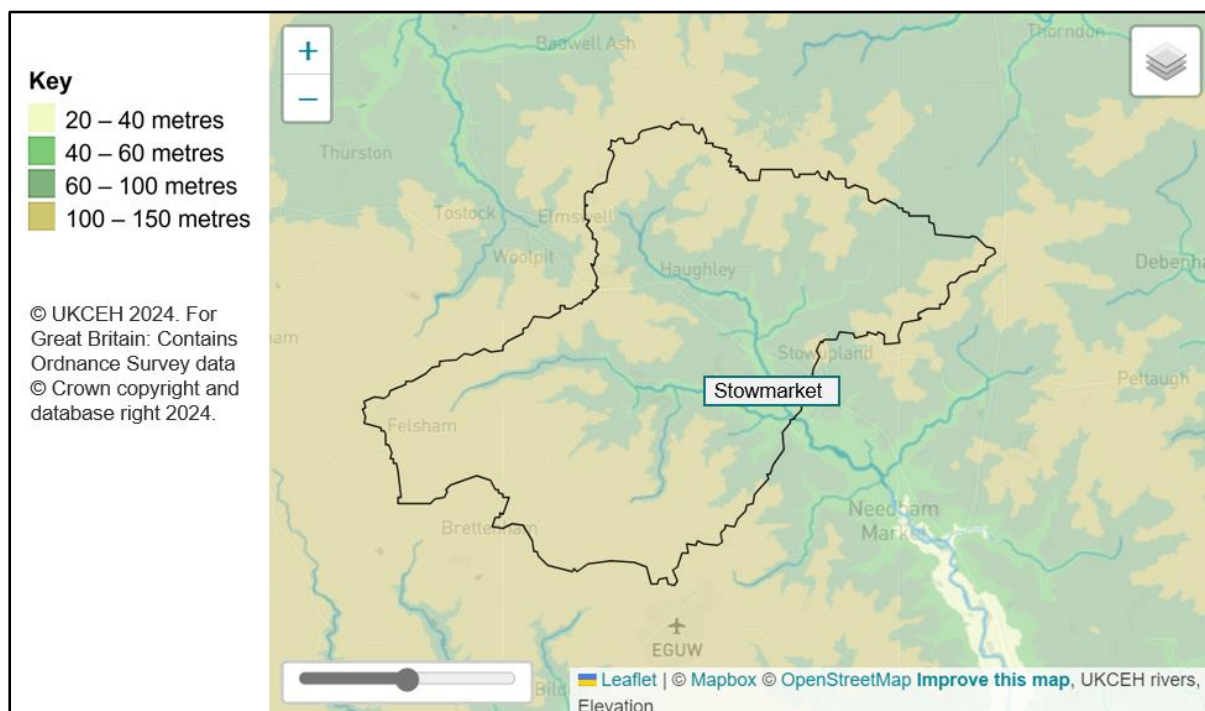
Figure 7. Elevation map of catchment area (National River Flow Archive)

Stowmarket is an urban area situated on low lying land in the upper River Gipping catchment, which also includes the Rattlesden River and Combs Beck (Figure 7). Combs Beck joins the Rattlesden River in Stowmarket, which then converges with the

River Gipping, also in Stowmarket. The catchment is predominantly rural with mainly arable land. There is minimal natural storage within the catchment and the river levels rise quickly in response to high rainfall. Overwhelmed infrastructure and watercourses may be observed during these intense rainfall events. The River Gipping in Stowmarket has been heavily modified historically to allow for construction and navigation.

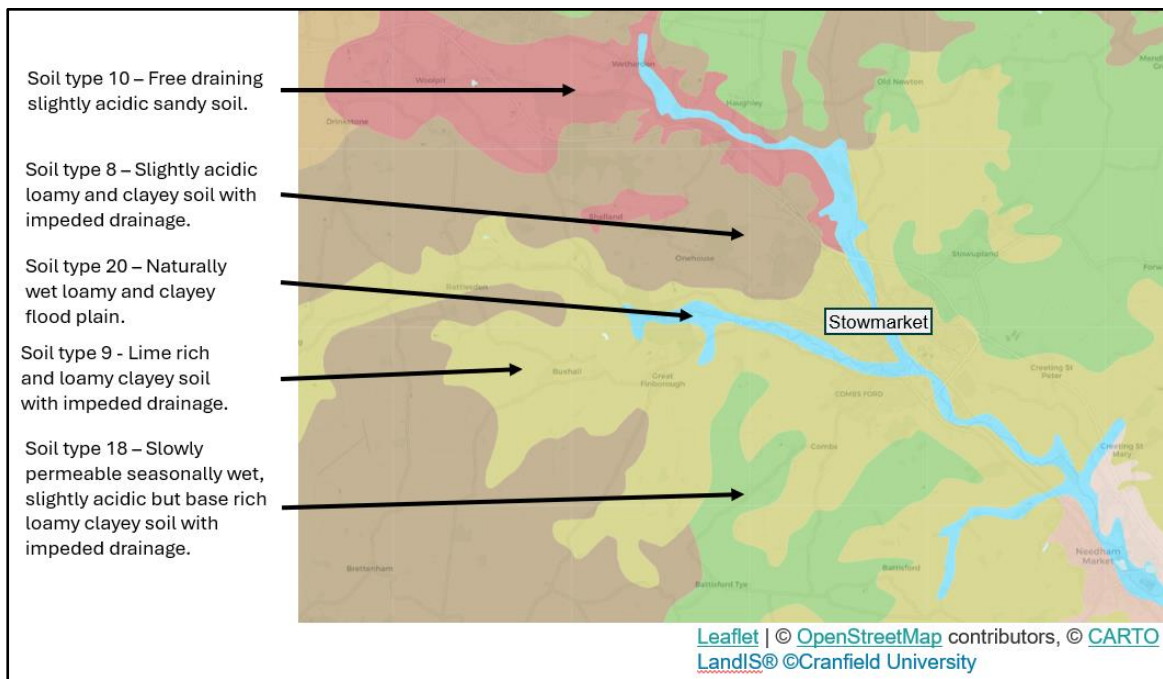
Figure 8. Soil map of catchment area (LandIS Soilscales)

The soils surrounding Stowmarket are predominantly loamy and clayey with impeded drainage, meaning that water permeates more slowly and surface water runoff is greater, particularly during intense rainfall. However, the saturated nature of the soils leading up to Storm Babet would also have prevented some infiltration (Fig. 8).

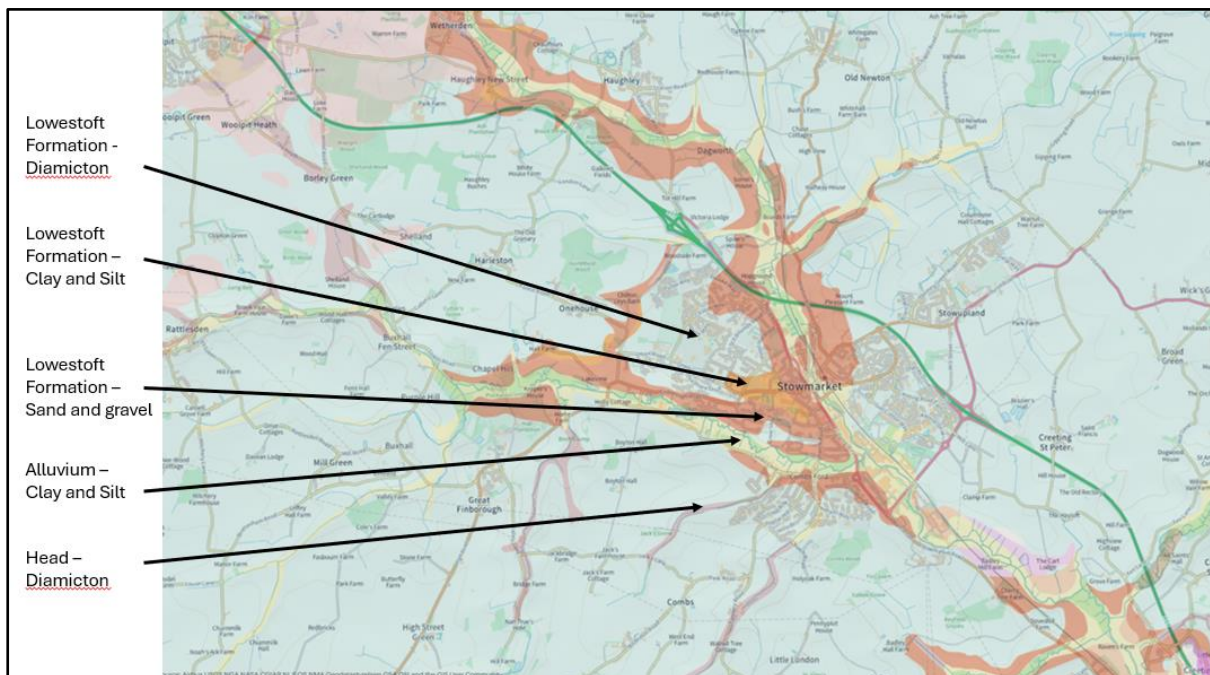
Figure 9. Superficial geology (BGS Viewer)

Figure 9 shows that much of the superficial geology surrounding Stowmarket is made up of ‘Lowestoft Formation – Diamicton’ which is described by the British Geological Survey as a diverse mixture of clay, sand, gravel, and boulders varying widely in size and shape. This is sometimes known as boulder clay. This generally has a low permeability meaning water will tend to flow off it before it can infiltrate, which also reflects the reports collected during Storm Babet.

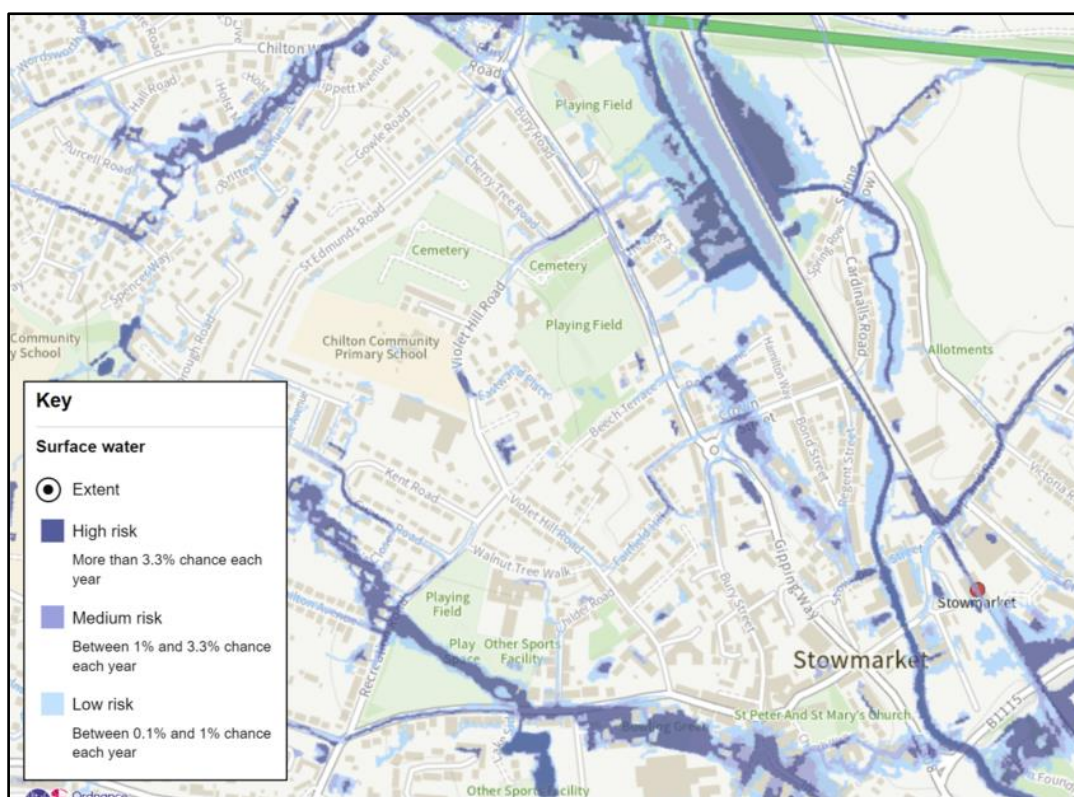
Figure 10 Predicted flood risk from surface water (pluvial) in north Stowmarket

Projected areas of surface water and rivers flood risk for north Stowmarket (including Cardinalls Road, Regent Street, Stowupland Street, Station Road East and Purcell Road) are shown in Figures 10 and 11. Fluvial flooding in north Stowmarket is associated with Cardinalls Drain and the River Gipping. Approximately four residential properties and one commercial property were impacted within this area.

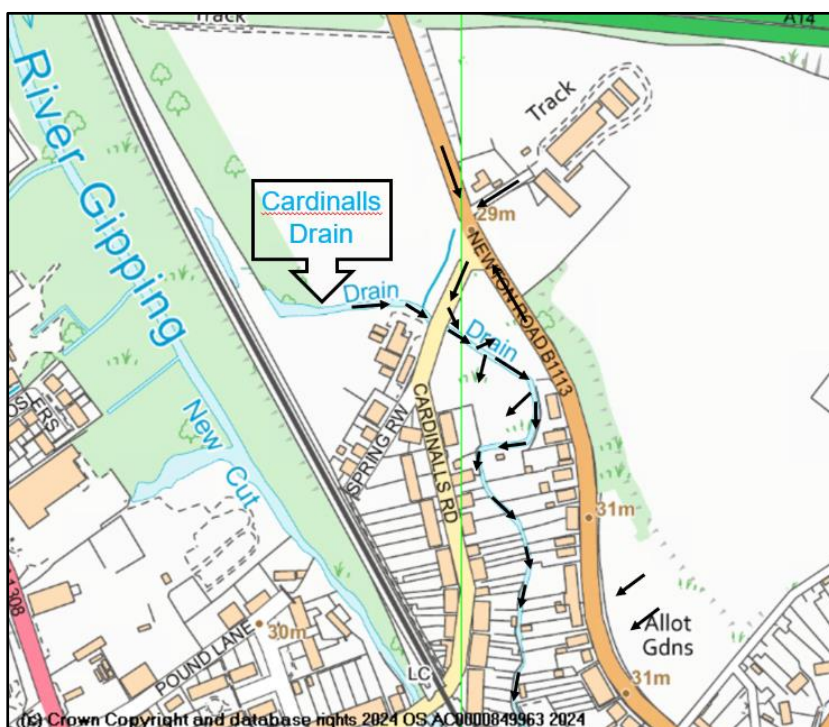
Figure 12 Cardinals Road approximate floodwater flowpaths

Cardinals Road is the northernmost road to suffer with internal flooding of property during Storm Babet. The affected property is projected to be at high risk of fluvial flooding and low risk of pluvial flooding, with water flow coming predominantly from the river, rather than overland run off. During Storm Babet, intense and prolonged rainfall caused Cardinals Drain to exceed its current capacity and overtop its banks to the rear of Cardinals Road, resulting in internal flooding to property. Silt build-up has reduced the capacity of Cardinals Drain.

- Residents to install Property Flood Resilience (PFR) via grant funded scheme.
- Residents to report obstructions in Cardinals Drain to the Environment Agency.
- Landowners to undertake targeted maintenance of Cardinals Drain between Spring Row and the Pump at the lower end of Cardinals Road as per riparian responsibilities.
- Relevant authority to inform landowners of riparian responsibilities.

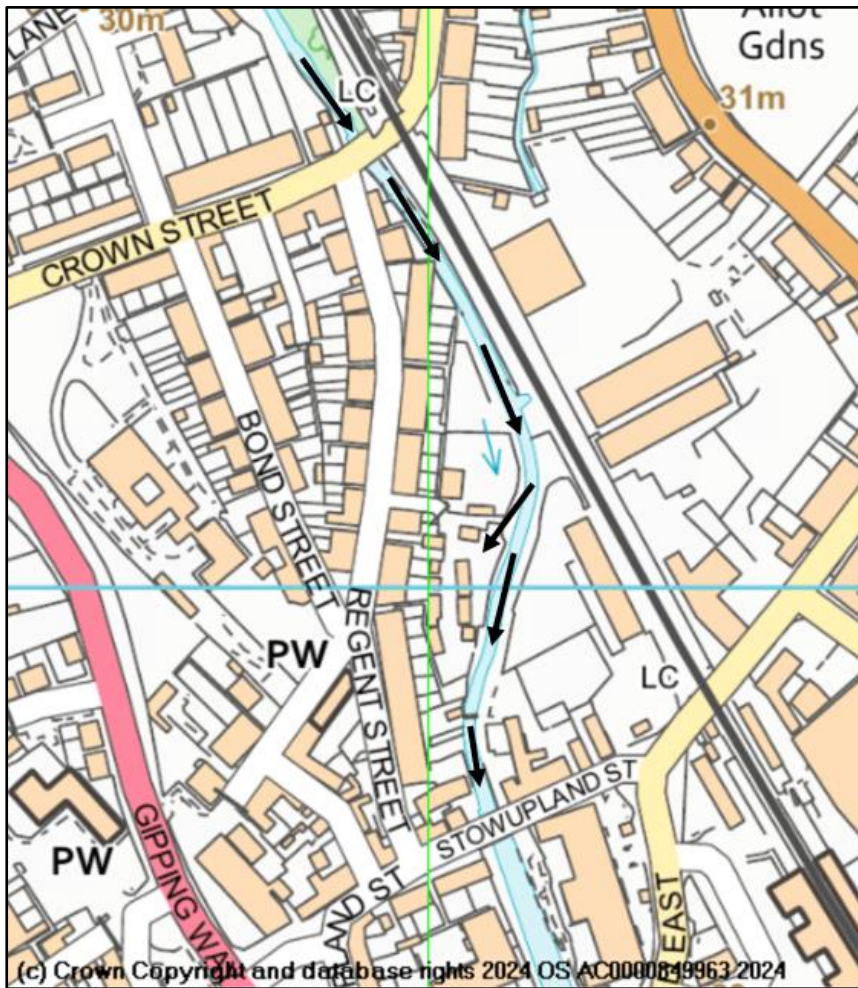
Figure 13 Regent Street approximate floodwater flowpaths

The River Gipping flows south behind properties on Regent Street. It is joined near the northern end of this stretch by water pumped into it from Cardinalls Drain. Affected property in Regent Street is projected to be at high risk of fluvial flooding and low risk of pluvial flooding with water flow coming predominantly from the river, rather than overland run off.

- Residents to install Property Flood Resilience (PFR) via grant funded scheme.
- Residents to report obstructions in the watercourse to the Environment Agency.
- Relevant authority to inform landowners of riparian responsibilities.
- Explore the potential for NFM measures which aim to attenuate surface water in the upper catchment of the River Gipping.

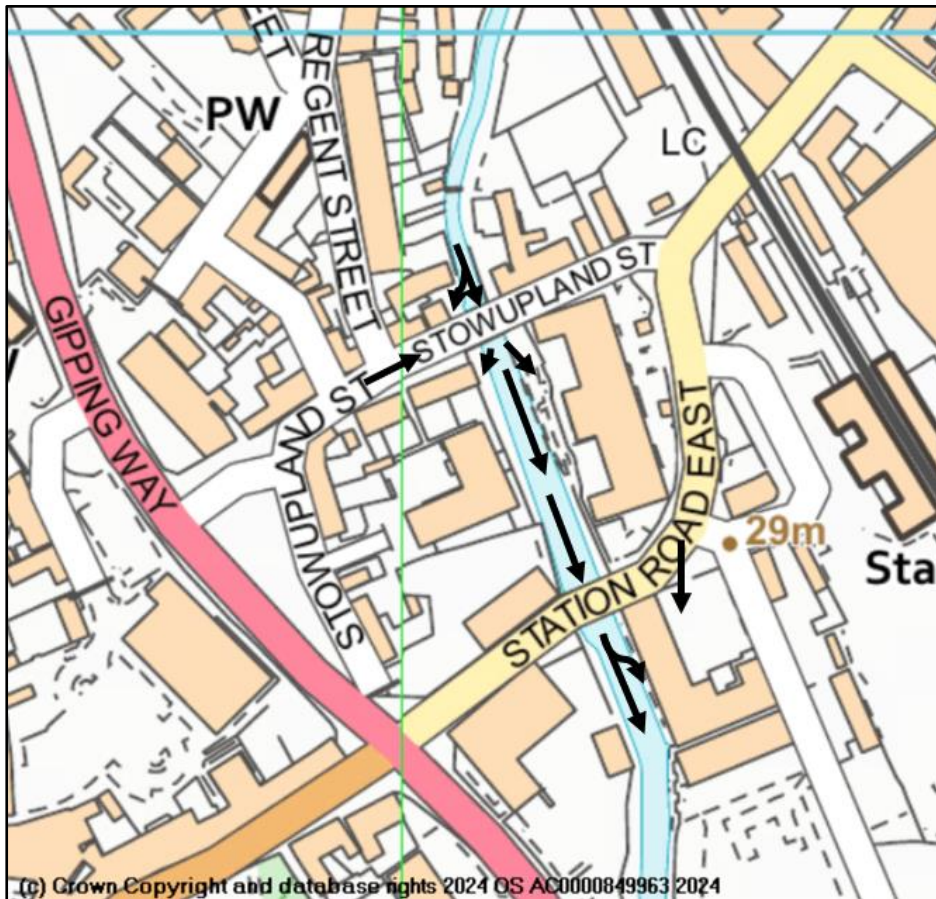
Figure 14 Stowupland Street and Station Road East approximate floodwater flowpaths

Affected property in Stowupland Street and Station Road East is projected to be at high risk of fluvial and pluvial flooding with water flow coming from the river and overland run off.

- Residents to install Property Flood Resilience (PFR) via grant funded scheme.
- Residents to report obstructions in the watercourse to the Environment Agency.
- Relevant authority to inform landowners of riparian responsibilities
- Explore the potential for NFM measures which aim to attenuate surface water in the upper catchment of the River Gipping.

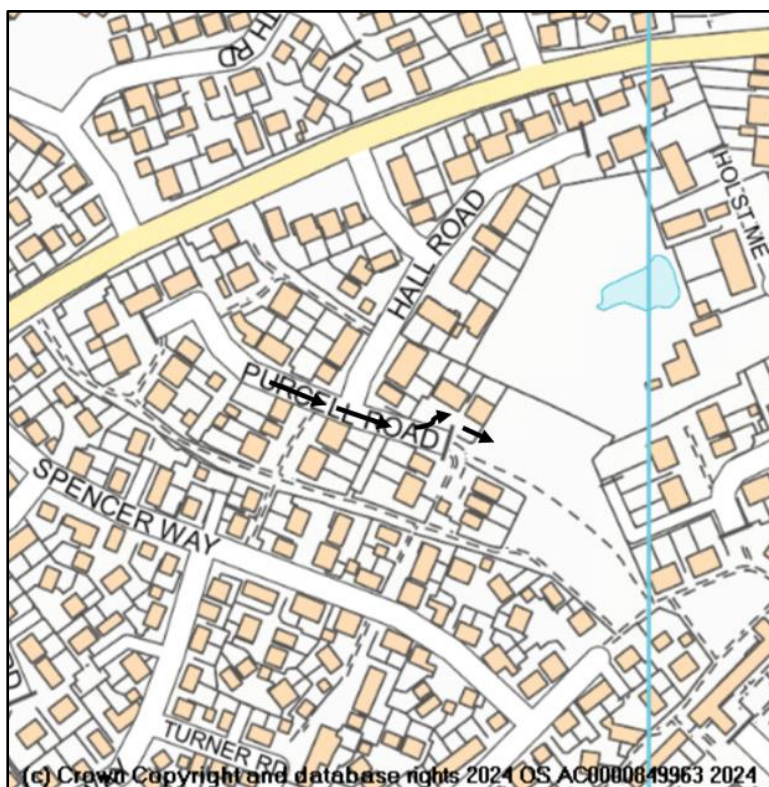
Figure 15 Purcell Road approximate floodwater flowpaths

Affected property in Purcell Road suffered internal flooding from surface water on the highway. The area is projected to be at medium surface water flood risk and during the event, residents reported that highways drainage was overwhelmed, unable to cope with the volume of floodwater. Surface water flowed down Purcell Road, travelling west to east, towards properties situated at a lower level, causing internal property flooding when floodwater breached property thresholds.

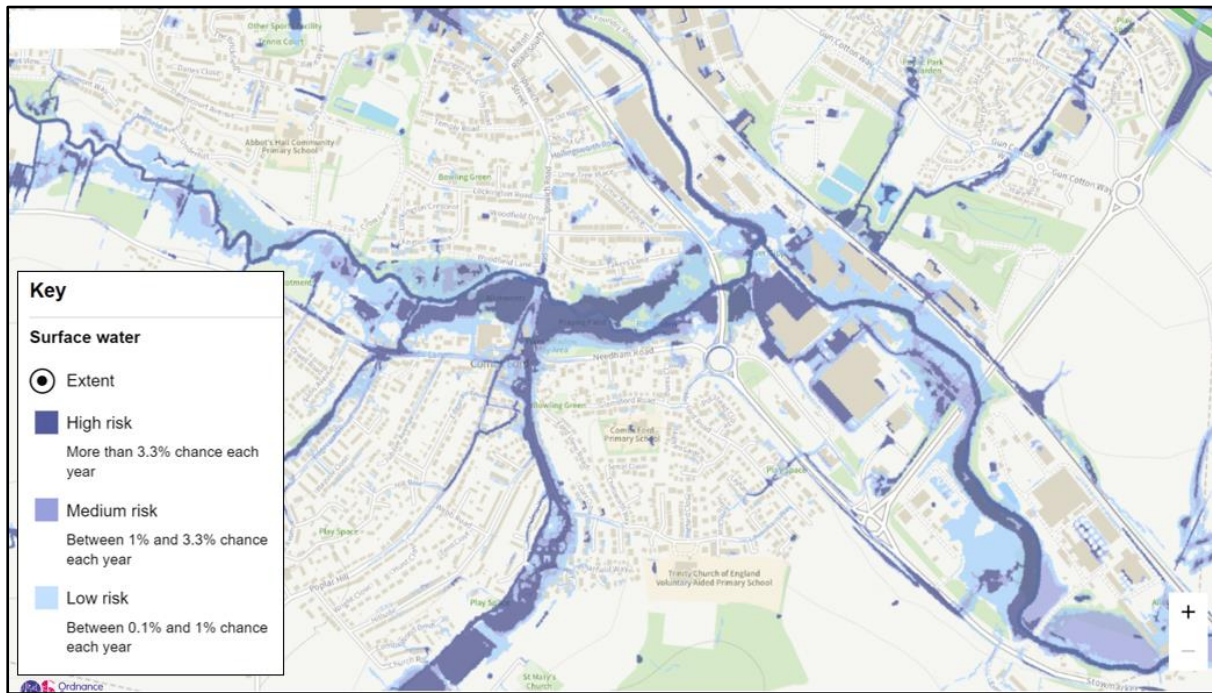
Figure 16 Predicted flood risk from surface water (pluvial) in south Stowmarket

Predicted areas of surface water and rivers flood risk for south Stowmarket (including Needham Road, Combs Ford, Bramford Court, Danescourt Avenue, Lindsey Way and the A1120) are shown in Figures 16 and 17. Fluvial flooding in south Stowmarket is associated with the River Gipping, Rattlesden River and Combs Beck. Approximately five commercial properties and twelve residential properties were impacted within this area.

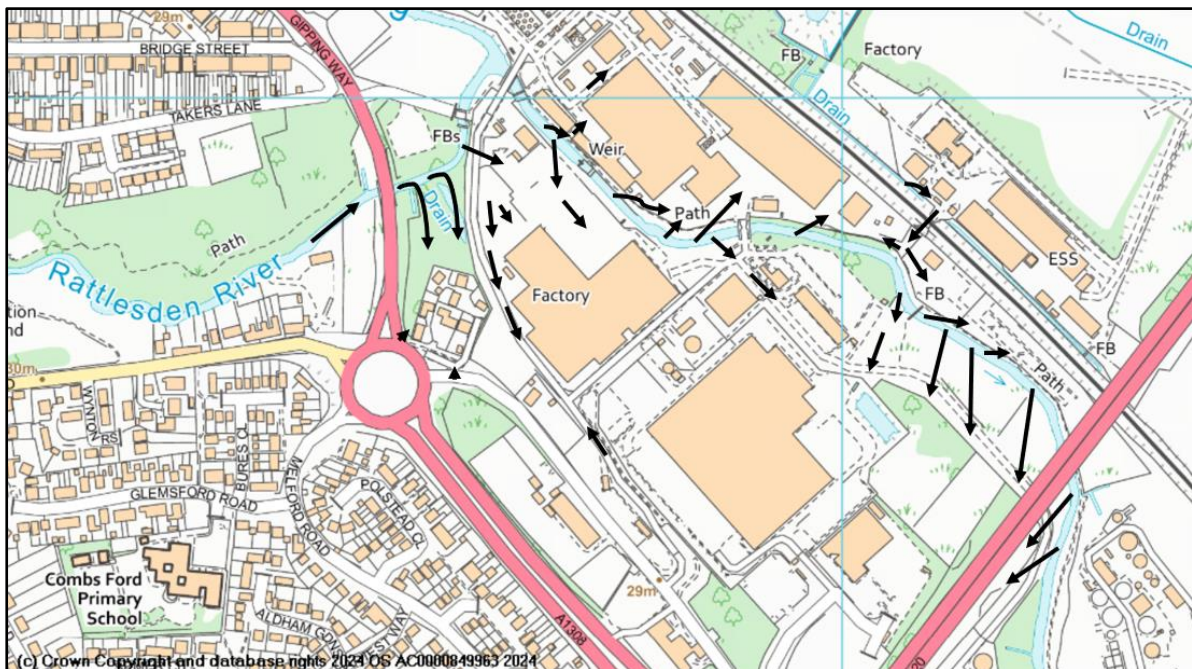
Figure 18 Needham Road approximate floodwater flowpaths for residential and commercial property

Commercial property to the east of the Gipping Way/Needham Road roundabout was impacted by flooding. Affected property in this location is predicted to be at high fluvial and pluvial flood risk, with water flow coming from rivers and overland run off.

At 2pm on 20th October 2023, floodwater was reported as exceeding the capacity of drains on the east side of the railway line and flowing southwest through an underpass beneath the railway line and on to the site, flooding eastern areas between the River Gipping and the railway. By 8pm, the River Gipping had overtopped adjacent to this area, contributing to flooding on the east and southeast side of the site. Roads on this side of the site are known to be vulnerable to flooding and are reported to flood typically 1-2 times per year. At 8pm, internal flooding, also caused by the River Gipping overtopping, was reported on the northeast of the site, close to the confluence of the Rattlesden River and the River Gipping. At 10pm, the River Rattlesden was also reported as overtopping and flooding the northwest of the site. Surface water also accumulated on the site due to the considerable amount of hard impermeable surfaces. Floodwater continued to rise on the site, causing further internal flooding until 2.30am on 21st October, when levels began to subside.

- Business to install Property Flood Resilience (PFR) via grant funded scheme.
- Business to report obstructions in the Rattlesden River and River Gipping to the Environment Agency.
- Relevant authority to inform landowners of riparian responsibilities.
- Explore the potential for NFM measures which aim to attenuate surface water in the upper catchment of the Rattlesden River.
- Explore the potential for NFM measures which aim to attenuate surface water in the upper catchment of the River Gipping.

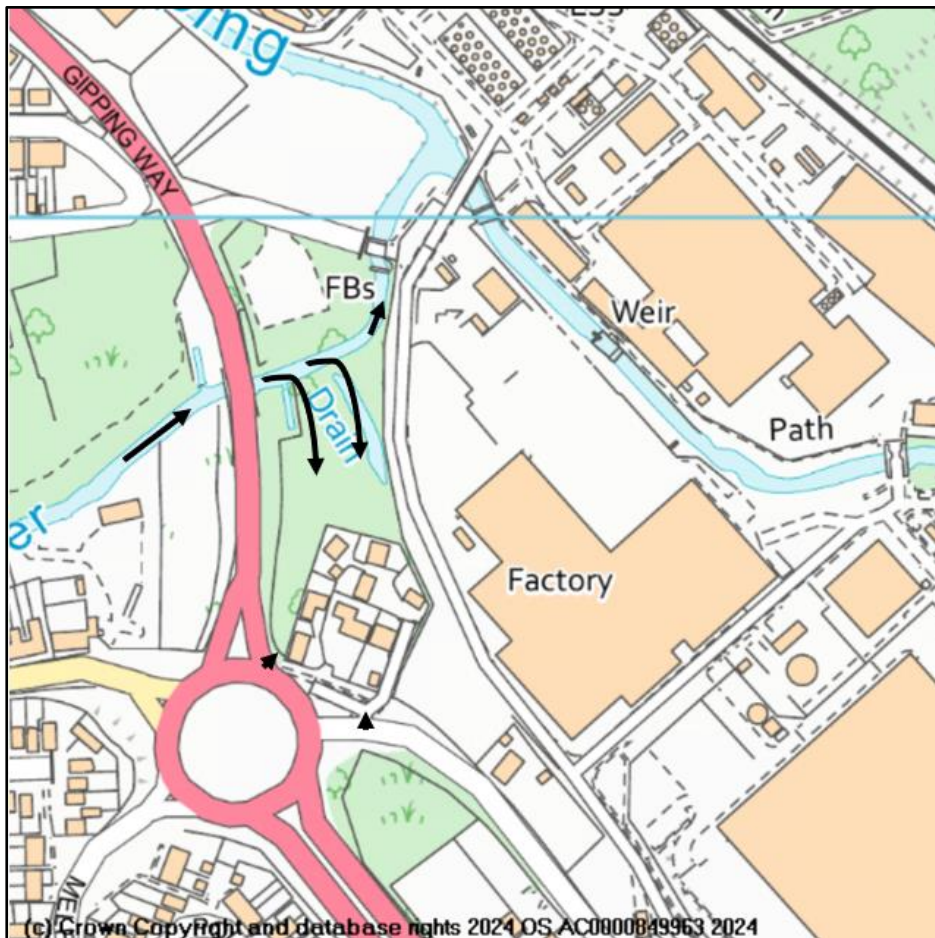
Figure 19 Needham Road approximate flowpaths for residential property

Affected residential property on the Rattlesden River floodplain, situated between the Gipping Way and Needham Road roundabout and commercial property to the east of the roundabout, is projected to be at high fluvial and pluvial flood risk, with water flow coming from rivers and overland run off. Impacted residential property in this location was reported to be flooded from the Rattlesden River overtopping and flowing south. This would have been compounded by surface water flowing north over roads from the south side of affected property. Internal flooding was reported to a depth of 20cm. This location also reported that rubbish and trees were obstructing the River Gipping.

- Residents to report obstructions in the Rattlesden River to the Environment Agency.
- Relevant authority to inform landowners of riparian responsibilities.
- Explore the potential for NFM measures which aim to attenuate surface water in the upper catchment of the Rattlesden River.

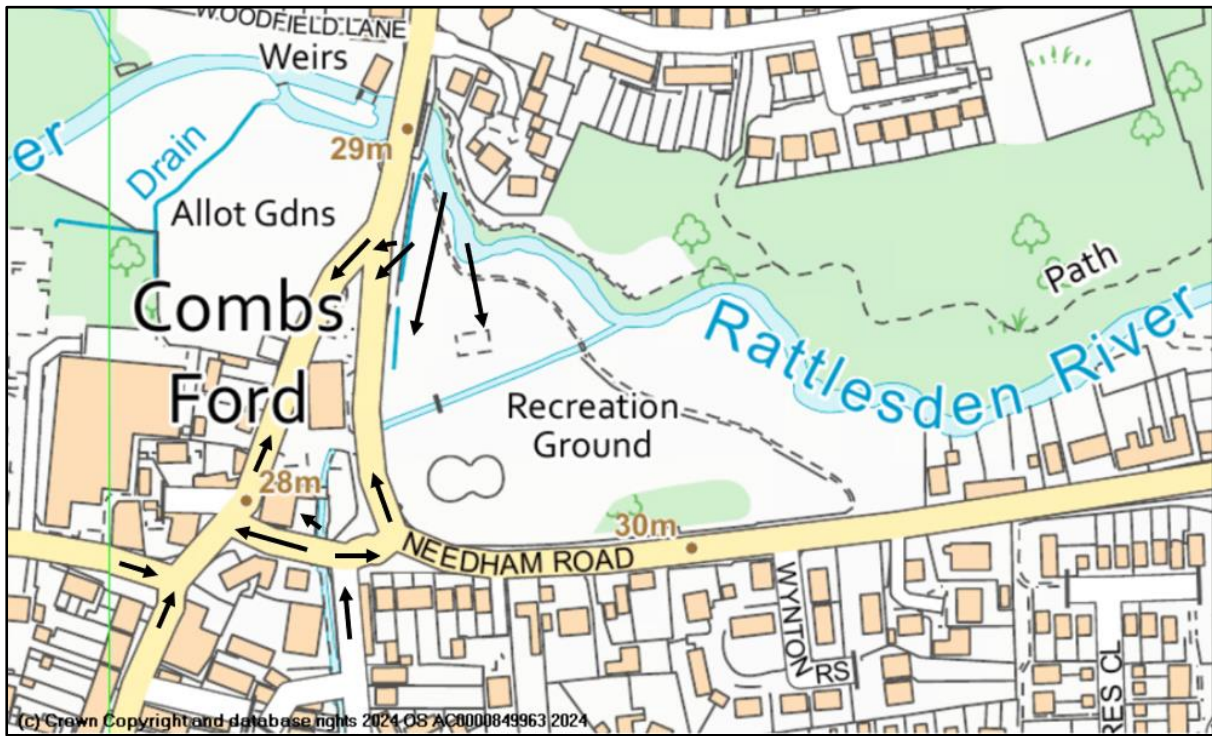
Figure 20 Combs Ford approximate floodwater flowpaths

Combs Ford is an area projected to be at high risk of pluvial and fluvial flooding, with fluvial flood risk arising from both Combs Beck and Rattlesden River. Combs Beck flows north through Combs Ford and turns east across Pikes Meadow to join the Rattlesden River.

- Intense and prolonged rainfall caused Rattlesden River to overtop, flowing south and flooding several commercial properties on Poplar Hill and Needham Road in Combs Ford.

- Residents to install Property Flood Resilience (PFR) via grant funded scheme.
- Residents to report obstructions in Combs Beck and the Rattlesden River to the Environment Agency.
- Explore the potential for NFM measures which aim to attenuate floodwater in the upper catchment of the Rattlesden River.
- Explore the potential for NFM measures which aim to attenuate floodwater in the upper catchment of Combs Beck.

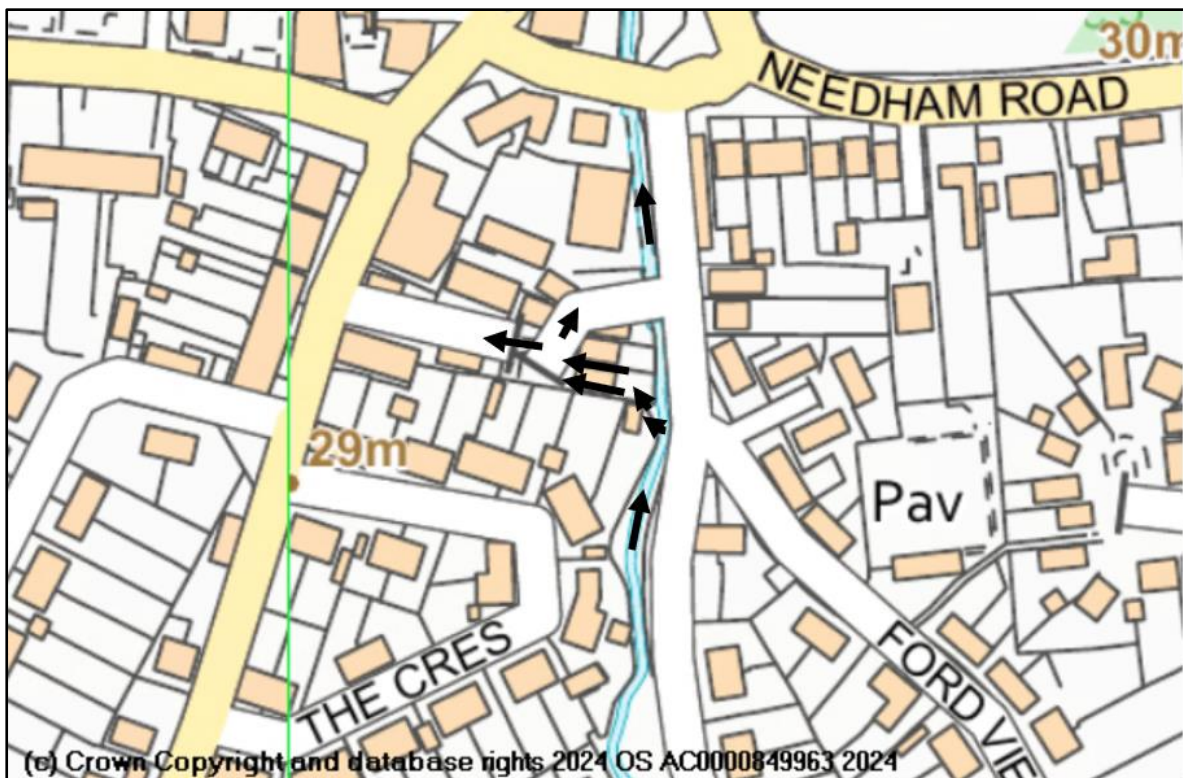
Figure 21 Bramford Court approximate floodwater flowpaths

Bramford Court is projected to be at high fluvial and pluvial flood risk with water flow coming from rivers and overland run off. Affected properties were flooded from Combs Beck overtopping its banks. Floodwater flowed across a section of low-lying bank through an adjacent garden area to the south of Bramford Court, entering Bramford

Court through the fence. It then continued to flow between property and flood further property in Bramford Court. Water levels in Combs Beck were reported as rising on the morning of the 20th October and reaching the level of the bridge into Bramford Court by midday. Flooding was also reported from highway surface water. However, drains in Bramford Court were reported by residents to be clear and were presumably overwhelmed by the extreme conditions.

- Intense and prolonged rainfall caused Combs Beck to overtop and floodwater to surround and enter property.,
- Surface water on the road in Bramford Court contributed to flooding.

- Residents to install Property Flood Resilience (PFR) via grant funded scheme.
- Residents to report obstructions in the watercourse to the Environment Agency.
- Environment Agency and/or riparian landowner to investigate whether raising the level of the low-lying bank on the west side of Comb's Beck, to the south of Bramford Court could reduce the flood risk to property without adversely impacting flood risk elsewhere.
- Explore the potential for NFM measures which aim to attenuate floodwater in the upper catchment of Combs Beck.

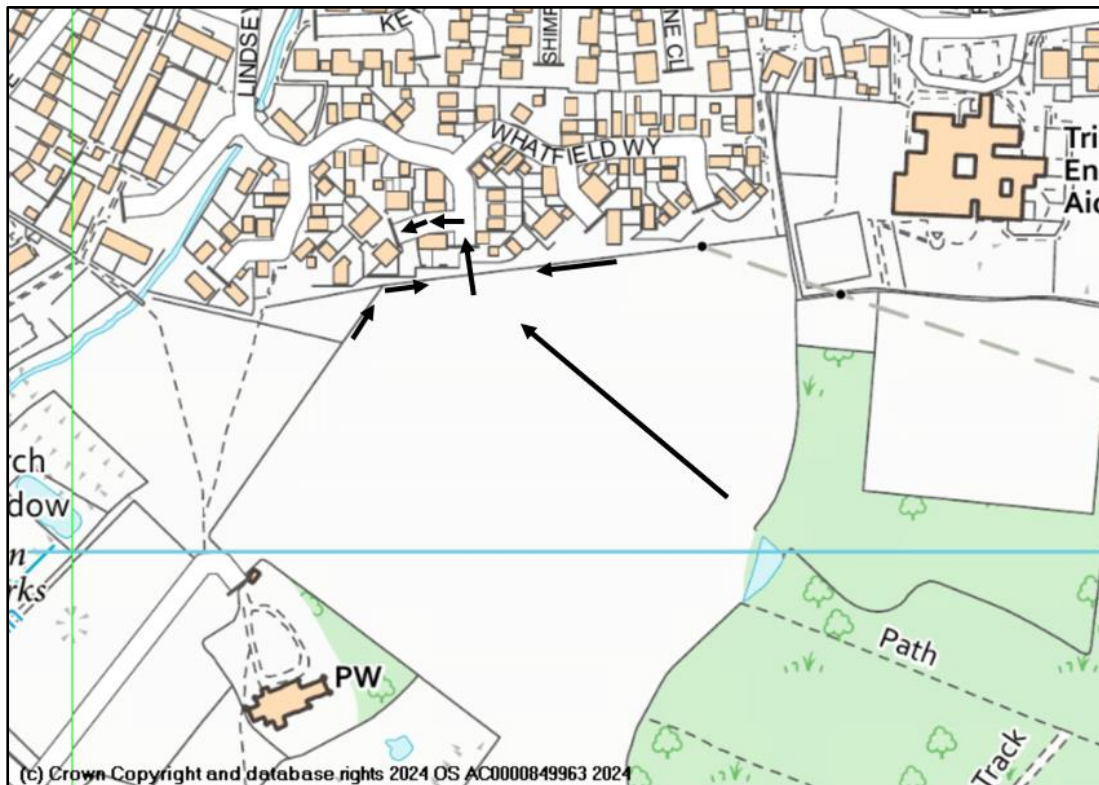
Figure 22 Lindsey Way approximate floodwater flowpaths

Affected property in the southeastern part of Lindsey Way is predicted to be at low pluvial flood risk and no fluvial flood risk. Property in this section of Lindsey Way was affected by surface water flooding from fields to the south which slope down northwest from Combs Wood towards Lindsey Way. Some of this floodwater overtopped a small ditch (which has partly filled with soil) at the bottom of the field and flowed between houses on to the highway. Highway drains were reported as being overwhelmed. Directly behind property in this section of Lindsey Way is a brick headwall with a piped opening across the section of the ditch which transports water from the west side of the field. This has a trash screen and is presumably intended to convey water from the ditch to the surface water drainage system in Lindsey Way. However, this section of ditch also overtopped, flooding property in Lindsey Way from the rear. Flooding of property in this section of Lindsey Way recurred during Storm Ciaran.

- Intense and prolonged rainfall caused surface water to flow northwest from Combs Wood down a field slope towards the southeastern section of Lindsey Way.
- Some of this floodwater overtopped a small ditch across its path and entered Lindsey Way directly.
- Highway drains in Lindsey Way were reported as being overwhelmed.

- Residents to install Property Flood Resilience (PFR) via grant funded scheme.
- Landowners to undertake targeted maintenance (clearing of soil and debris) to the east and west of brick headwall as per riparian responsibilities.
- Landowner(s) to investigate the function and condition of pipe transporting floodwater from ditch at rear of properties in Lindsey Way.
- Suffolk County Council Highways to ensure completion of cyclic maintenance of highway gullies on Lindsey Way.
- Investigate the potential for increasing the storage capacity of the ditch.
- Investigate the potential for additional natural flood management measures (for example bunds and buffer strips) in fields to the rear of affected property.

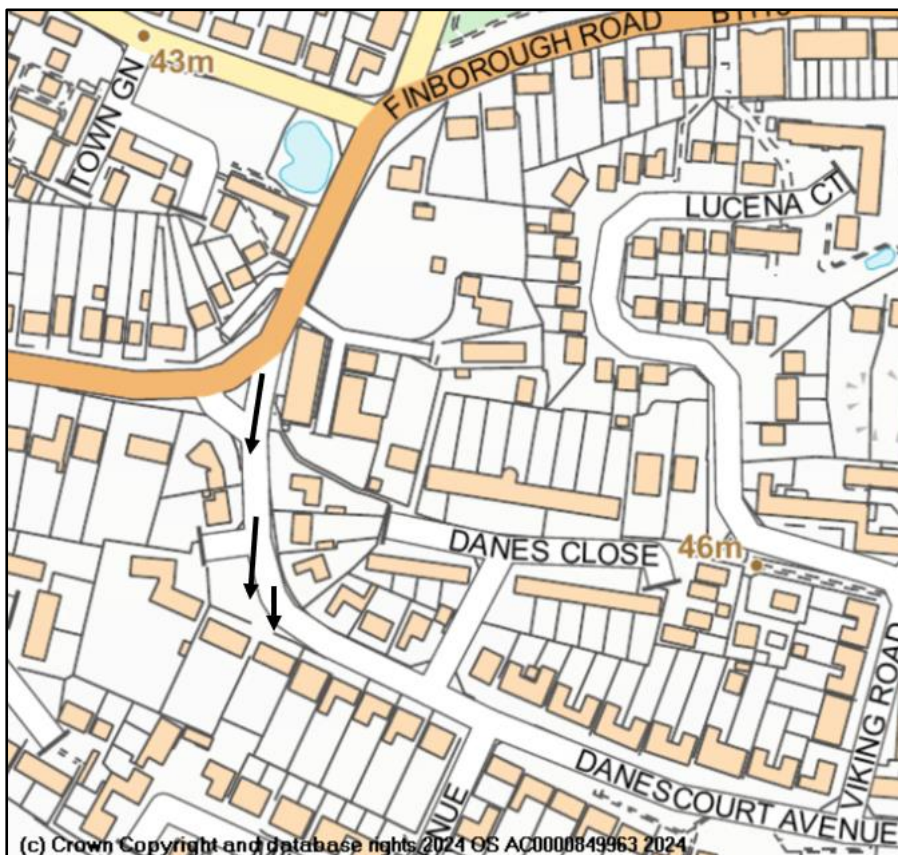
Figure 23 Danescourt Avenue approximate floodwater flowpaths

Affected property is not predicted to be at risk of flooding from fluvial or pluvial sources. However, during the event, surface water was experienced to be flowing south down

- Surface water flowed south down the western section of Danescourt Avenue.
- Highway drainage was overwhelmed and surcharging observed from manhole.
- Properties impacted were situated lower than the highway, causing water to be directed to property.

- Residents to install Property Flood Resilience (PFR) via grant funded scheme.
- Suffolk County Council Highways to ensure completion of cyclic maintenance of highway gullies on Danescourt Avenue.

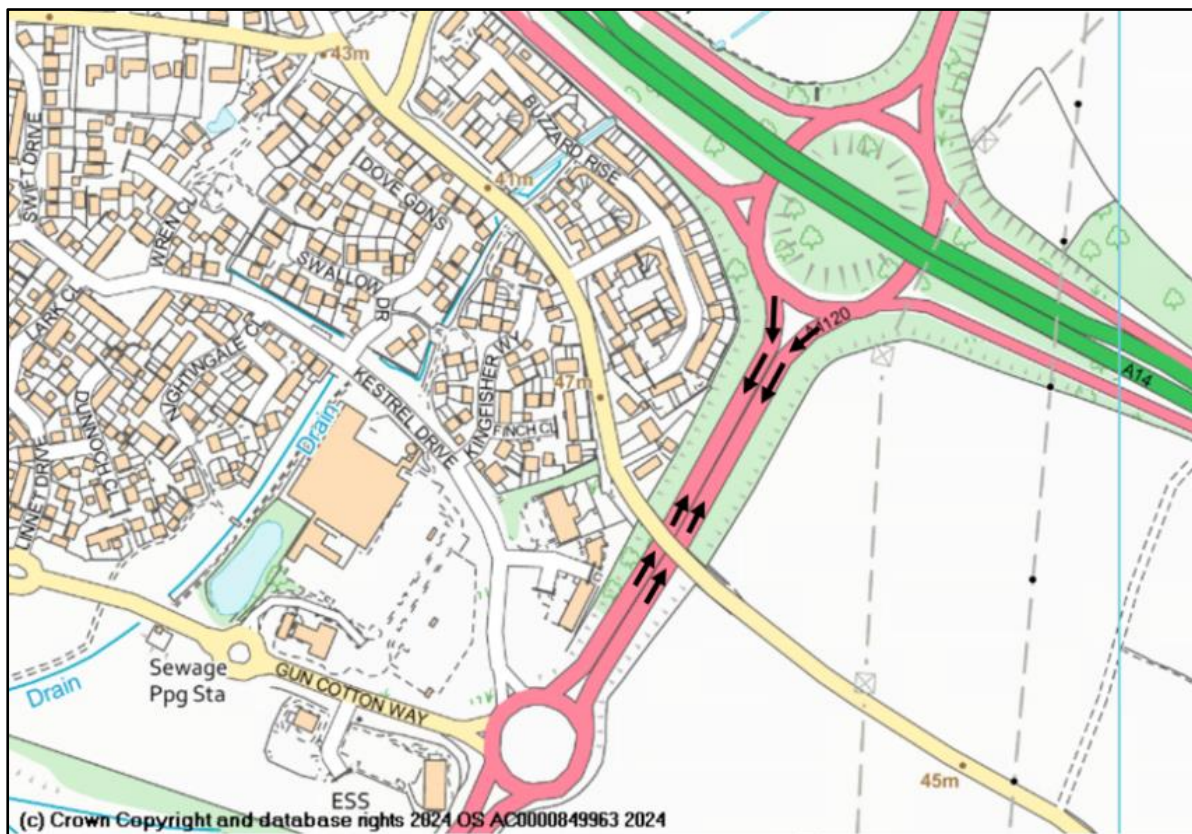
Figure 24 A1120 approximate floodwater flowpaths

Surface water flowed down highway gradients to collect on a section of the A1120, adjacent to the A14 junction roundabout. This resulted in the closure of Lane 1 of the northeast bound carriageway. Subsequently, extensive work has been undertaken to

clear and jet highway drainage assets. Further repair work to drainage in this area is being planned to complete this work through to outfalls.

Clear/repair drainage assets to outfalls on A1120 by A14 junction	Suffolk County Council Highways Authority	Jetting and CCTV video survey completed August 2024.

Complete clearing/repair of drainage assets to outfalls on A1120 by A14 junction	SCC Highways Authority	6 months – 12 months	The next stages of A1120 to jet and investigate further towards outfall and carry out
