## Section 19 Flood and Water Management Act 2010

### Hoxne Flood Investigation – Storm Babet 2023

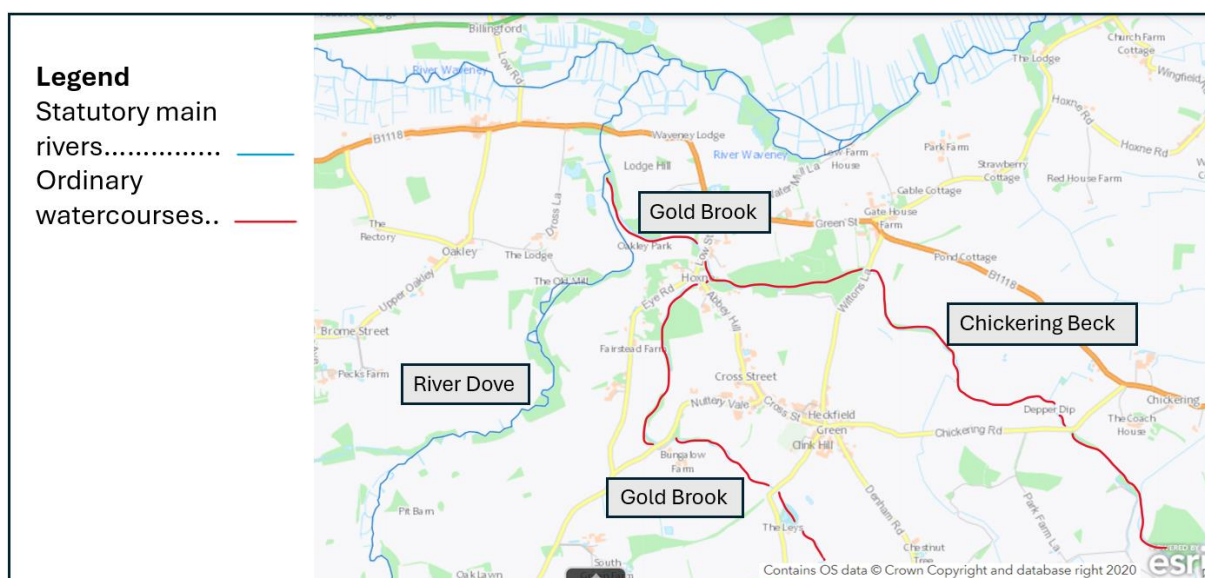
Figure 3 shows the most significant watercourses in the area surrounding Hoxne. The Environment Agency has permissive powers to carry out maintenance, improvement or construction work on main rivers to manage flood risk. The Internal Drainage Boards (IDBs) have similar permissive powers but instead relate to ordinary watercourses within their board area.

Lead Local Flood Authorities (LLFAs) and Internal Drainage Boards (IDBs) manage the flood risk from ordinary watercourses but responsibility for maintaining watercourses rests with the Riparian Landowner, defined as those who have a river, stream or ditch which runs next to or through their land or property. The two watercourses within Hoxne, Chickering Beck and Gold Brook, are not designated as main river and instead are considered ordinary watercourses. The two watercourses are located within the Waveney, Lower Yare and Lothingland IDB.

Figure 3. Location of statutory main rivers and significant ordinary watercourses

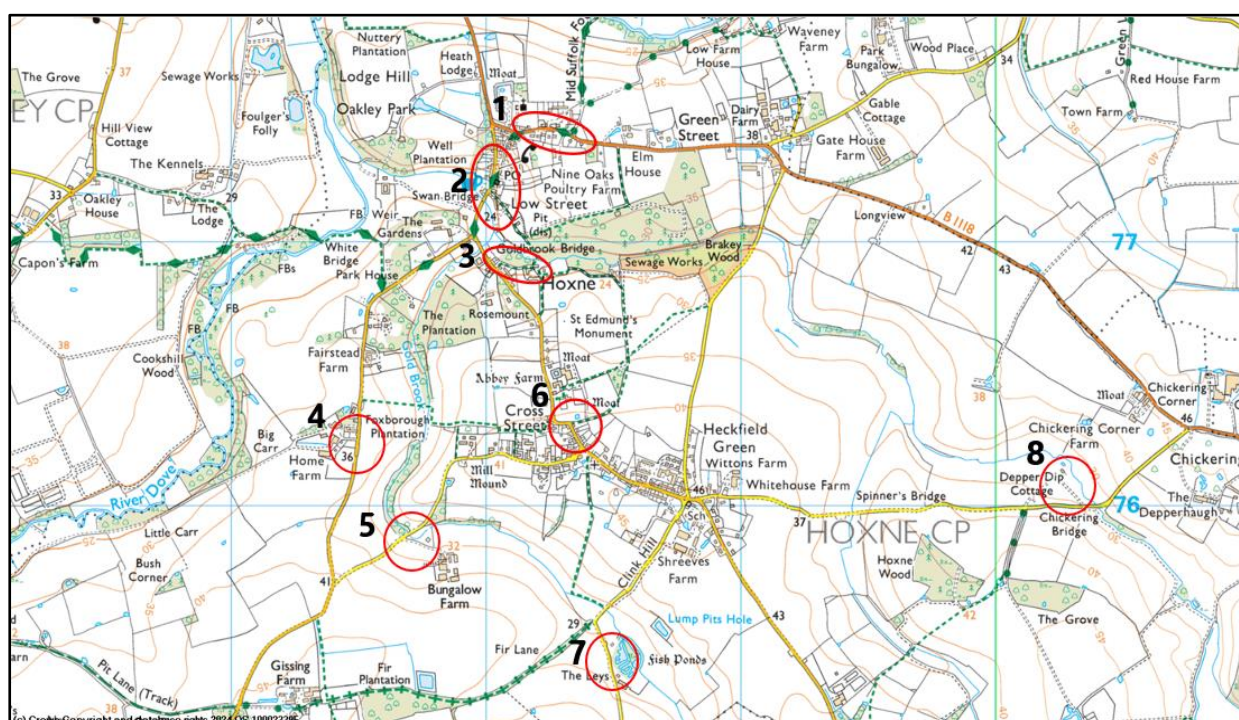
For the purposes of this investigation the various areas affected by flooding have been separated into eight distinct locations (see Figure 4). The locations are as follows:

1. Green Street
2. Low Street
3. Abbey Hill
4. Eye Road
5. Nuttery Vale
6. Cross Street
7. Denham Low Road
8. Chickering Road

Figure 4. Investigation area map with locations

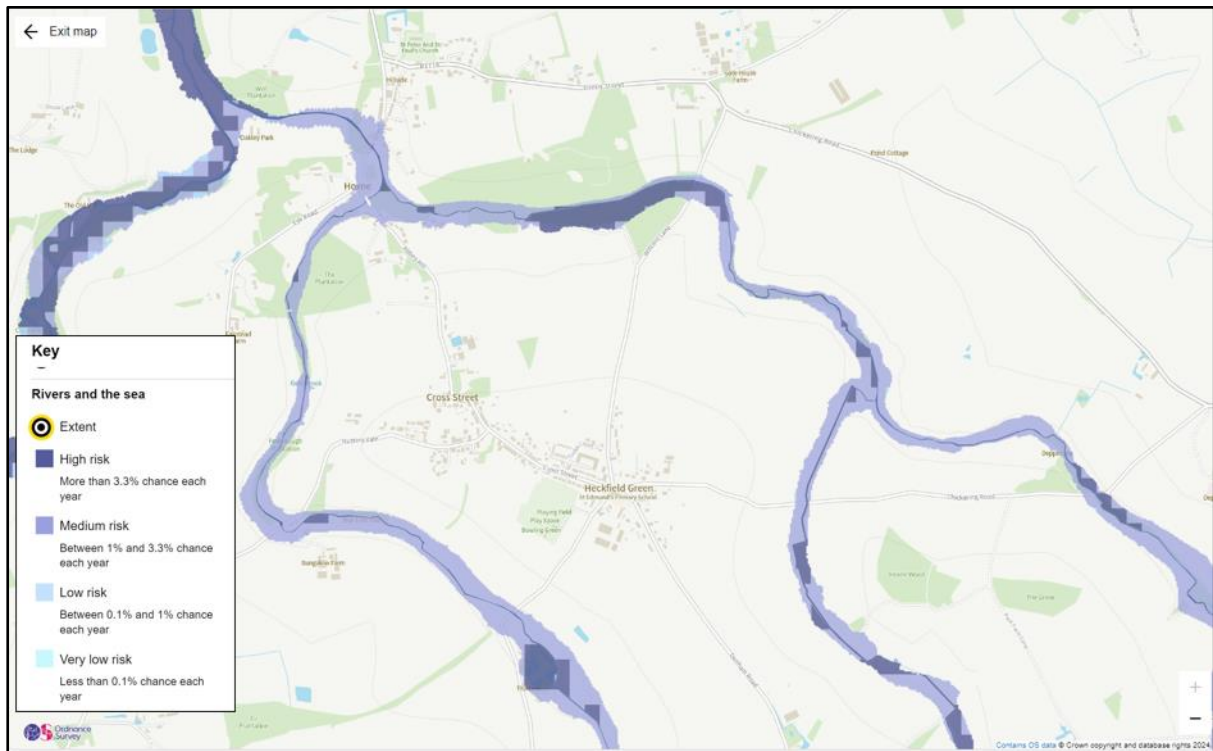
Figure 6. Predicted flood risk from rivers and sea

Figure 6 highlights the predicted fluvial (from designated main river and ordinary watercourses) flood risk in and around Hoxne. Fluvial flood risk around Hoxne is associated with the Chickering Beck and Gold Brook watercourses. Areas at high risk of fluvial flooding include the Denham Low Road, Low Street, Abbey Hill and parts of Chickering Road. These areas were affected by flooding during Storm Babet.

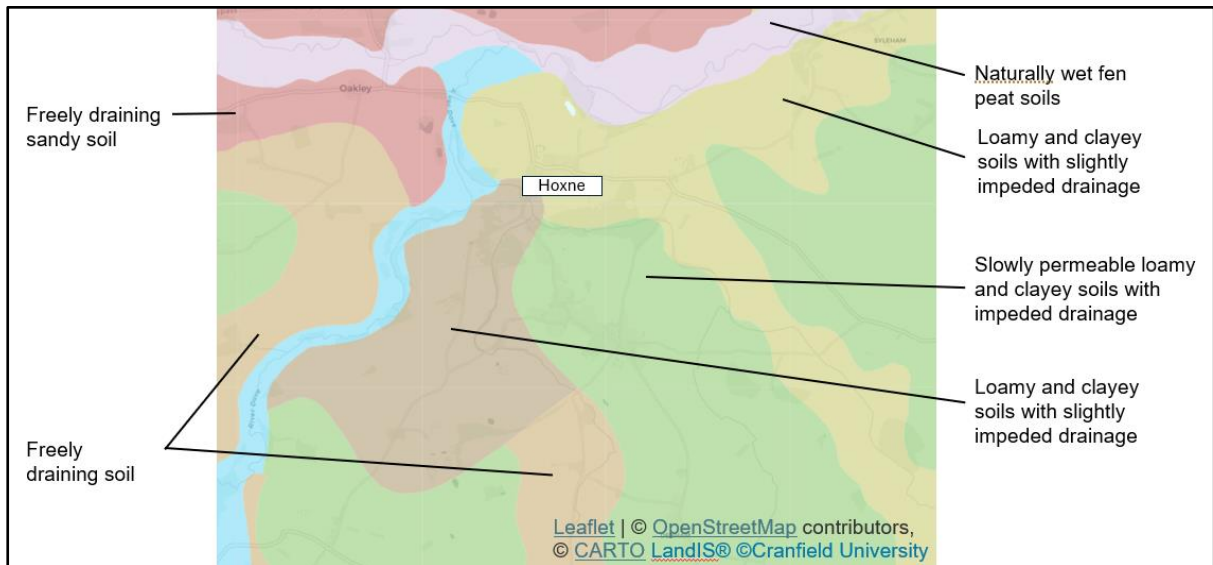
Figure 8. Hoxne and surrounding soils (LandIS Soilscales)

With regards to soils, Hoxne is situated mostly on sand and gravels with a mixture of clay and silts. To the east and immediately south of the village they are described as loamy and clayey, with impeded drainage. To the west and further due south of Hoxne village, soils are more freely draining, allowing water to permeate more rapidly and therefore reducing the amount of surface water run-off. The floodplain soils surrounding the Gold Brook and Chickering Beck watercourses usually have naturally high groundwater and tend to be wetter.

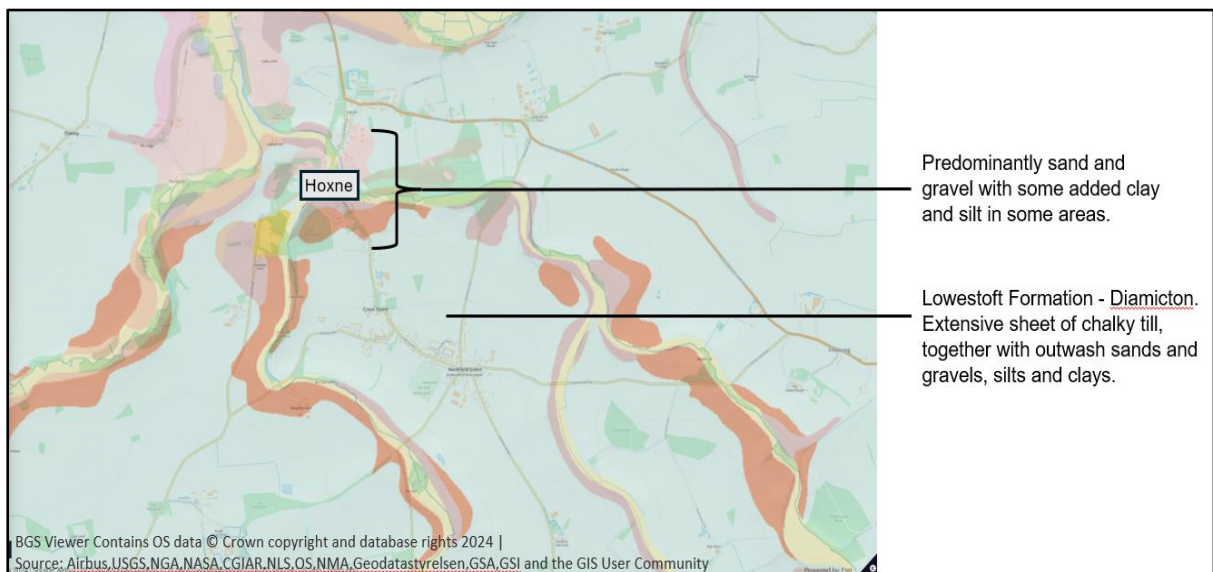
Figure 9. Superficial geology (BGS Geology Viewer)

Lowestoft Formation 'Diamicton' surrounds the village more generally which is described by the British geological survey as a diverse mixture of clay, sand, gravel, and boulders varying widely in size and shape. This generally has a low permeability meaning water will tend to flow off it before it can be infiltrated, which reflects some of the reports from the Storm Babet event.
