## Section 19 Flood and Water Management Act 2010

### Report Title: Elm Close, Hazel Close, Greenwood Close & Harewood Terrace, Haverhill

CRNos 330018, 329910 & 330025

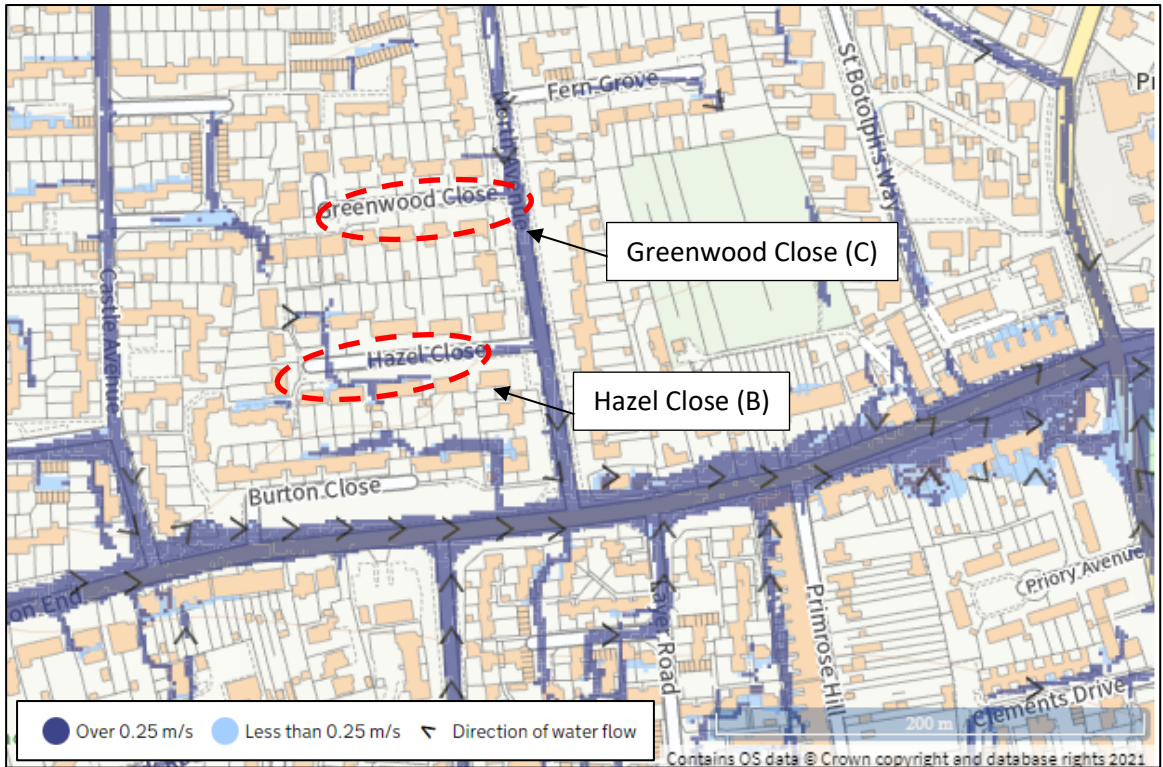
Figure 7 – Surface water flood risk: water velocity in low-risk scenario (GOV.UK mapping)

The flow path through Elm Close towards Property A, can clearly be seen in the above figure. Likewise, the flow path can clearly be identified past and through Property B, in Hazel Close, in figure 7 overleaf.

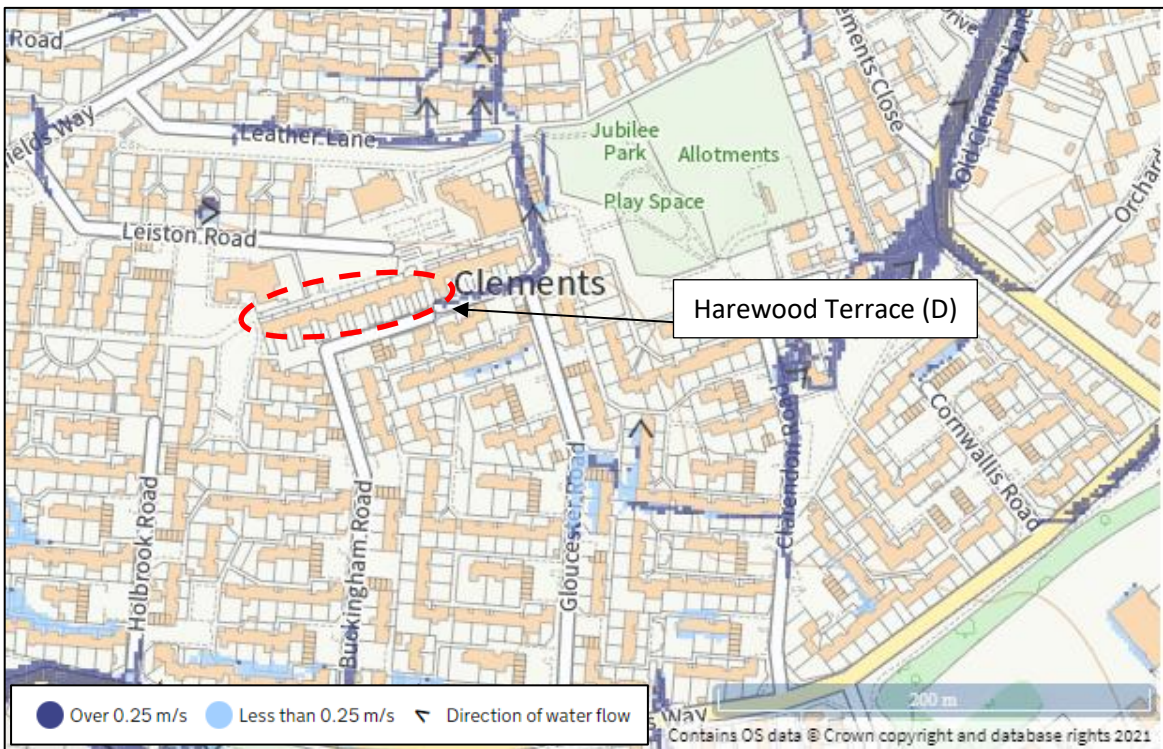
Figure 8 - Surface water flood risk: water velocity in low-risk scenario (GOV.UK mapping)

The flow paths in Greenwood Close and Harewood Terrace are not so evident from the mapping however this is likely to be a result of the inaccuracies within

the model rather than a true representation of the surface water flow regime locally.
