Section 19 Flood and Water Management Act 2010

Report Title: Sturmer Road, Haverhill

CRNos 288982 & 329959

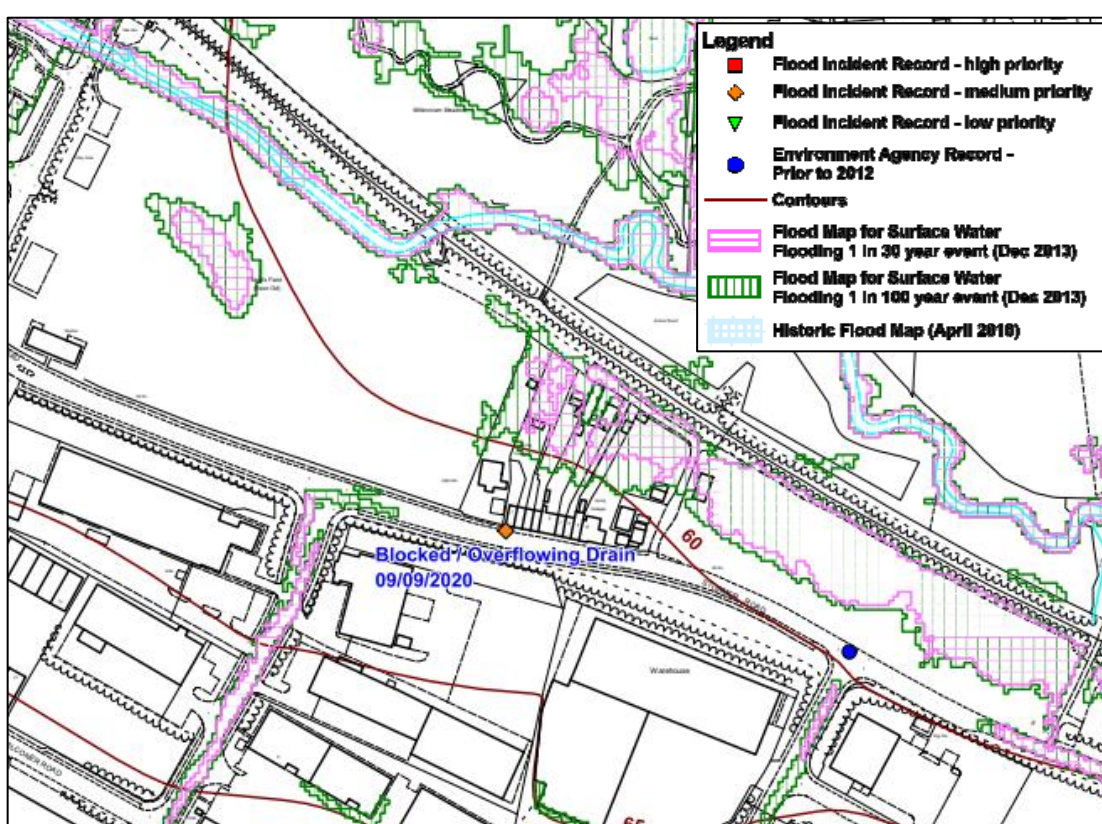
Figure 2 - Historical Pluvial Flood Incidents (to be updated once the 2021 events have been mapped)
©Crown copyright and database rights, Suffolk County Council Licence No. 100023395 2021

Anecdotal evidence indicates that several of the properties in this area experience internal flooding once or twice annually during sudden and intense rainfall events. The most recent dates are August 2020 and July 2021.

Shown in Figure 2 below is a map extract of the recorded historical pluvial flood events as held by SCC. Please note that as all of the above events were not formally reported to SCC, they do not all appear on the following extract.
