Section 19 Flood and Water Management Act 2010

Long Melford Flood Investigation – Storm Babet 2023

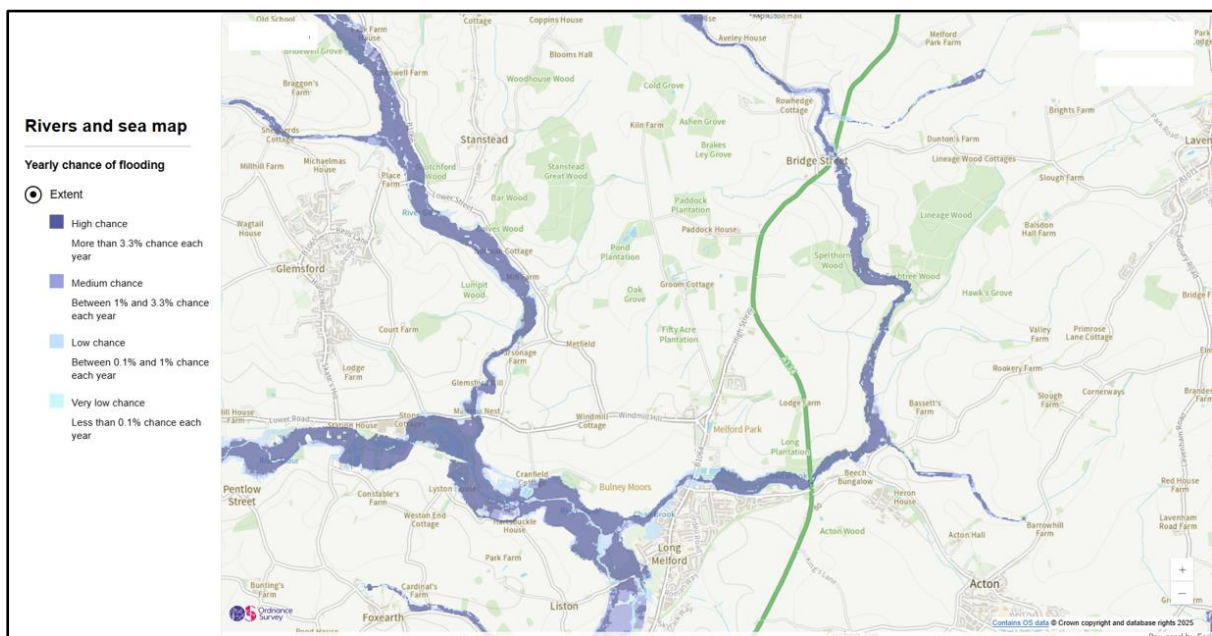
Figure 5. Predicted flood risk from river water (fluvial)

Fluvial flood risk in Long Melford village and Bridge Street is associated with Chad Brook, (Figure 5). Further west on the A1092, fluvial flood risk is associated with the River Glem. Projected fluvial flood risk corresponds with affected property in Bull Lane, Clare Road, Cock and Bell Lane, Hall Street and Bridge Street Road which reported being flooded from watercourses.

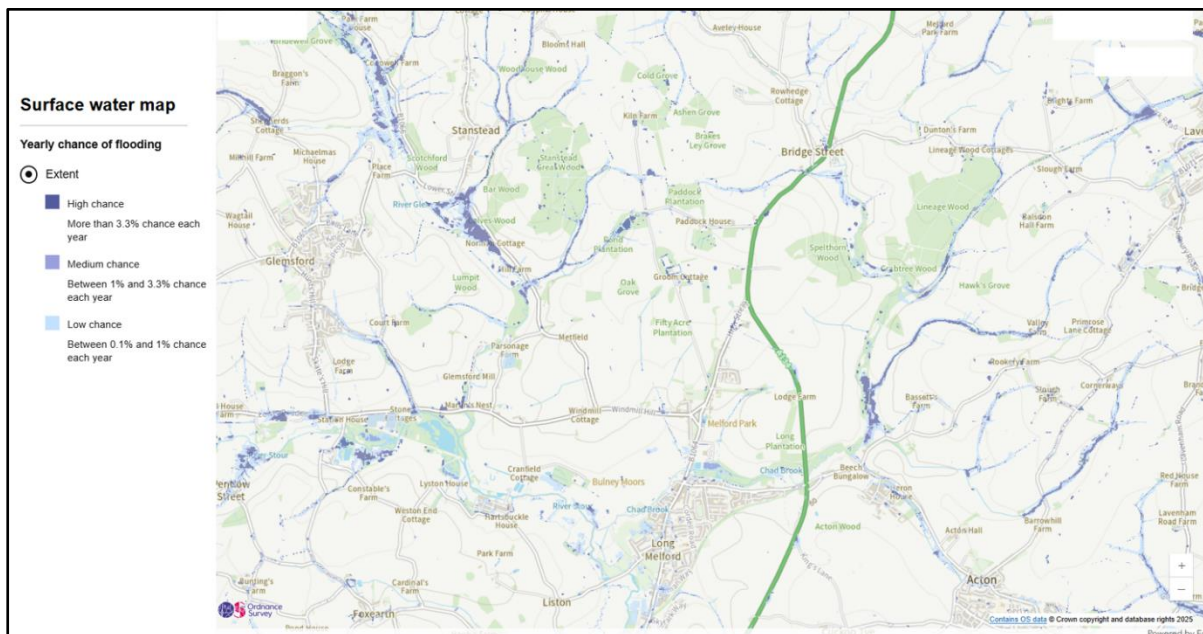
Figure 6. Predicted flood risk from surface water (pluvial)

Most of the affected property was projected to be at surface water flood risk, or adjacent to areas of surface water flood risk (Figure 6). Surface water flood risk was projected to be the sole flood risk for affected property in Westgate Street.

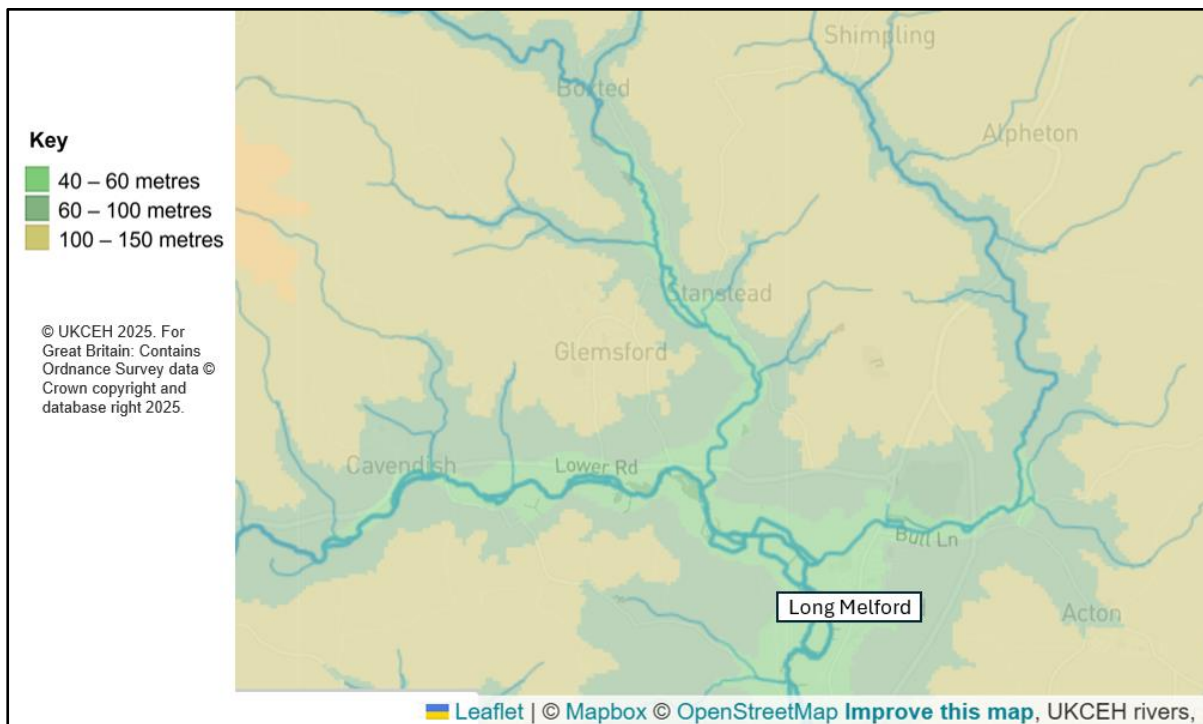
Figure 7. Elevation map of Chad Brook and River Glem catchment areas (National River Flow Archive)

The primary catchment affected by internal flooding of property in the parish of Long Melford is the Chad Brook catchment, where 8 properties were flooded. One property was flooded in the River Glem catchment. The rivers in both these catchments contribute to the River Stour, but this is downstream of affected properties. Both the Chad Brook and River Glem catchment and the parish of Long Melford which partly overlies them are located in a rural and predominantly arable area. The affected parts of the A1092, the village of Long Melford and Bridge Street are all in relatively low-lying areas (Figure 7).

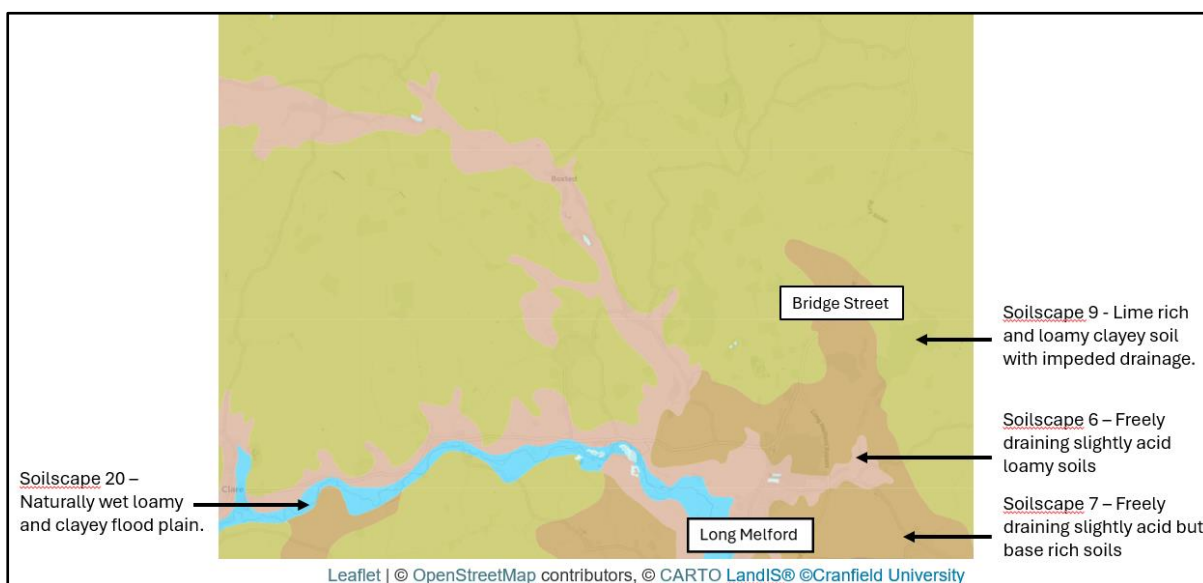
Figure 8. Soil map of upstream catchment areas for the River Glem and Chad Brook (LandIS Soilscales)

The soils in Long Melford village and Bridge Street are described as freely draining (Fig. 8). However, the soil type that covers much of the upstream catchment for the River Glem and Chad Brook is described as being loamy, clayey and having impeded drainage. In these areas, water permeates more slowly and surface water runoff is greater, particularly during intense rainfall. The saturated nature of the soils leading up to Storm Babet would also have prevented some infiltration, increasing runoff.

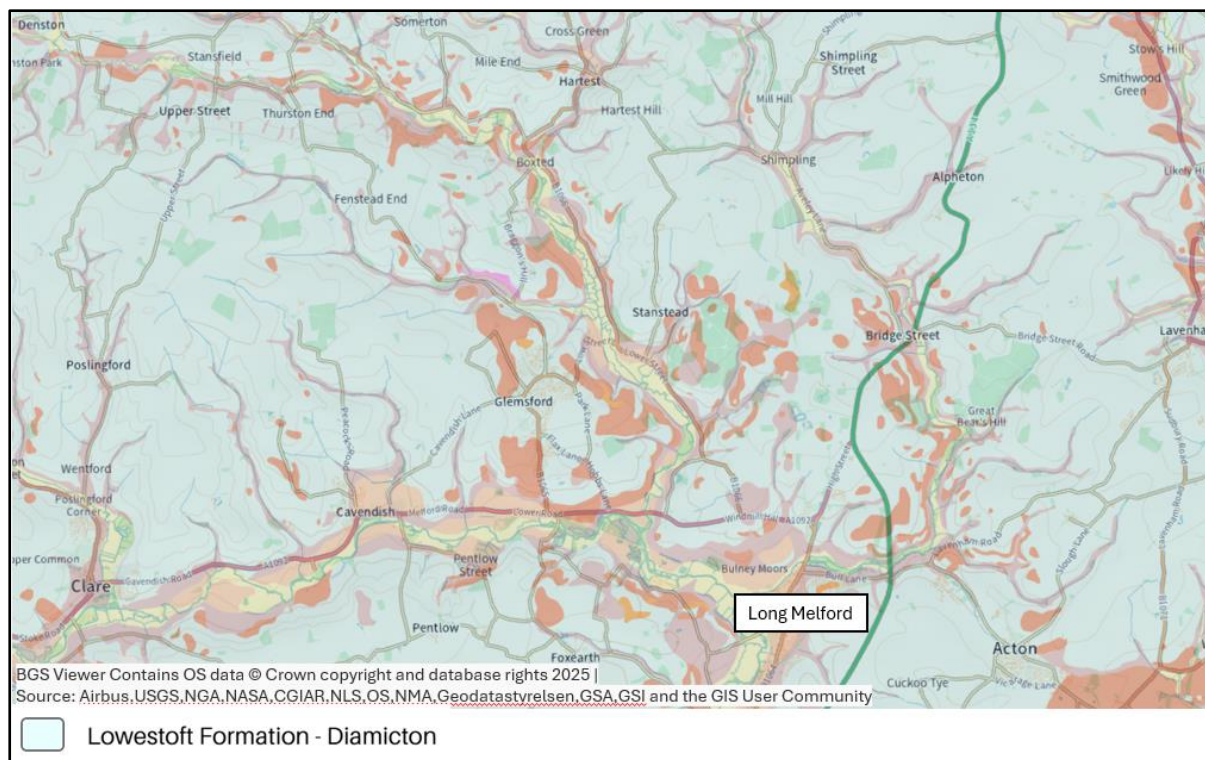
Figure 9. Superficial geology (BGS Viewer)

Superficial geology layers within the parish are diverse (Figure 9). However, much of the superficial geology in the wider area and upstream catchment is made up of 'Lowestoft Formation – Diamiction' which is described by the British Geological Survey as a diverse mixture of clay, sand, gravel, and boulders varying widely in size and shape. This is sometimes known as boulder clay. This generally has a low permeability meaning water will also tend to flow off it before it can infiltrate, which reflects the reports collected during Storm Babet. This also further increases fluvial flows as the surface water joins rivers.
