## Section 19 Flood and Water Management Act 2010

### Needham Market Flood Investigation – Storm Babet 2023

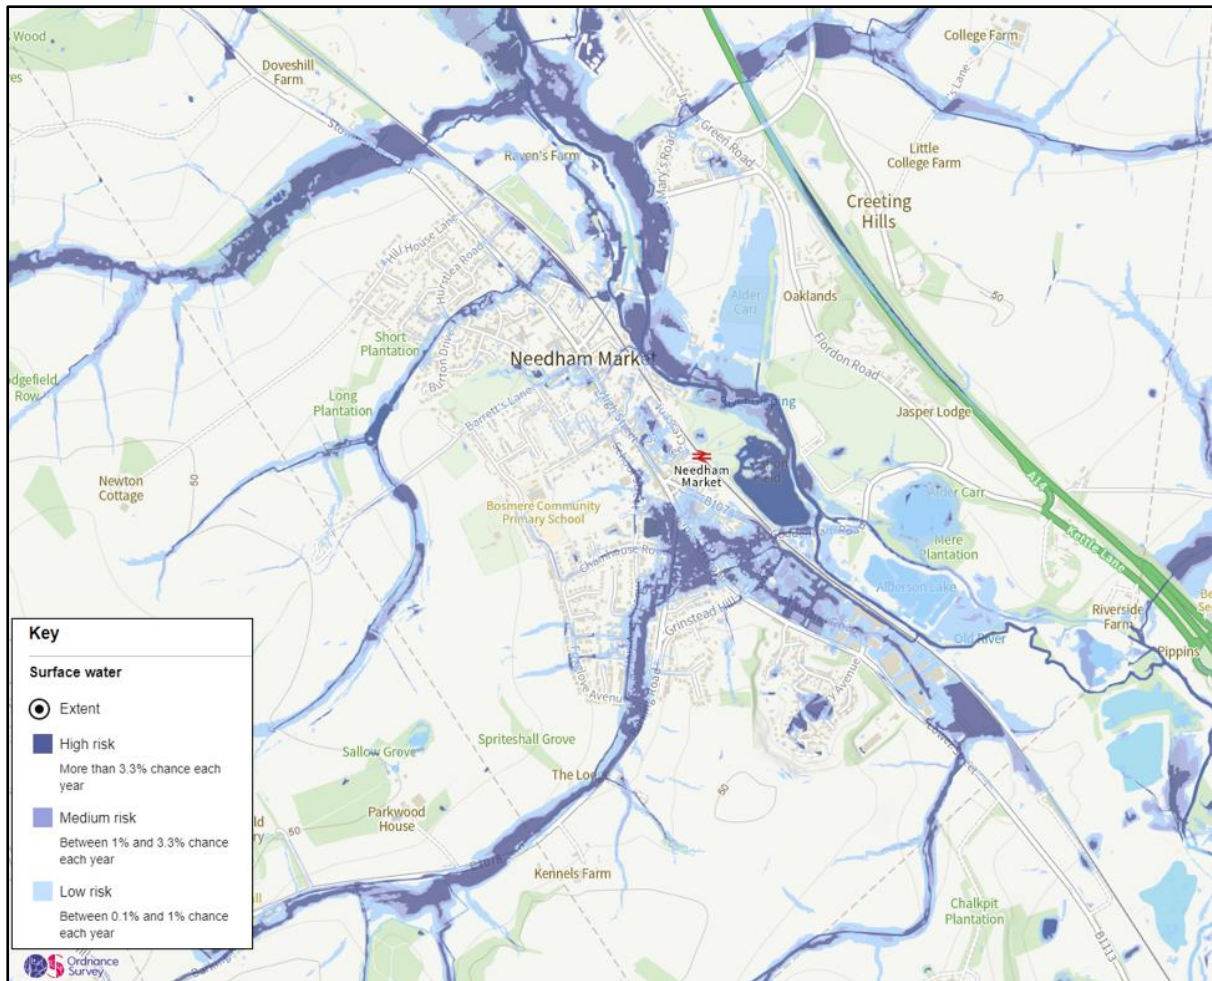
Figure 5 - Predicted Pluvial Flood Risk

Figure 5 highlights the predicted pluvial (surface water run-off from surrounding land and ditches) flood risk within Needham Market, with five main flow paths coming into the town. This indicates that there is significant risk of surface water flooding on Barking Road, Foxglove Avenue, Hargrave Avenue, Pinecroft Way, Limetree Close, Hawks Mill Street, Crown Street and Highland Close. These areas were all affected by flooding during Storm Babet.

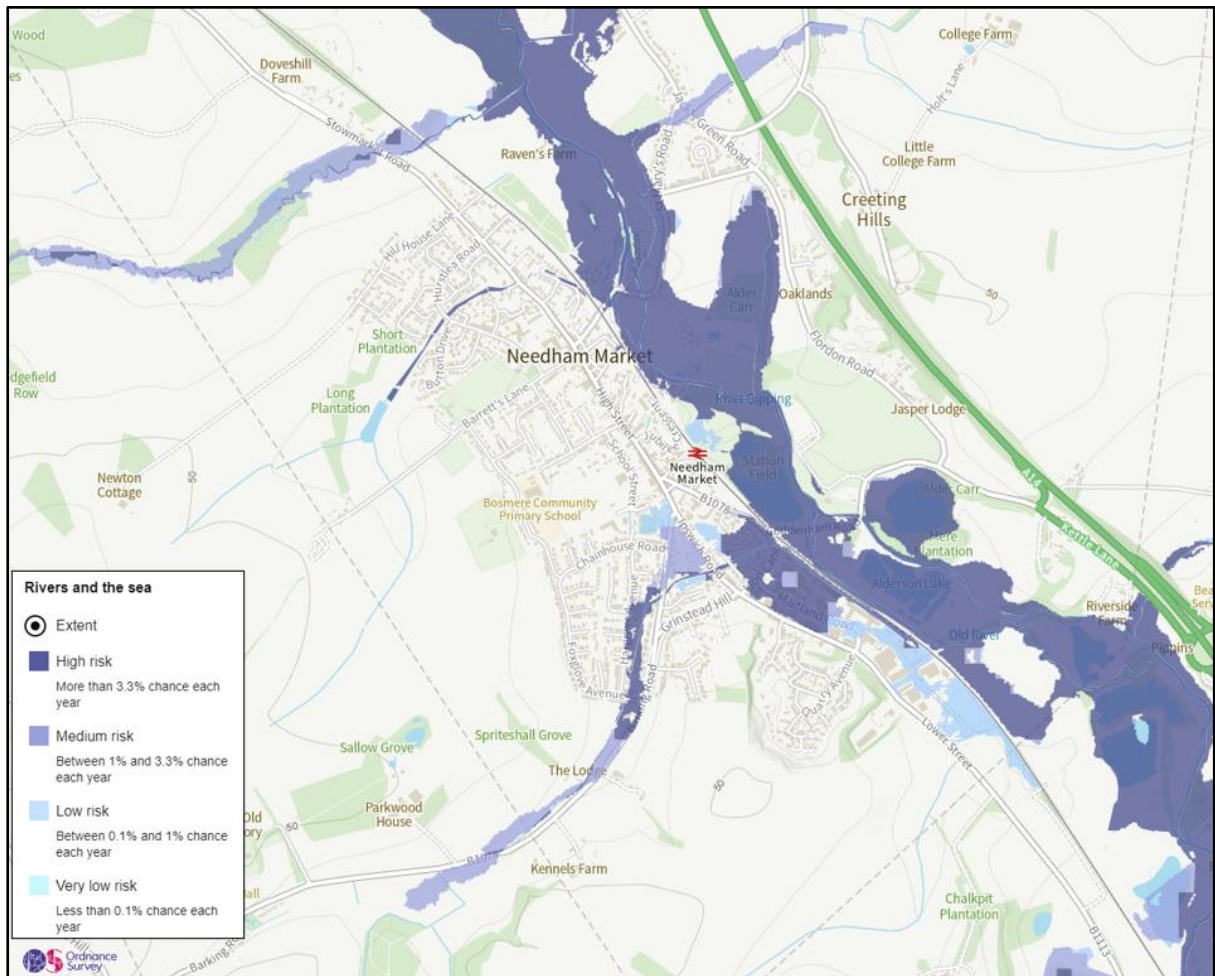
Figure 6 - Predicted Fluvial Flood Risk

Figure 6 highlights the predicted fluvial (from designated main river) flood risk within Needham Market. The main fluvial influences consist of the main river Gipping, the Lion Barn drain and the Orchard Gate watercourse. The Hawks Mill area, Crown Street, Pinecroft Way, Maitland Road, Barking Road and some areas of Foxglove Avenue are shown as being at risk for fluvial flooding. These areas were affected by flooding during Storm Babet.

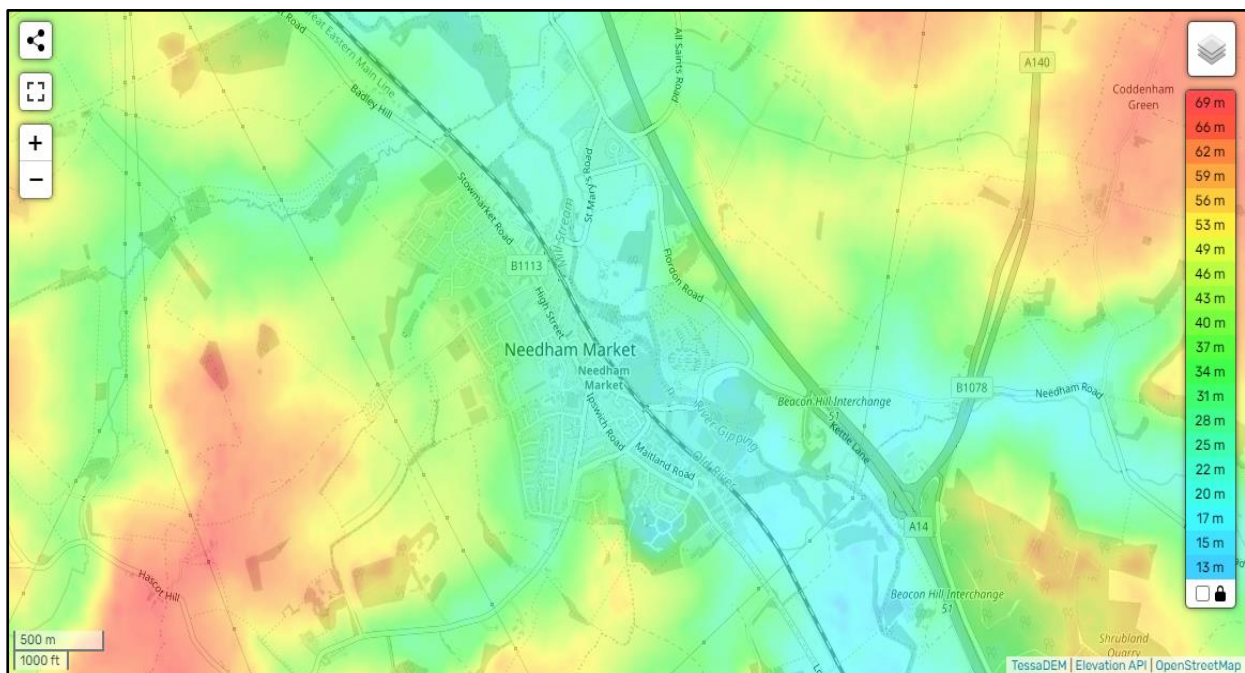
Figure 7 - Needham Market and surrounding topography

Figure 7 shows the topography surrounding Needham Market and the gradient changes across the town. Hawks Mill, Pinecroft Way, Limetree Close, Maitland Road and Lion Lane are among the lowest lying locations in Needham Market. These were identified as being some of the worst affected areas following Storm Babet.

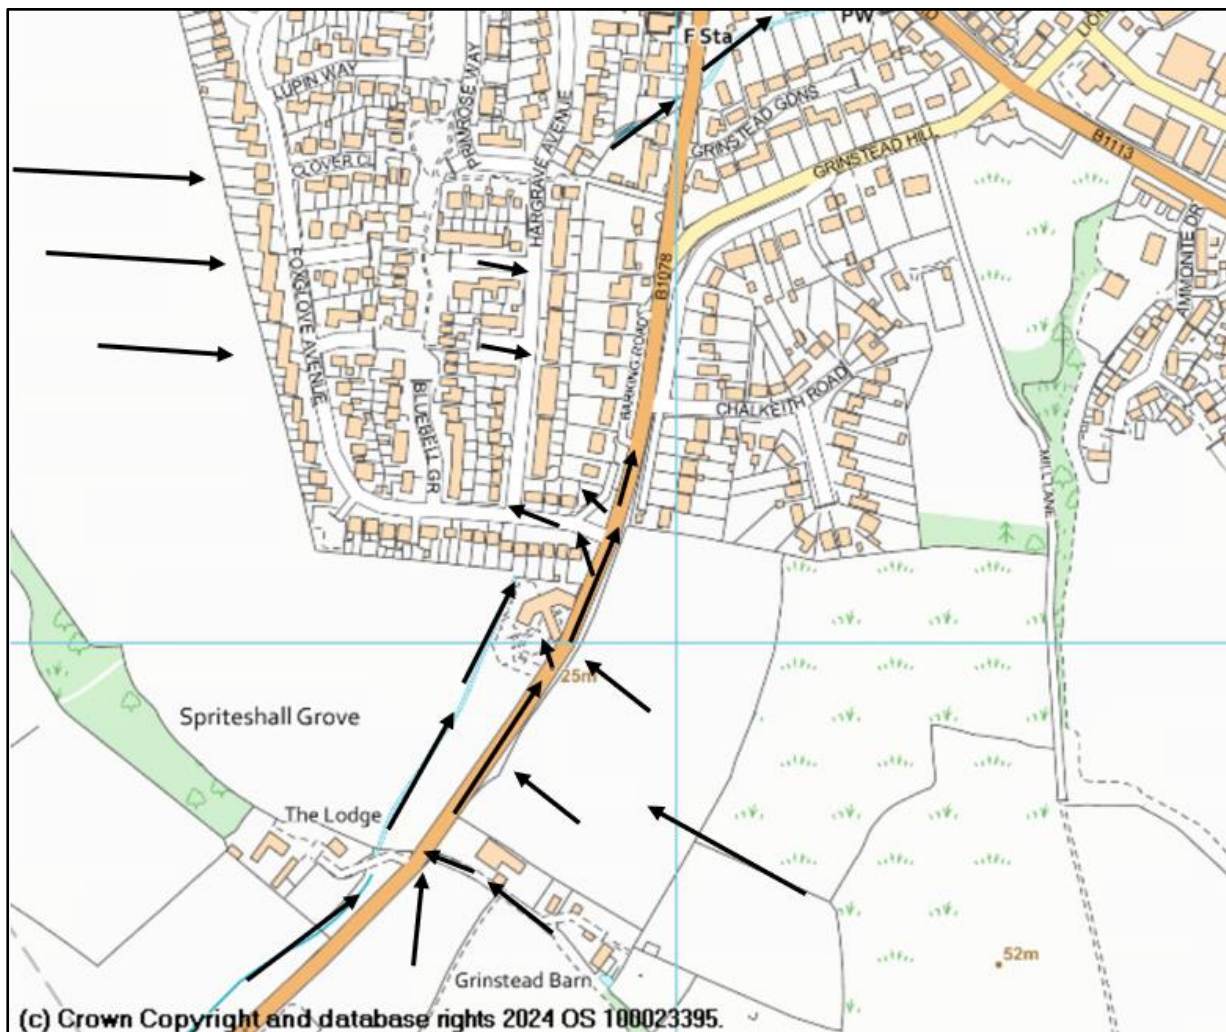
Figure 10 - Approximate floodwater flow routes on Barking Road, Foxglove Avenue, Hargrave Avenue and School Street

On the morning of 20 October 2023, a number of tributaries in the rural upper catchment directed water into the town. Floodwater flowed along Barking Road towards Foxglove Avenue originating from fields to the east around Grinstead Barn, before emerging onto the carriageway. There were additional overland (surface water run-off) flow paths merging onto Barking Road from fields to the south either side of Priestly Wood close to Barking. Outside the pharmacy entrance on Barking Road, water was starting to pool from 09:00am onwards and by 11:00am water was observed to be coming into the car park from the road (Image 1).

Water was also arising from a surcharging manhole at the entrance to the Grinstead Barn turnoff. Additionally, an inspection chamber in the field to the west of Barking Road was blocked and added to the floodwater flowing along the road. Since Storm Babet, there have been additional reports that water is still surcharging from the area near the entranceway to Grinstead Barn and flowing north-eastwards along the Barking Road and towards Foxglove Avenue. Suffolk Highways are aware of the issues at this location. Jetting and initial investigations have already happened, and further actions are planned to be carried out.

Properties near to the junction of Foxglove Avenue and Barking Road were impacted by water entering Foxglove Avenue from Barking Road later in the morning. A drop kerb immediately south of the junction created a low entry point from the road (Image 2). This low point allowed water to pass onto Foxglove Avenue at a quicker rate and bypass a raised traffic calming road bump on Foxglove Avenue close to the junction with Barking Road. Properties at this location were also flooded internally in early January 2024 during Storm Henk.

- Investigate potential NFM projects to 'slow the flow' and attenuate water on overland flow paths (leaky dams, restoration of watercourses, etc.) to the west and south of Needham Market.
- Explore options to reduce the field run off from the west of Foxglove Avenue. Possible use of a vegetation strip / break, bund or ditch between field and properties.
- Investigate the potential to raise the dropped kerb on Barking Road.
- Investigate the drainage problems below Barking Road near Grinstead Barn
- Ensure a maintenance regime is in place for the entrance to the Anglian Water culvert upstream Hargrave Avenue. A CCTV survey to be conducted.
- Investigate highway drainage infrastructure to ensure capacity and condition are sufficient.

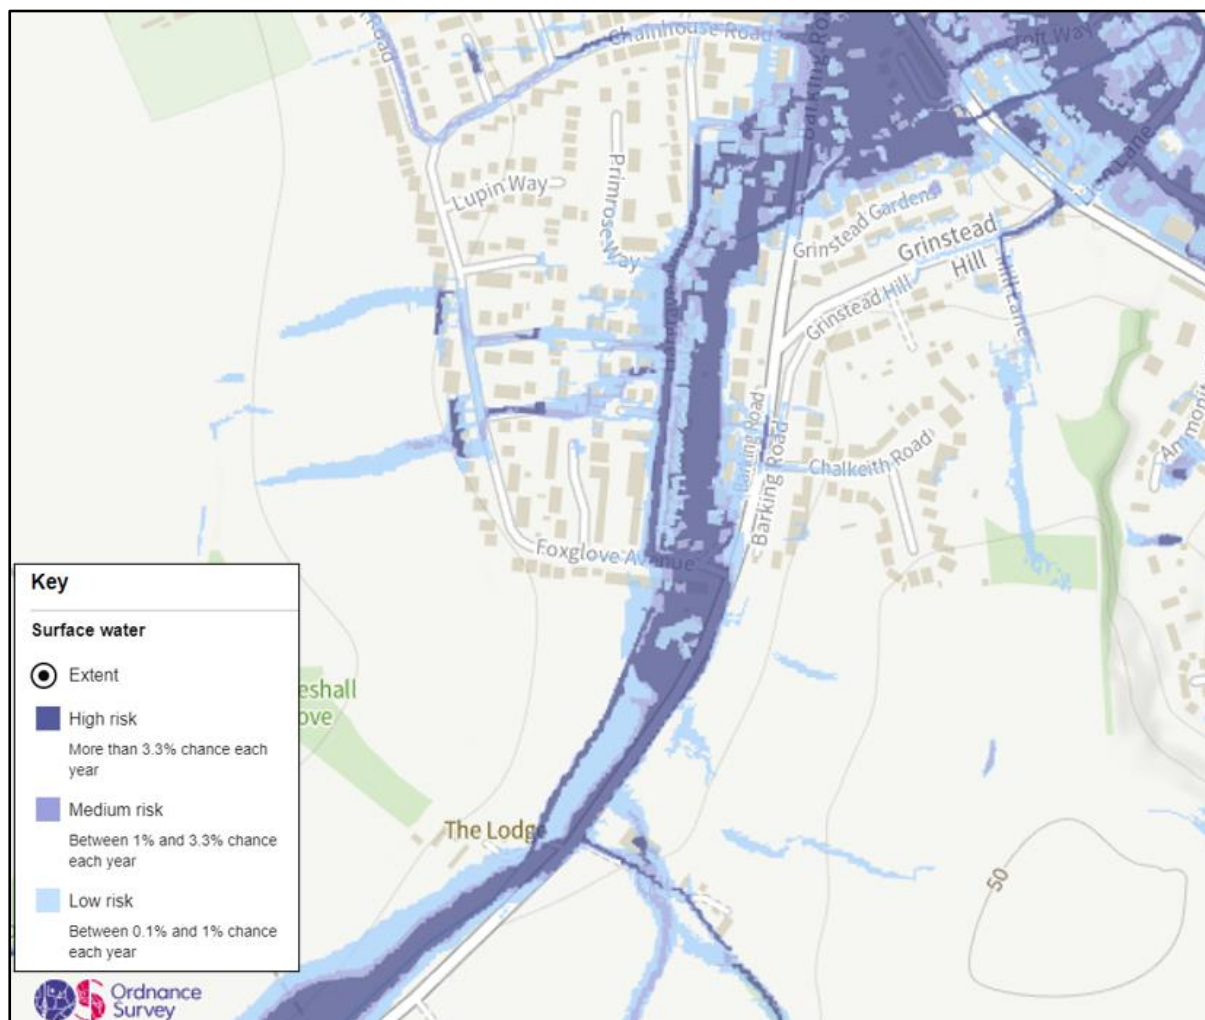
Figure 11 - Predicted Pluvial Flood Risk, Barking Road and Foxglove Avenue

Several properties along Foxglove Avenue were reported to have flooded from the fields to the west, at the rear of the properties. Local reports coupled with LIDAR imagery of the field, indicate the field slopes to the east funnel the surface water runoff towards the affected properties. This happened in the early hours of 20 October from around 03:00 am onwards. This closely matches the flow paths and extents shown in the predicted surface water flood risk mapping (Figure 11).

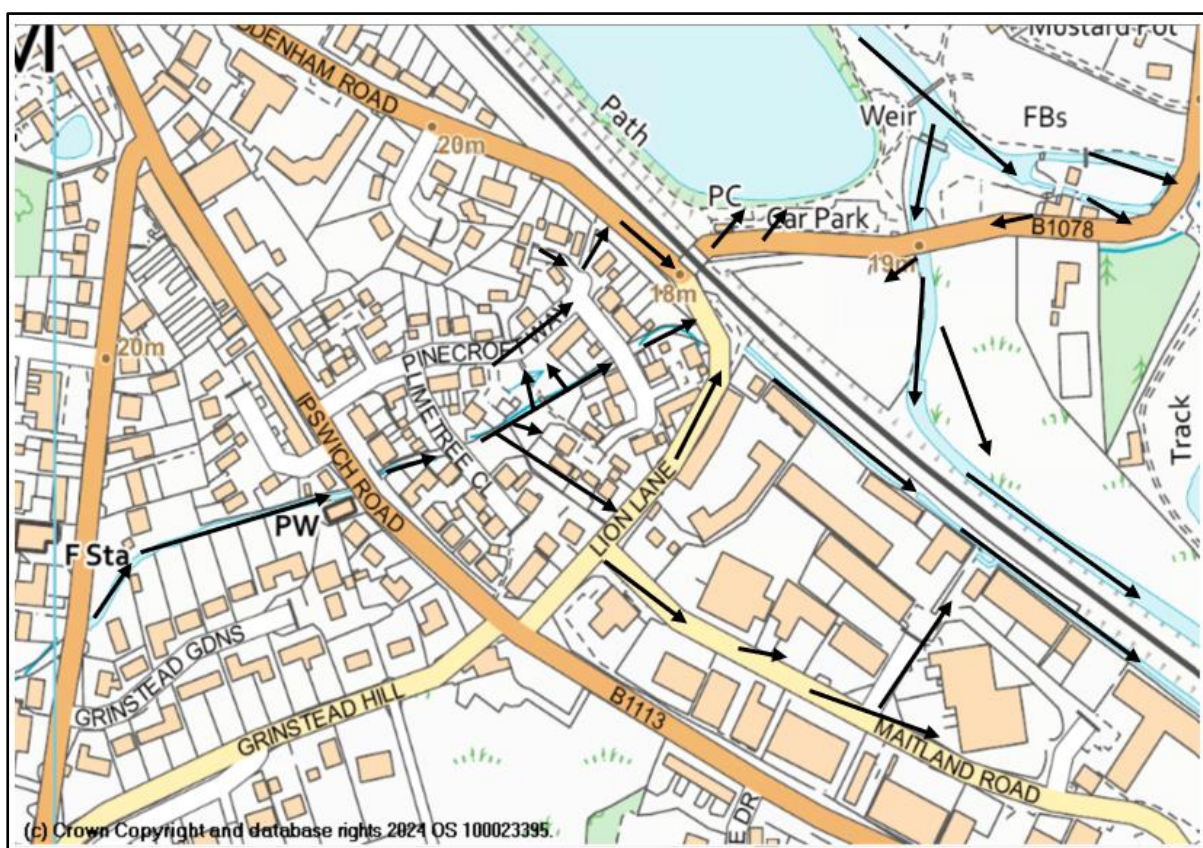
Figure 12 - Approximate floodwater flow routes on Pinecroft Way, Lime Tree Close, Lion Lane, Maitland Road and Coddendam Road

Puddles began to form on the highway from 10am onwards and water levels continued to rise throughout the morning. Eyewitness testimony and photographic evidence indicate that some of the water from Lion Barn drain was surcharging back out of the road gullies as the water level within the watercourse rose higher than the relative level of the road gully prior to any overtopping of the watercourse banks (Image 3). The floodwater began to accumulate on the roadway and by early afternoon the water was impacting houses.

There were multiple flow pathways for the floodwater to travel across Pinecroft Way once water levels in the channel rose above the banks, resulting in water leaving the channel. Some of the floodwater flow paths followed the course of historic ditches and ponds that existed on the land prior to the housing estate. The channels and ponds have historically been infilled to aid the construction of the estate in the early 1980's. Historic maps that precede the development of Pinecroft Way show the alignment of a ditch and associated pond. It is this pathway that flooded properties on Lime Tree Close before flowing onto Lion Lane. Over time the ditch infill material has settled and created low spots in the landscape over which the floodwater could flow.

Floodwater overtopped the northern bank of the watercourse flooding properties on the northern side of Pineroft Way and overtopped the southern bank flooding properties on the southern side of Pineroft Way and Limetree Close (Images 4 & 5). It also backed up onto Lion Lane through another unflapped outfall, merging with floodwater on the corner with Coddendam Road from the railway bridge direction and then into Maitland Road, affecting buildings on the Lion Barn industrial estate (Image 6).

- Investigate potential NFM projects to ‘slow the flow’ and attenuate water on overland flow paths (leaky dams, restoration of watercourses, etc.) to the west and south of Needham Market.
- Fit non-return flaps on the outfalls along the Lion Barn drain through Pinecroft Way.
- Investigate capacity of the culvert under Lion Lane / Coddenham road corner. Carry out a de-silt / cleanse if required.
- Investigate options to enhance the flood risk benefit of the bund between Pinecroft and Coddenham way to allow drainage from the estate and defence from flooding from the main river Gipping.
- Investigate highway drainage infrastructure to ensure capacity and condition are sufficient.
