Sea Link Grid Reinforcement
Pre-Submission Engagement
Suffolk County Council Response

January 2025

Sea Link Pre-Submission Engagement
Suffolk County Council Response
Appendix C: Benhall Railway Bridge
Principal Inspection Report

**BENHALL RAILWAY BRIDGE
BRIDGE No. 59/42
(BRIDGE CODE 1717)
BENHALL**

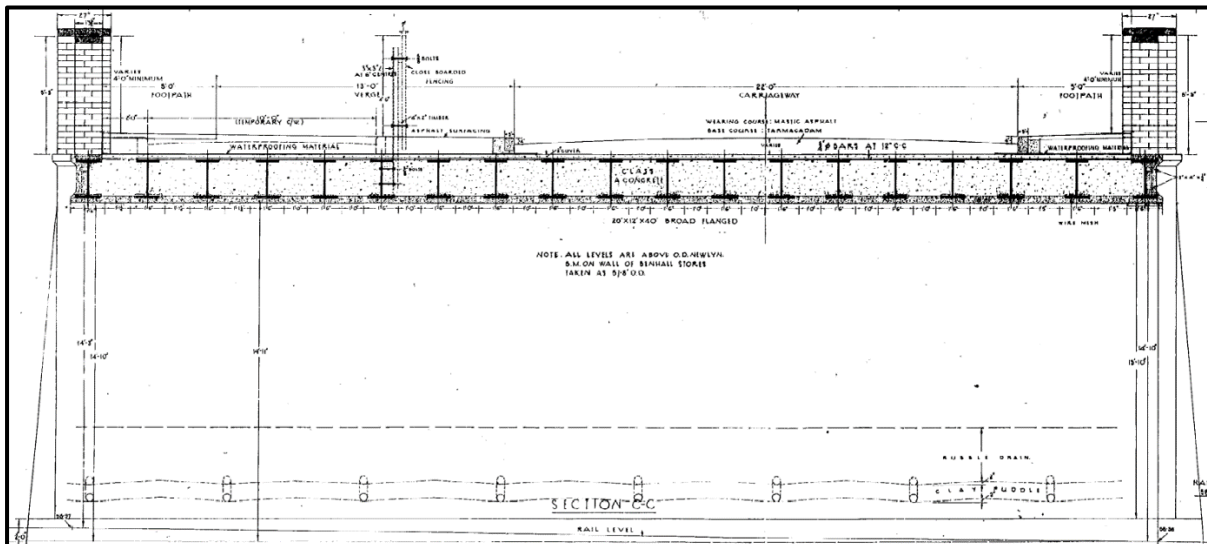
Figure 1: Cross section of Benhall Railway Bridge

The bridge deck comprises 19 steel I-beams encased in reinforced concrete supported by mass concrete abutments and wingwalls, which are founded on 0.5m diameter bored piles.

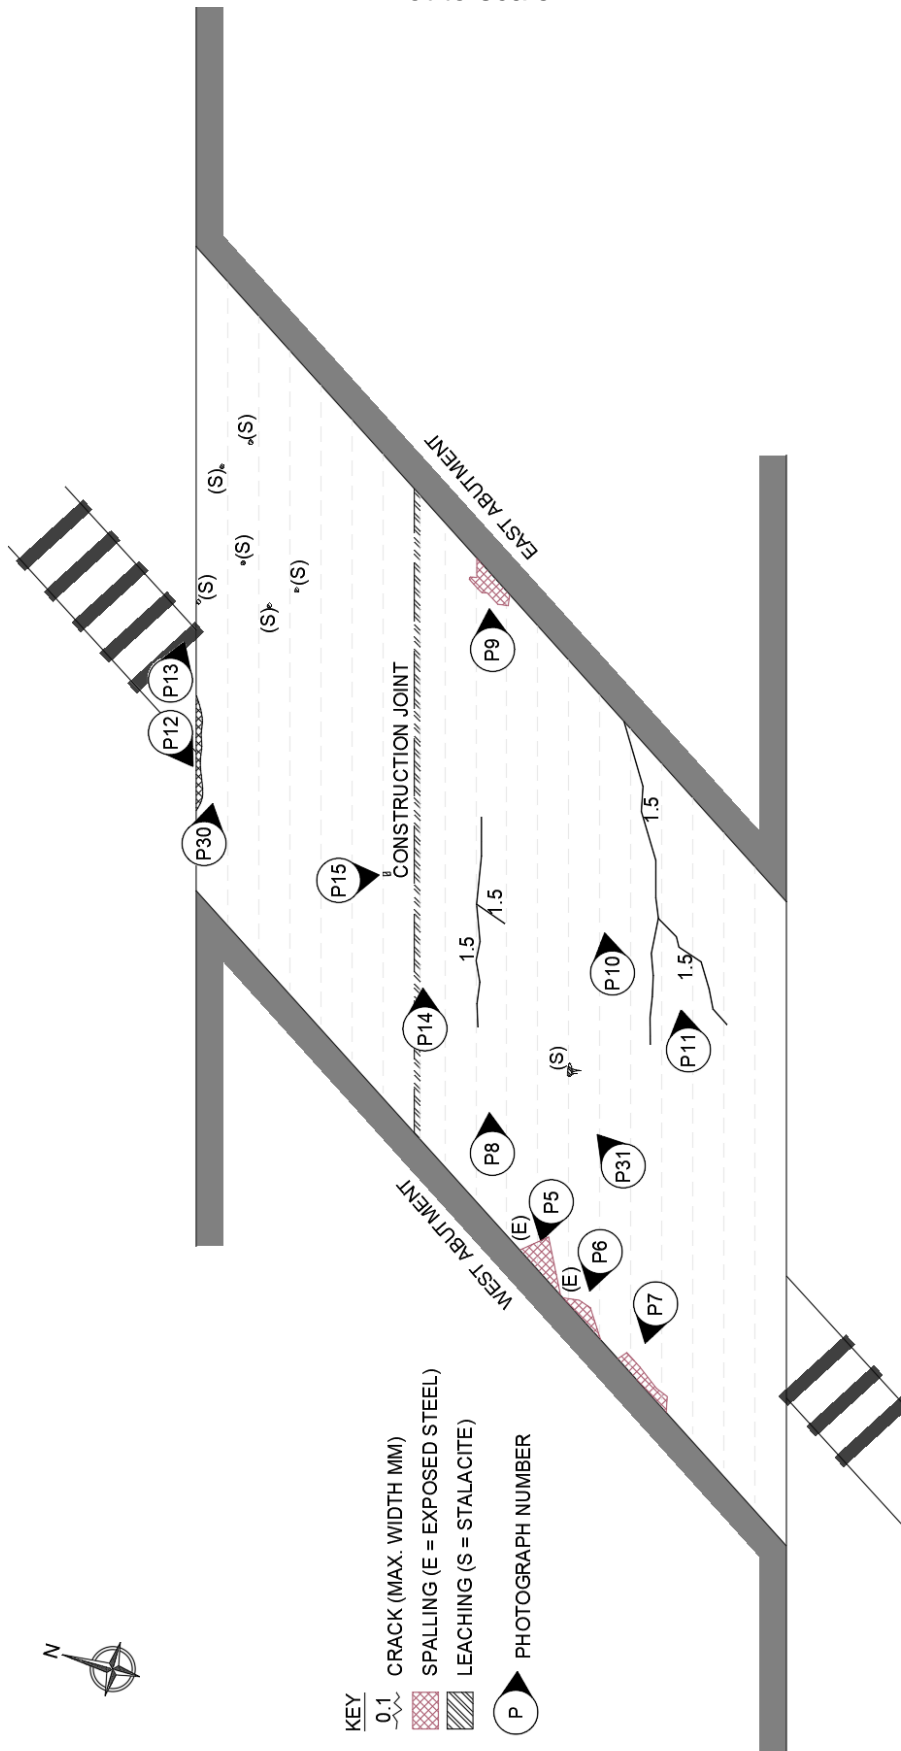
DIAGRAM D1 – BRIDGE SOFFIT

Multiple areas of hollow and spalled concrete concentrated to the West deck edge adjacent the West abutment. Two areas of spalled concrete exposing corroding steel I beam encased within.

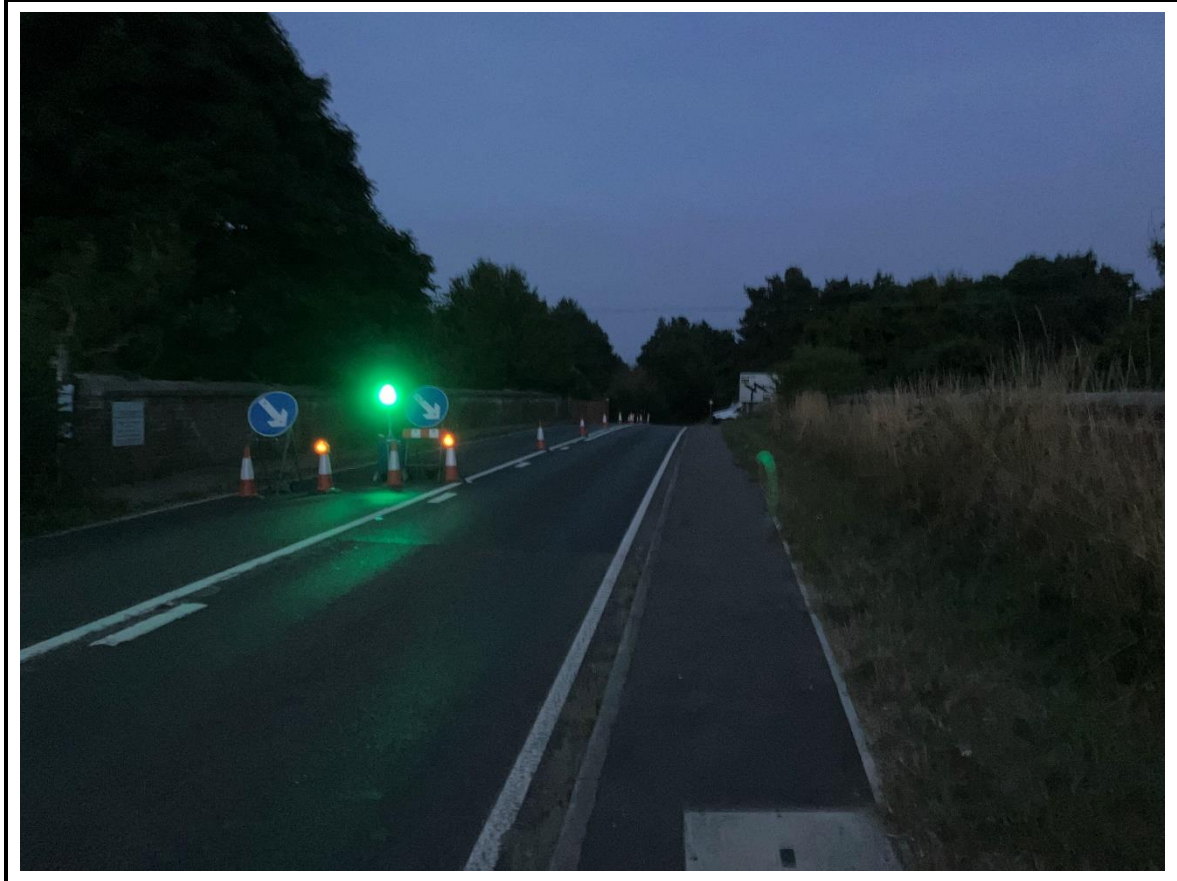
1717_P42_2024 West view - Carriageway
