Section 19 Flood and Water Management Act 2010
Wetheringsett-cum-Brockford Flood Investigation – Storm
Babet 2023

Name	Date
Report Author	John Jousiffe	
Responsible Officer:	John Jousiffe	
Checked by:	Ellie Beecroft	17/09/2024
RMA Review:		08/10/2024
Approved by:	Matt Hullis	08/11/2024
Date Published		11/11/2024
Date Report Closed

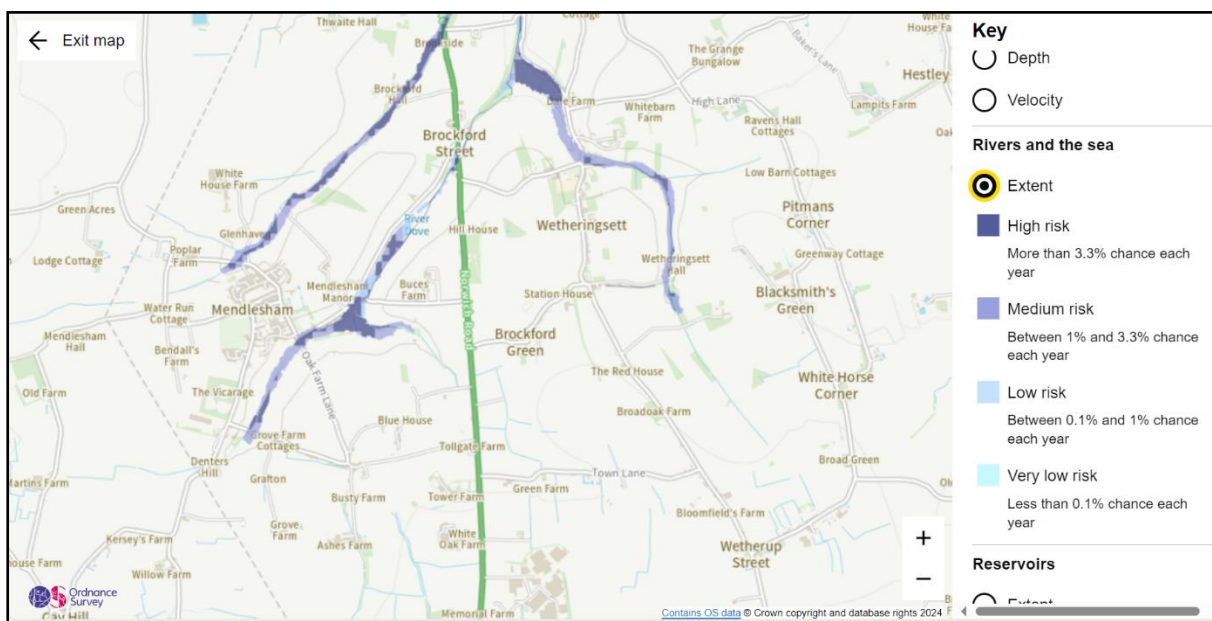
Figure 7 – Fluvial Flood risk map

Fluvial flood risk, described as water overflowing out of watercourses, is evident in the area. The River Dove (designated main river) runs through the Brockford Street area, flowing south to north. There is a significant watercourse that flows through Wetheringsett, before discharging into the River Dove, just north of the village. The map shows significant flood risk to central Wetheringsett and Brockford Street from the watercourses, in particular where the river crosses the A140, northwest Wetheringsett and the southern end of Brockford Road, see figure 7.

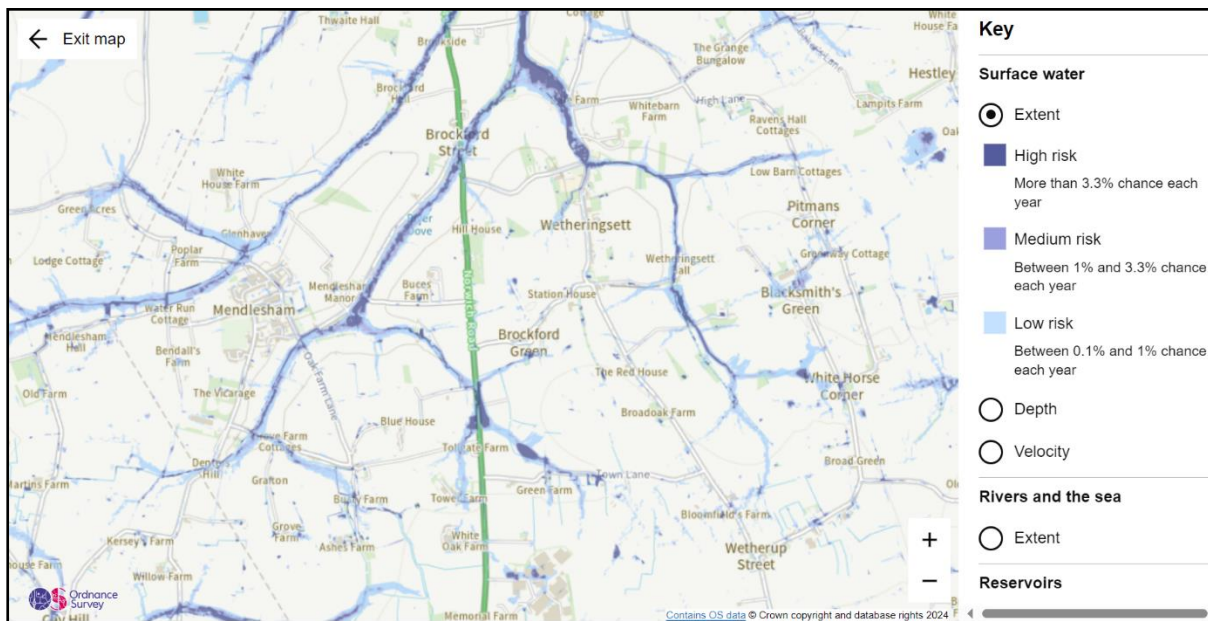
Figure 8 – Surface water flood risk map

The catchment is also at risk from pluvial flood risk (surface water run-off from surrounding land). As seen in figure 8, the flow paths roughly following the line of existing watercourses but also identifies changes in topography and localised low points of risk. Areas include Wetherup Street and Station Road.

As shown in figure 8, there are several flood flow paths which travel from south to north, flowing through Brockford Street and Wetheringsett. These areas are low-lying and noticeably shallower than the surrounding catchment and will be expected to be the primary locations to experience flooding during high rainfall events.

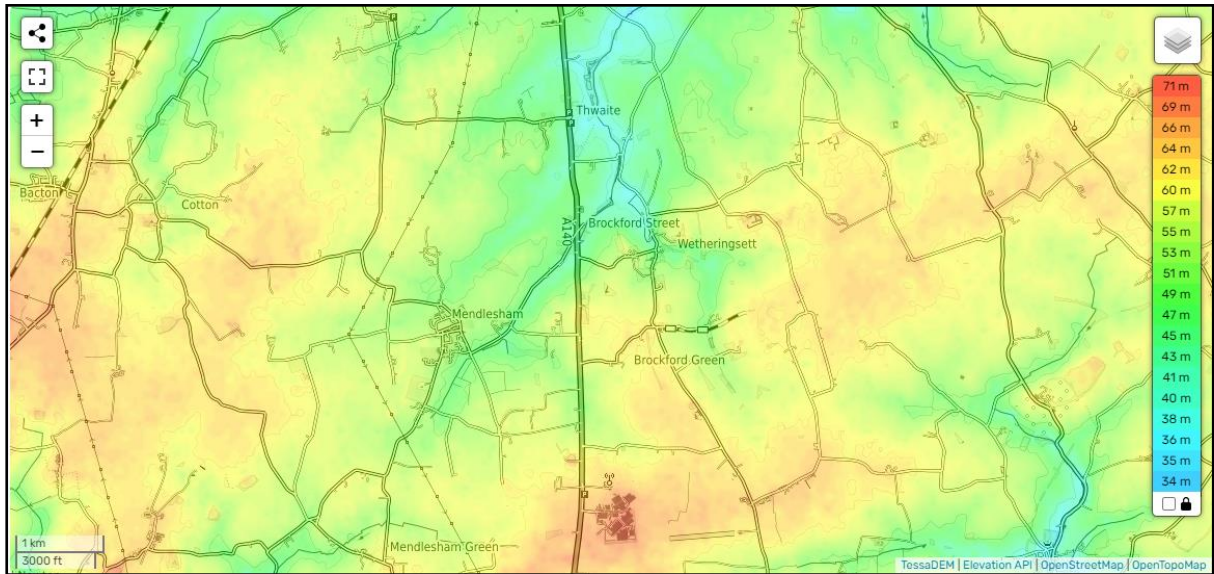
Figure 10 – Topographic map

Areas of Wetheringsett and Brockford Street are significantly lower lying than the surrounding topography to the east, south and west, causing all flow paths in the area to converge in these low spots before continuing their flow north towards the Waveney River (figure 9).

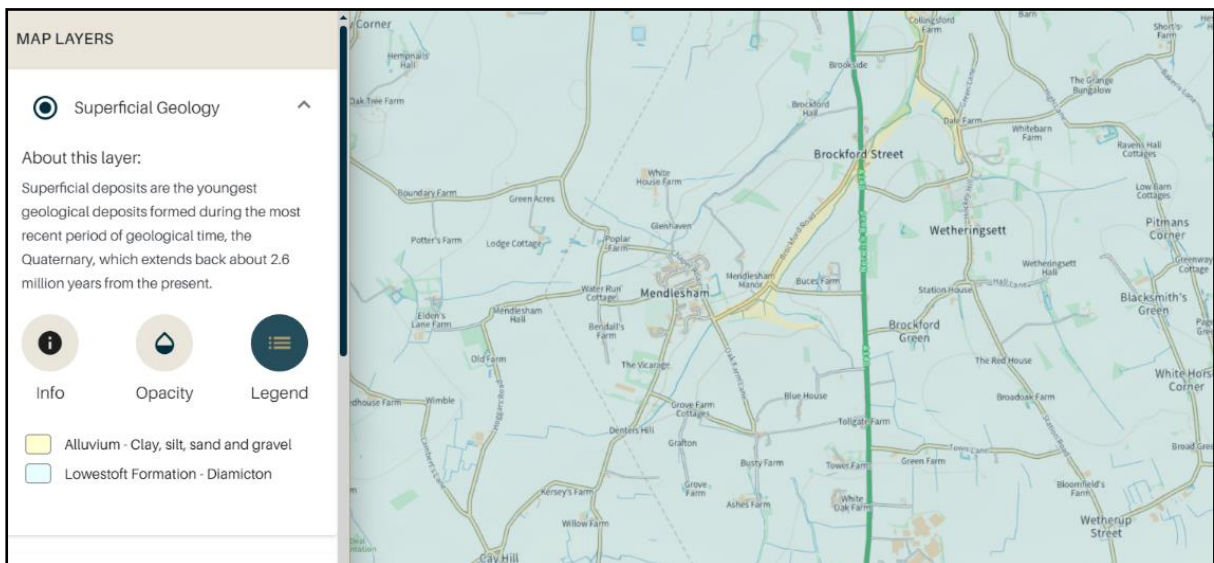
Figure 11 - Superficial Geology

The superficial geology in the area is primarily ‘Lowestoft Formation – Diamicton’ which is described by the British geological survey as a diverse mixture of clay, sand, gravel, and boulders varying widely in size and shape. This is sometimes known as boulder clay. This soil generally has a low permeability meaning water will tend to flow off it before it can infiltrate, which reflects the reports collected during Storm Babet.

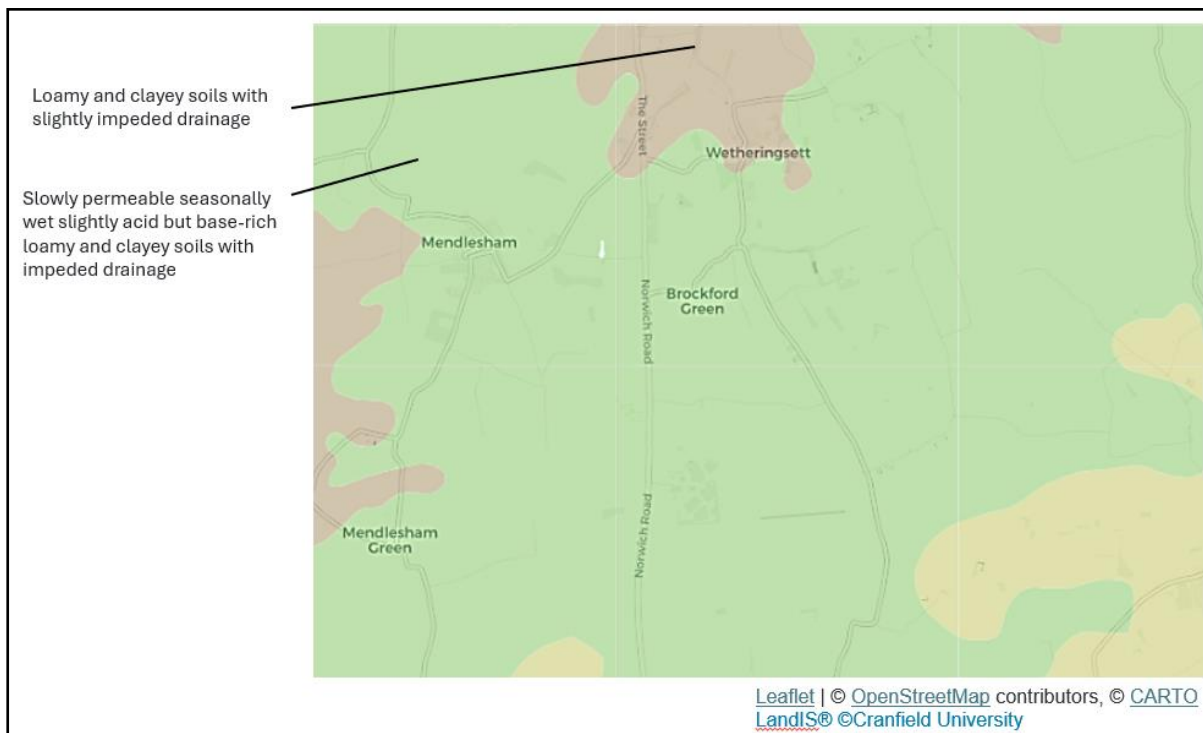
Figure 12 - Area map of soil composition

The soils in the area are primarily comprised of slowly permeable seasonally wet loamy and clayey soils with impeded drainage (see figure 12). This matches descriptions from the event of significant levels of surface water runoff and limited infiltration into the ground.
